Catalogue of iron and bronze cannon on the Black Swan site.

Catalogue of Iron and Bronze Cannon from Odyssey Marine Exploration's Black Swan Site

Sean Kingsley

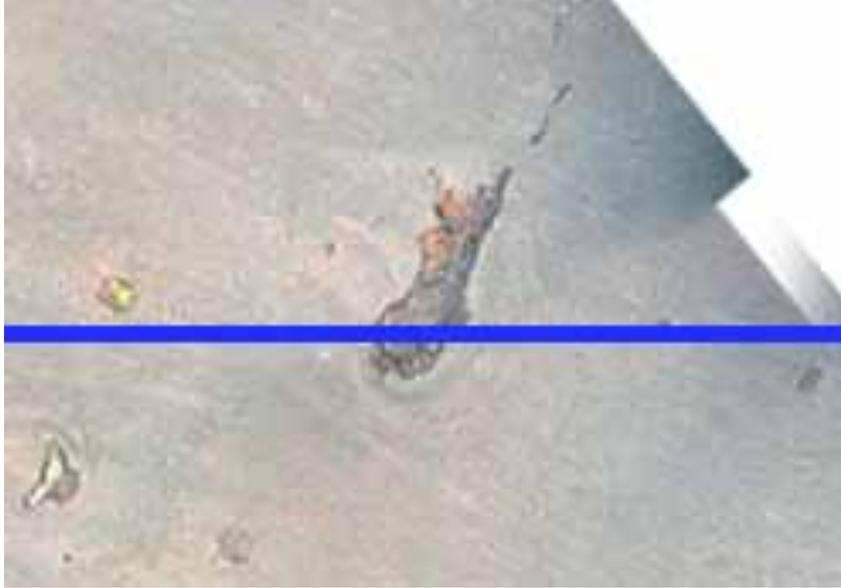
Fig. 1. Black Swan Cannon C1

Oriented with possible muzzle facing south-west. North-eastern quarter covered by light sediment and apparently extensively corroded. Visible L. 1.1m.

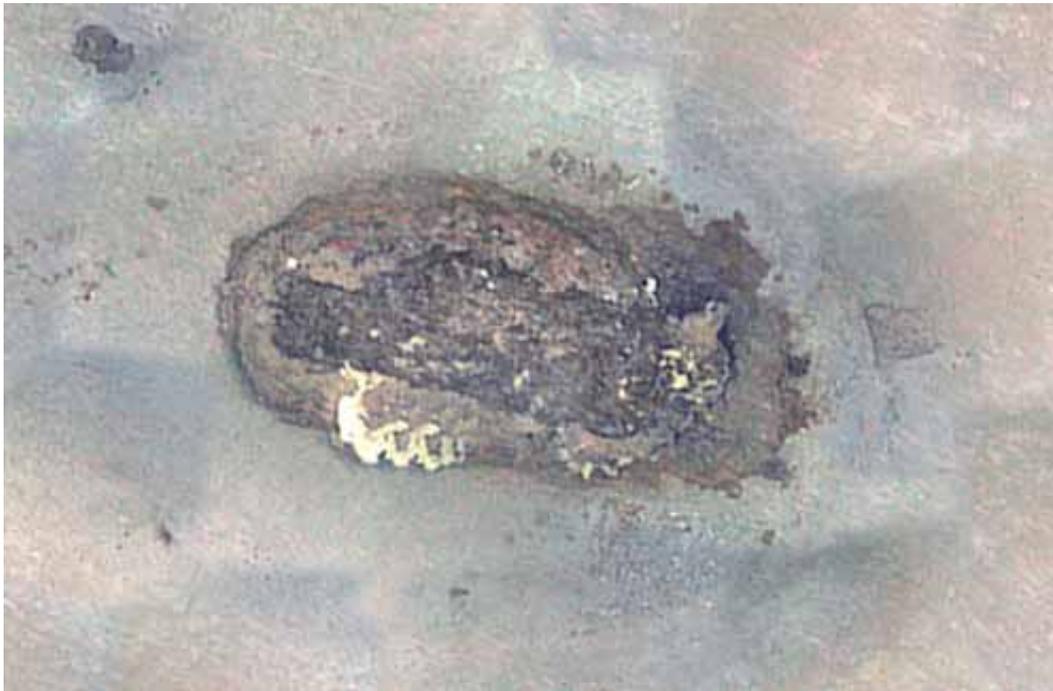
Fig. 2. Black Swan Cannon C2

Possible iron gun, heavily corroded; no anatomical shape survives. Oriented on an east/west axis. Visible iron L. 1.7m; concretion platform L. 2.3m.

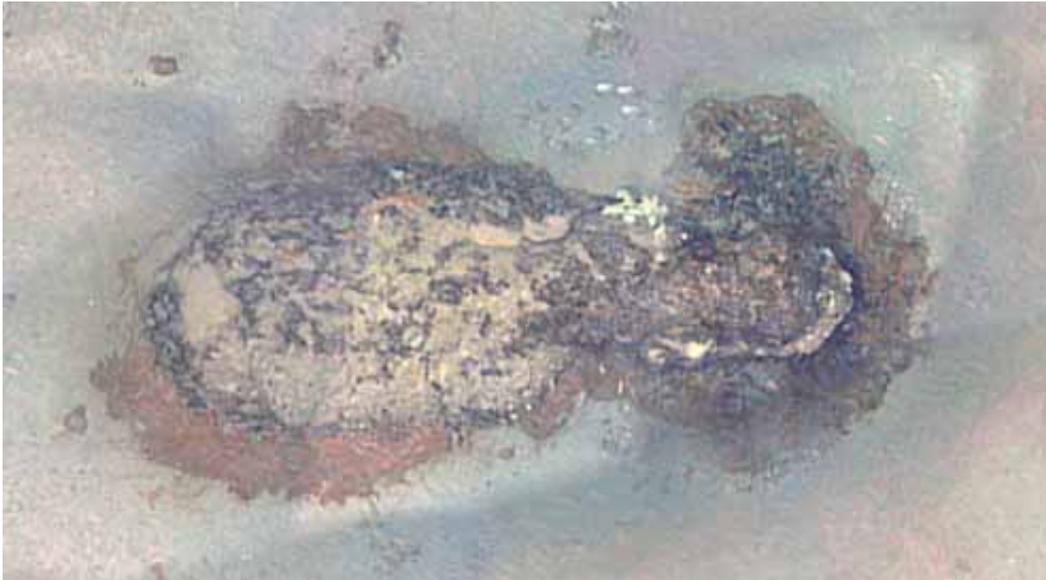
Fig. 3. Black Swan Cannon C3

Iron gun; no distinct shape survives. Oriented east/west. Visible iron L. 2.5m; massive concretion platform L. 3.1m and 1m wide. Additional rust-coloured leaching below this platform.

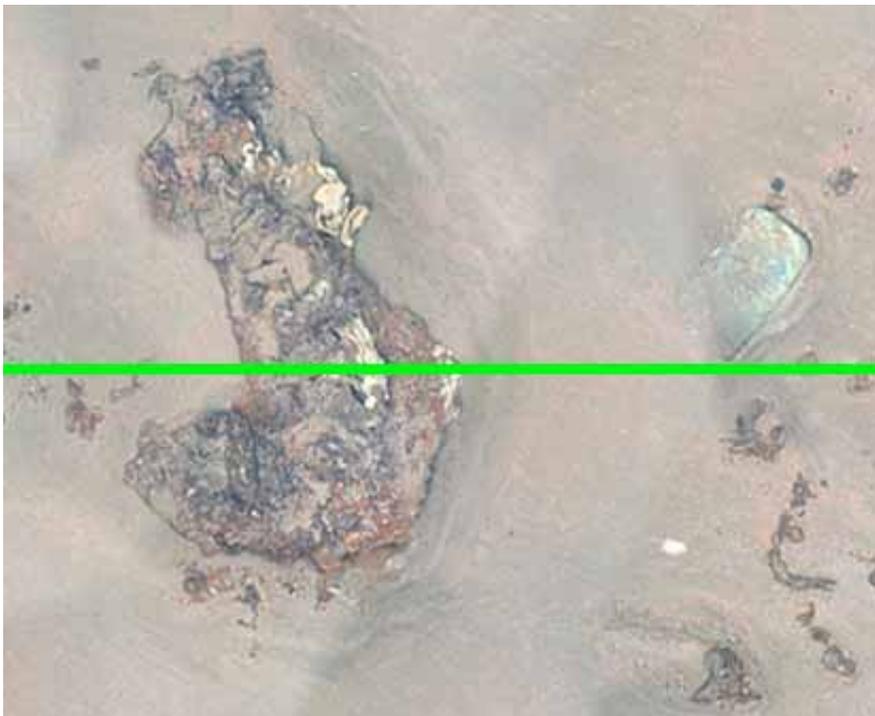
Fig. 4. Black Swan Cannon C4

Probable iron cannon, very heavily corroded concretion. Oriented northwest-southeast. Concretion L. 1.9m. Sponge growth on north-east side. Dense corrosion pedestal at south.

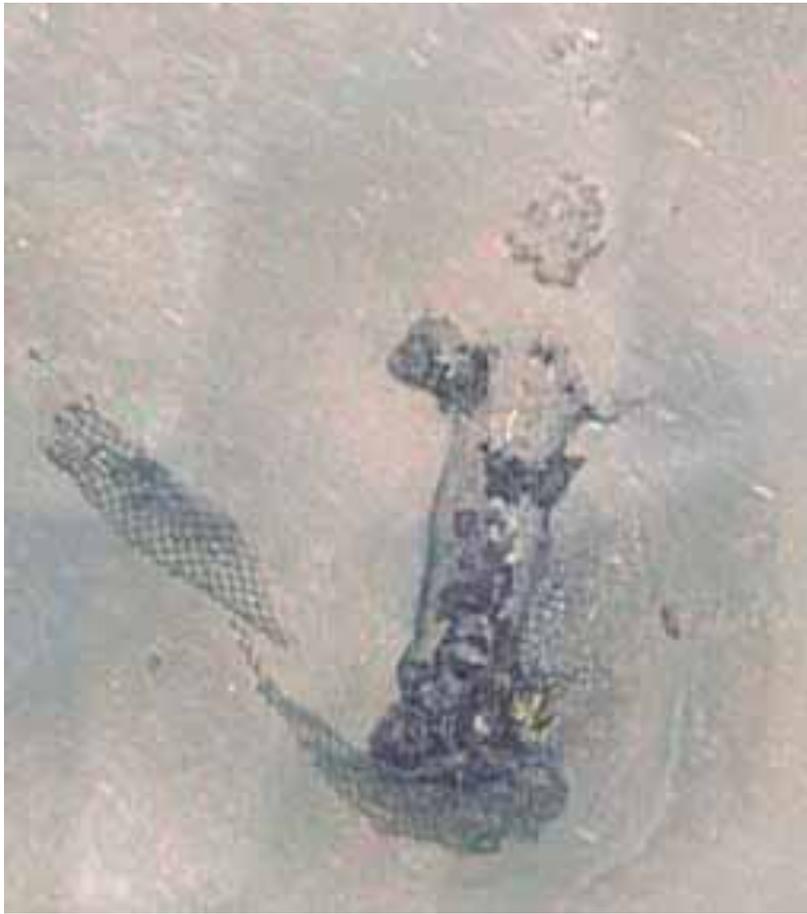
Fig. 5. Black Swan Cannon C5

Iron cannon with fishing net trapped around the southern end, lying on a flat, horizontal plane. Probable muzzle oriented southward. 1 trunnion visible on western flank. Northern half of cannon covered by light sediment, no less than 10cm deep. Typical kind of concretion found on marine sites; no leach pedestal. Visible L. 1.9m.

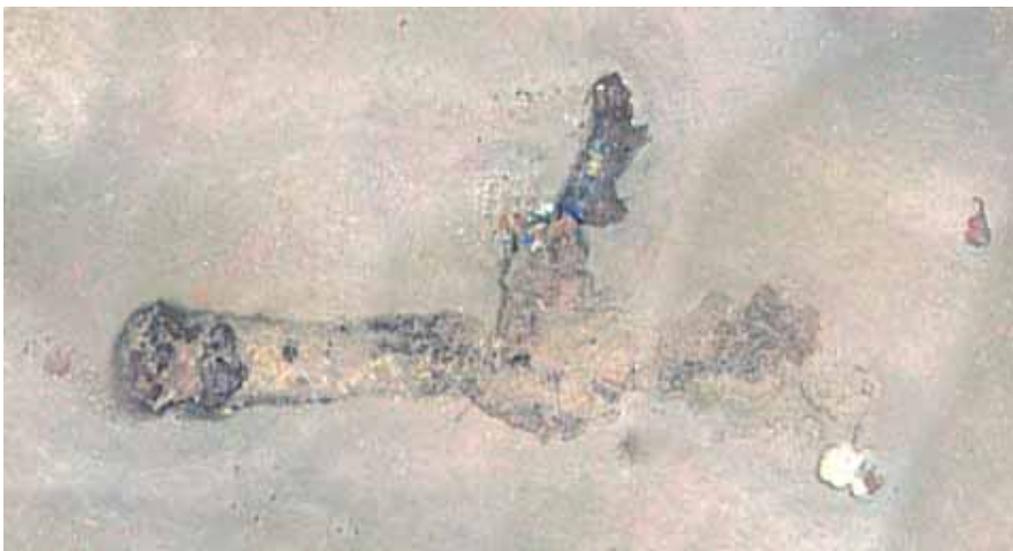
Fig. 6. Black Swan Cannon C6

Broken iron gun, muzzle oriented west. Preserved along three-quarters of its length, then broken. Normal iron concretion, no corrosion pedestal, but two corroded strips of leaching off the eastern end of gun. L. 1.4m.

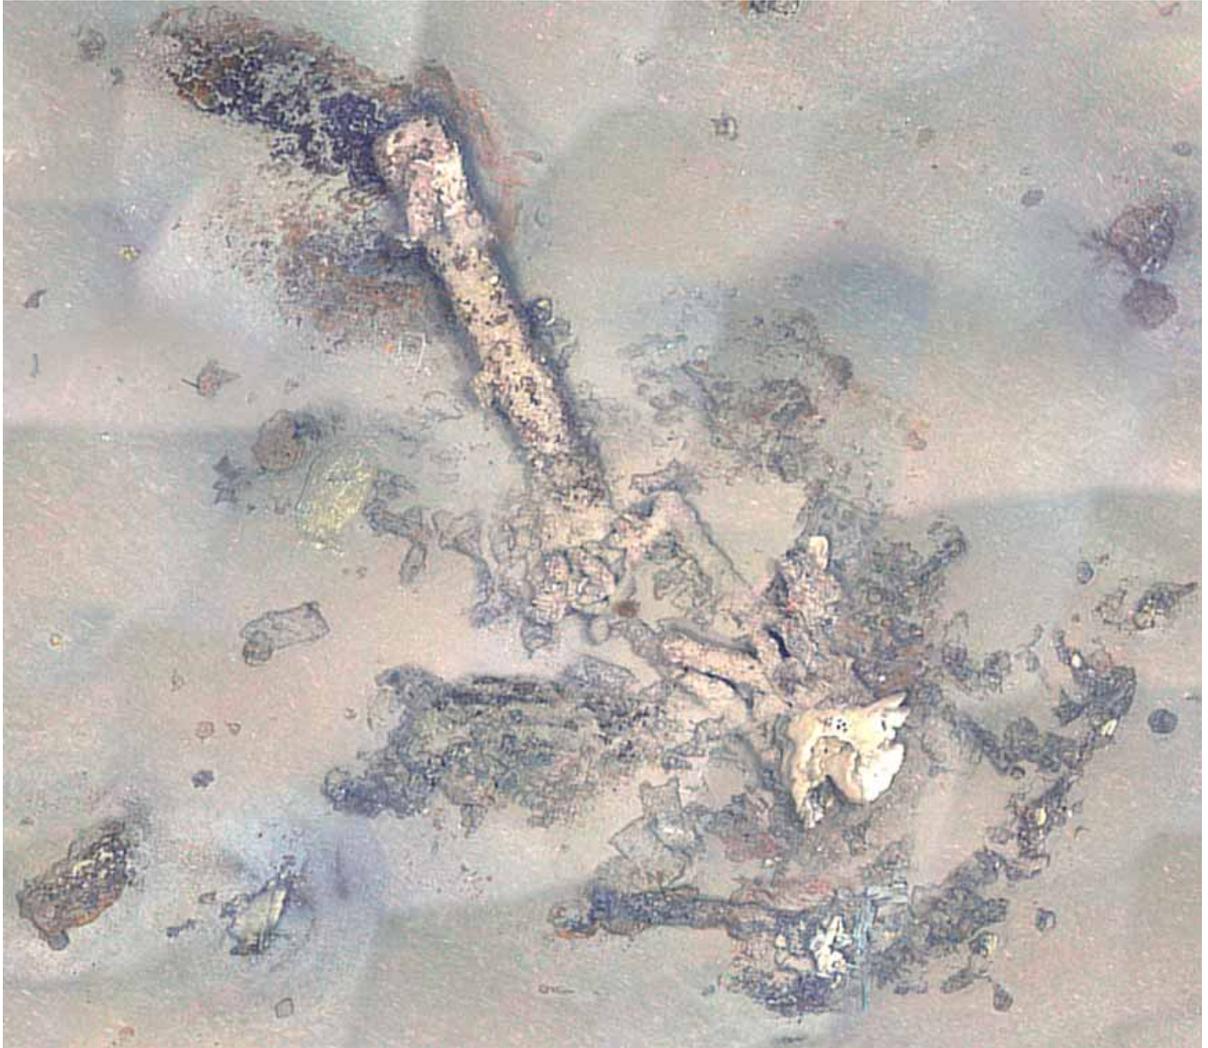
Fig. 7. Black Swan Cannon C7

Iron gun with light concretion and no pedestal. Muzzle oriented south-east. Iron leaching and chunks broken off to the north. Associated with dense area of probable 'rigging' (grid no. R24) immediately to the southeast, covering approximately 3.6 x 3.7m. Gun L. 2.5m. Dense sponge growth affixed to the mass, copper sheathing/tubing to north, 0.7m long. Possible one-armed iron anchor on north edge of rigging, directly facing southern end of cannon C7, either one-armed or with a single arm preserved on western flank and second one broken away. Anchor shank oriented southeast to northwest; arm oriented southwest.

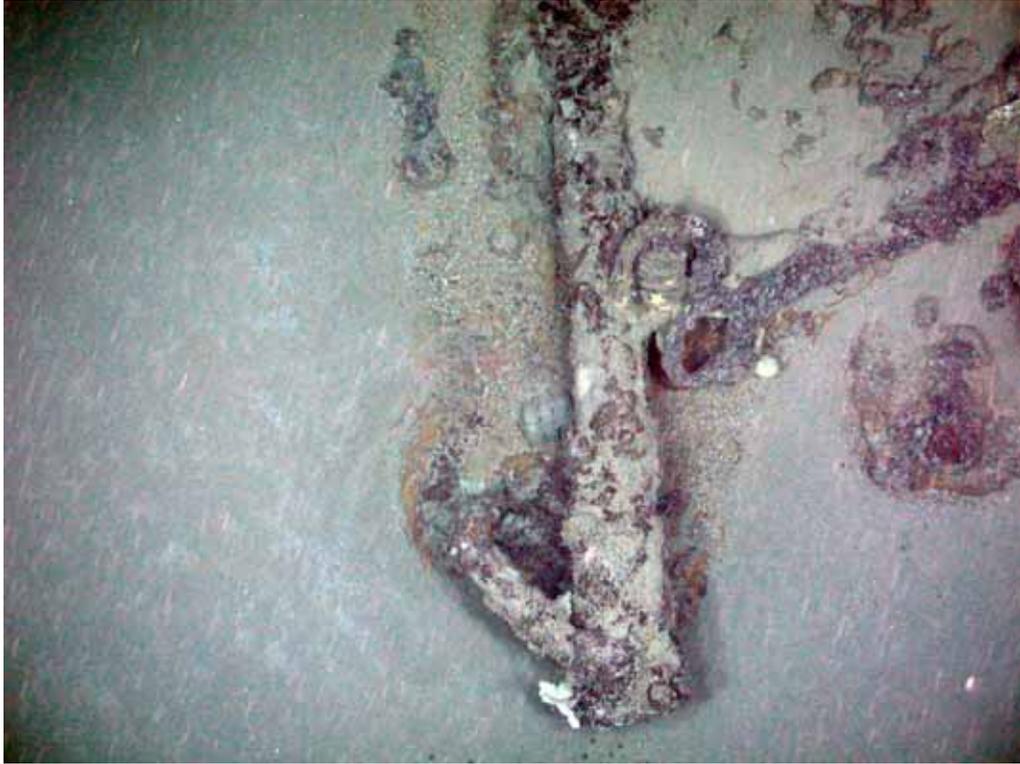
Fig. 8. Black Swan Cannon C8

7.2m south of probable rigging concretion associated with cannon C7 an iron gun retains its original shape within a thin concretion. The muzzle faces northwest. Contrary to Delgado (point 112, annex 9.35), this iron object is not an anchor because it narrows from south to north. Anchor shanks are straight-sided. Two iron rings are concreted to the sides of the gun: one on eastern side of the cascable, the other three-quarters down, towards the muzzle, on the western flank. L. 1.7m. Two sets of rope oriented east/west, spaced 0.6m apart, run at right-angles to C8 along its southern half. The northern rope is 1.8m long and touches C8, terminating with a loop c. 0.3m long and 0.25m wide. Mass of undeterminable probable rigging concretion to west. Traces of two other rope sections also oriented east/west and running directly parallel to the material associated with C8 located 4.8m northwest of the ring-looped northern rope element.

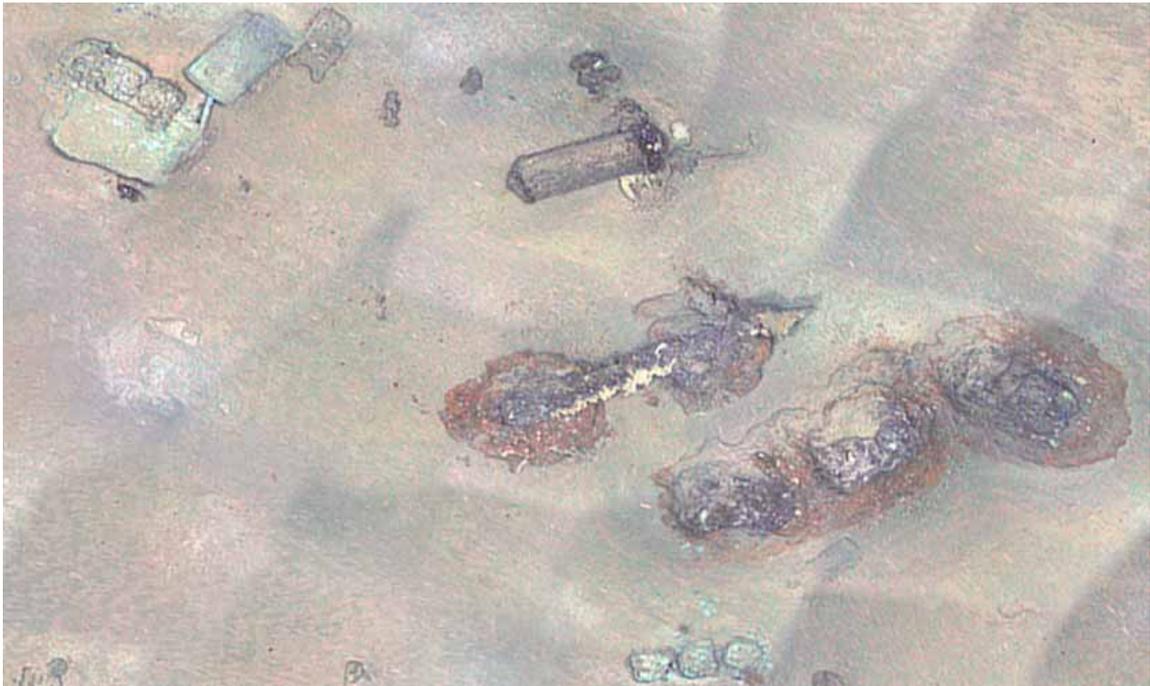
Fig. 9. Black Swan Cannon C9

Corroded remains of two possible parallel iron gun platforms. Oriented southwest-northeast. Ring encrusted to north-western example, which has two distinct leach platforms around each end, but is unlikely to be an anchor because the object narrows marginally from west to east, perhaps an indication that the muzzle lies to the east (if the anatomy has not been distorted by iron corrosion). However, neither a muzzle, cascable swelling or trunnions are visible. The southern concretion has split into three lumps with

leach platform around the mass. Though perhaps originally an iron cannon, the anatomy is so badly decomposed that no identification can be secured. Northern gun (C9) L. 1.7m; concretion L. 2.2m. Leach platform W. 1.0 x 0.7m. Two copper ingots, one tin ingot, coin clump and possible copper spike to northwest; miscellaneous iron tubular object to north; coin clump to south.

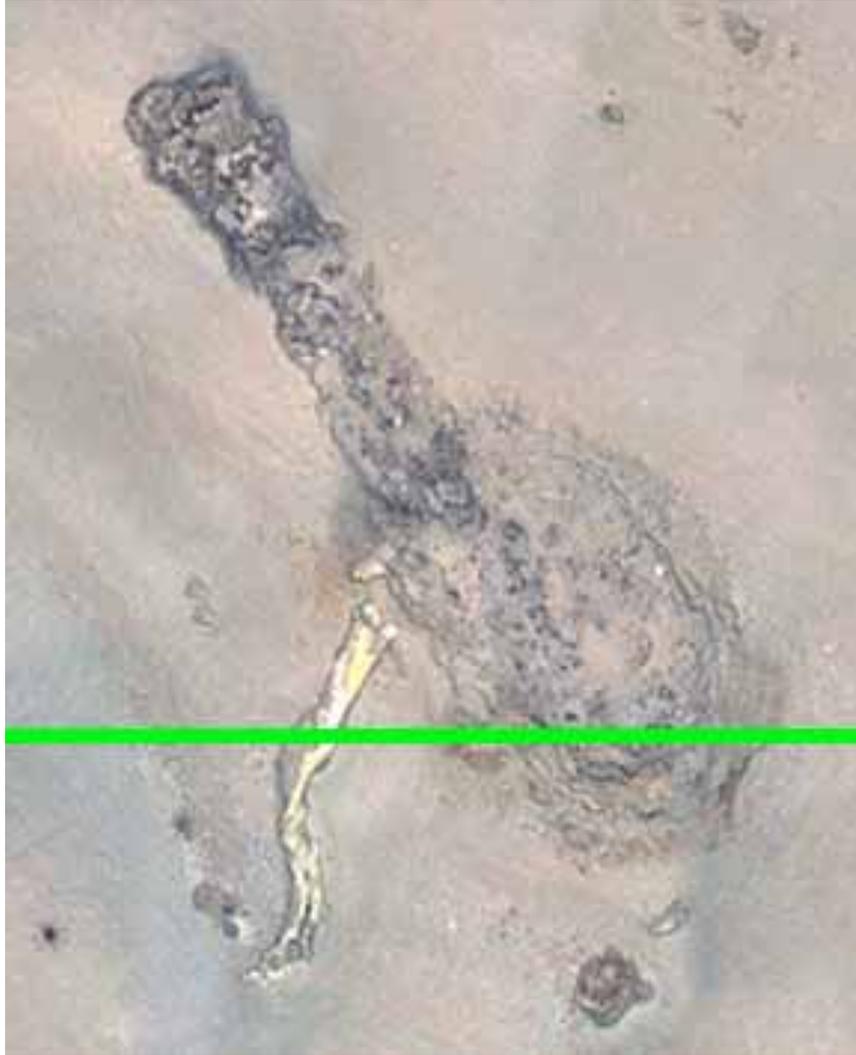
Fig. 10. Black Swan Cannon C10

Iron gun with lead pipe on western side. Muzzle faces northwest. Typical marine concretion along northern half, but dense corrosion pedestal across southern half. Cannon L. 2.4m; total L. with pedestal 2.7m. Lead pipe 1.1m long, extends southwest-northeast with possible junction to northeast.

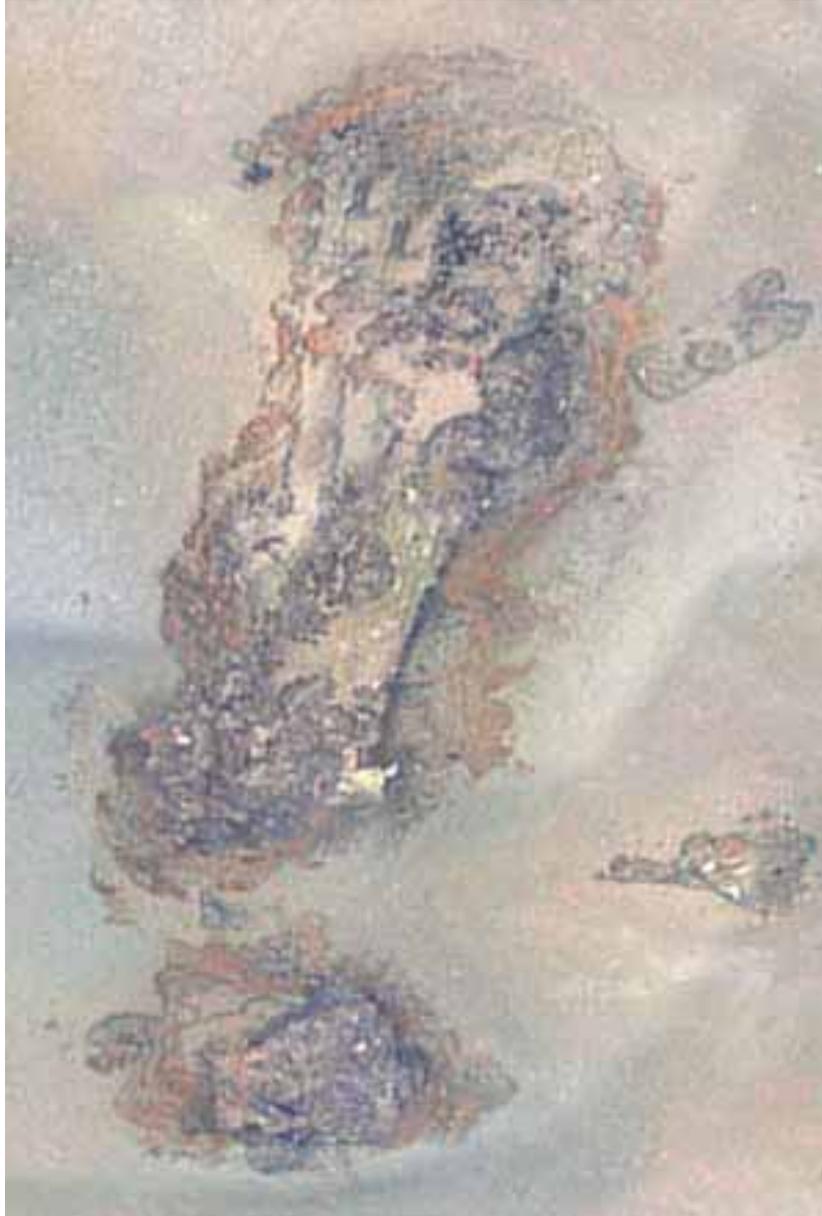
Fig. 11. Black Swan Cannon C11

Very heavily decomposed iron gun on northeast-southwest axis, 2.3m long (preserved length). Heavy corrosion pedestal, with southern end fully decomposed and broken off. Tin ingot to northeast.

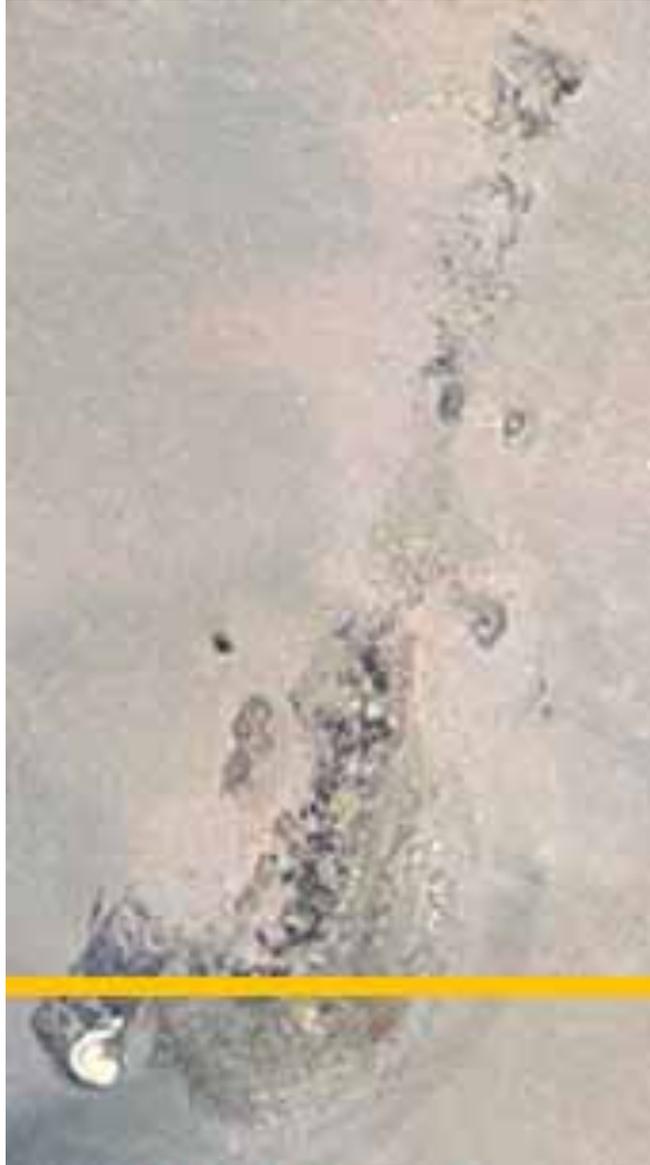
Fig. 12. Black Swan Cannon C12-C13

Two possible iron cannon with both ends lying under shallow sediment. Muzzles oriented in different axes: one to northeast and other to southwest. Concretion platform on east of to southern cannon. Total L. of both guns 2.4m. Southern gun (C12) identification positive; northern example tentative.

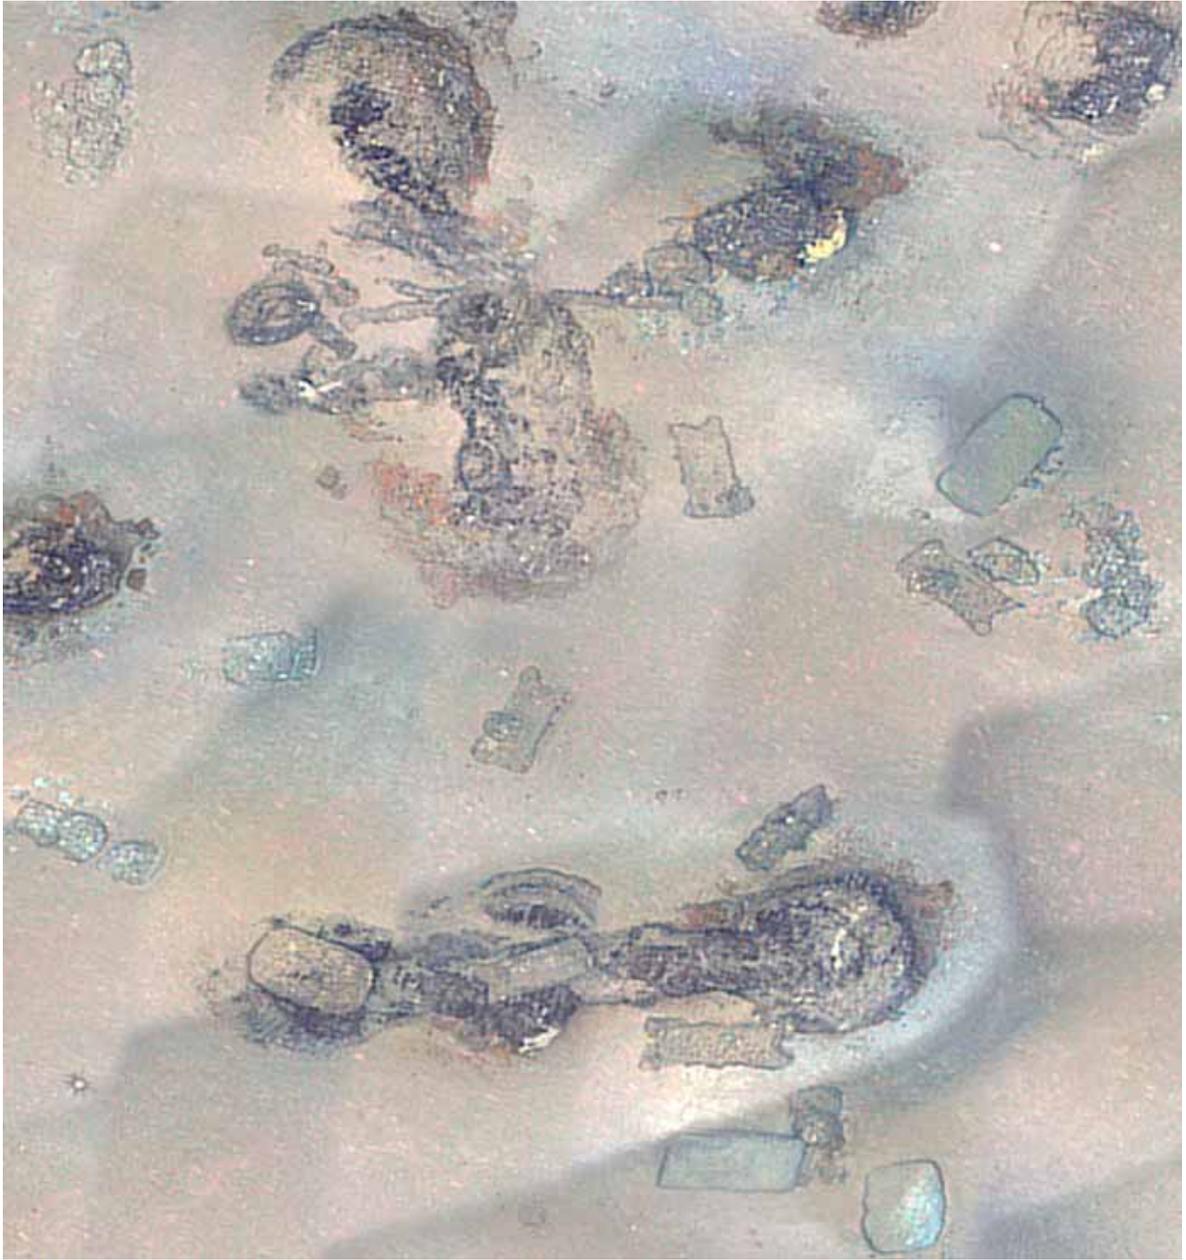
Fig. 13. Black Swan Cannon C14

Iron gun running east-west with a copper and tin ingot overlying it. Dense leach platform at east, narrowing towards the west. Visible iron 2.7m long; total L. of platform 3.4m. Dense area of coin clumps, ingots and probable rigging to north, including a second possible iron cannon, so heavily corroded that no positive identification is possible.

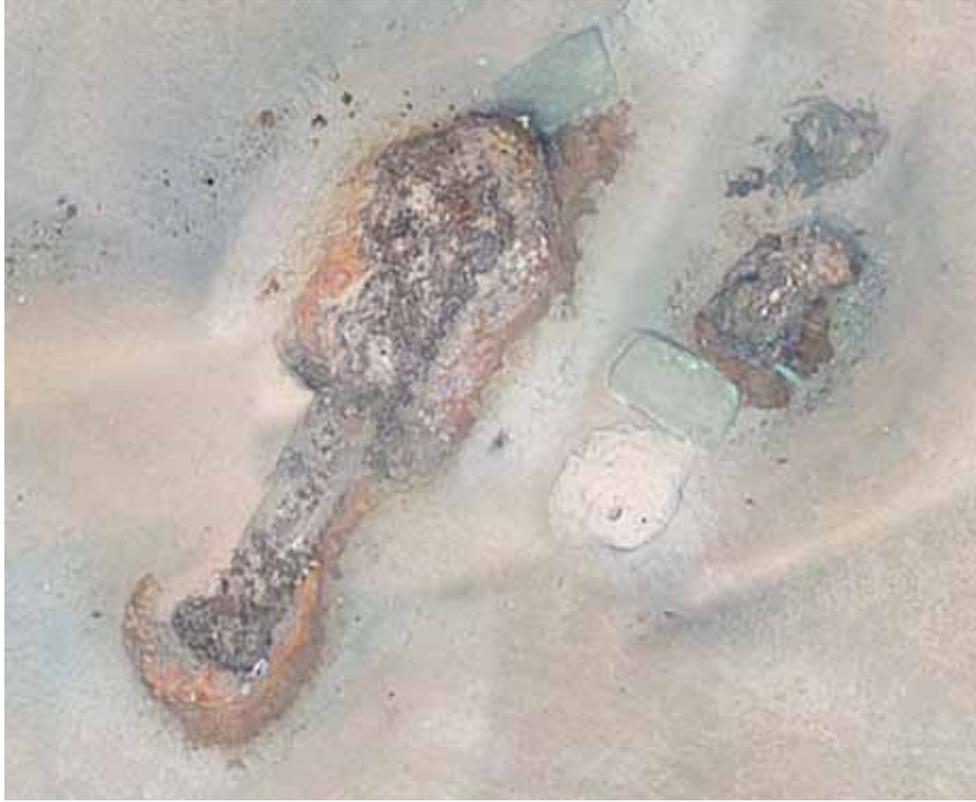
Fig. 14. Black Swan Cannon C15

Iron gun with muzzle facing southwest. Despite heavy corrosion, both muzzle, cascable and western trunnion can be discerned. Gun L. 2.2m long. Concretion stain 2.7m long. Gun W. midway along 30cm. Maximum W. of concretion 1m. The concretion is visibly thicker at the northeast where it is in proximity to a copper ingot.

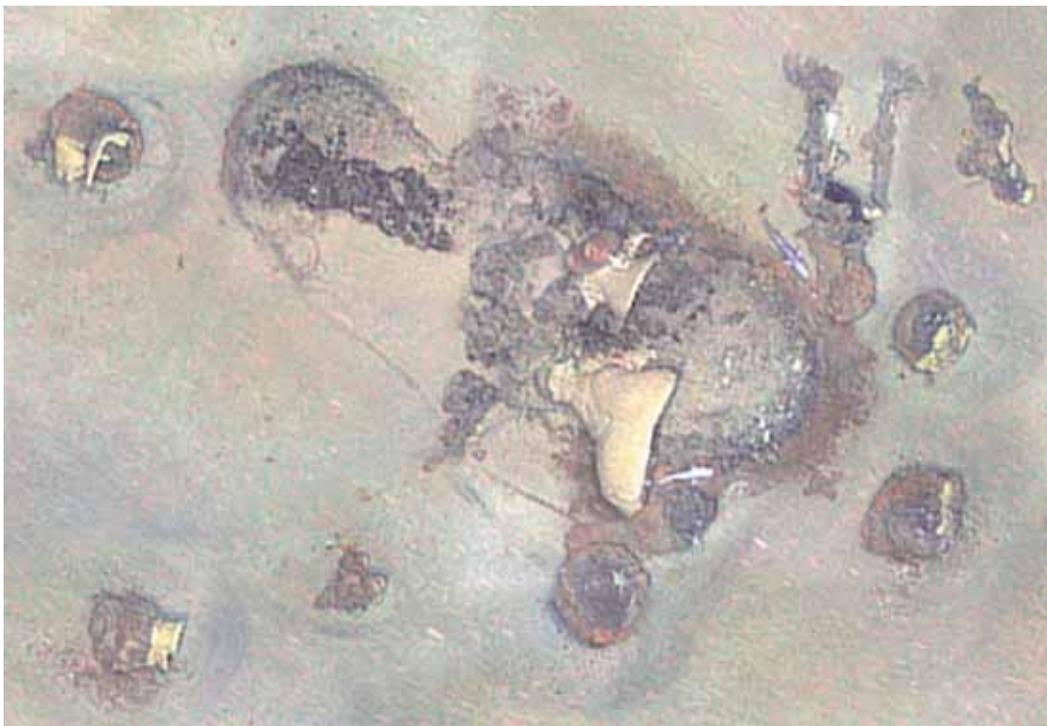
Fig. 15. Black Swan Cannon C16

Very heavily corroded iron gun with probable muzzle facing just north of westward. Gun between centre and muzzle anatomy visible; lower half towards cascable completely decomposed. Sponge overgrowth to south. Total corrosion pedestal L. 3.0m.

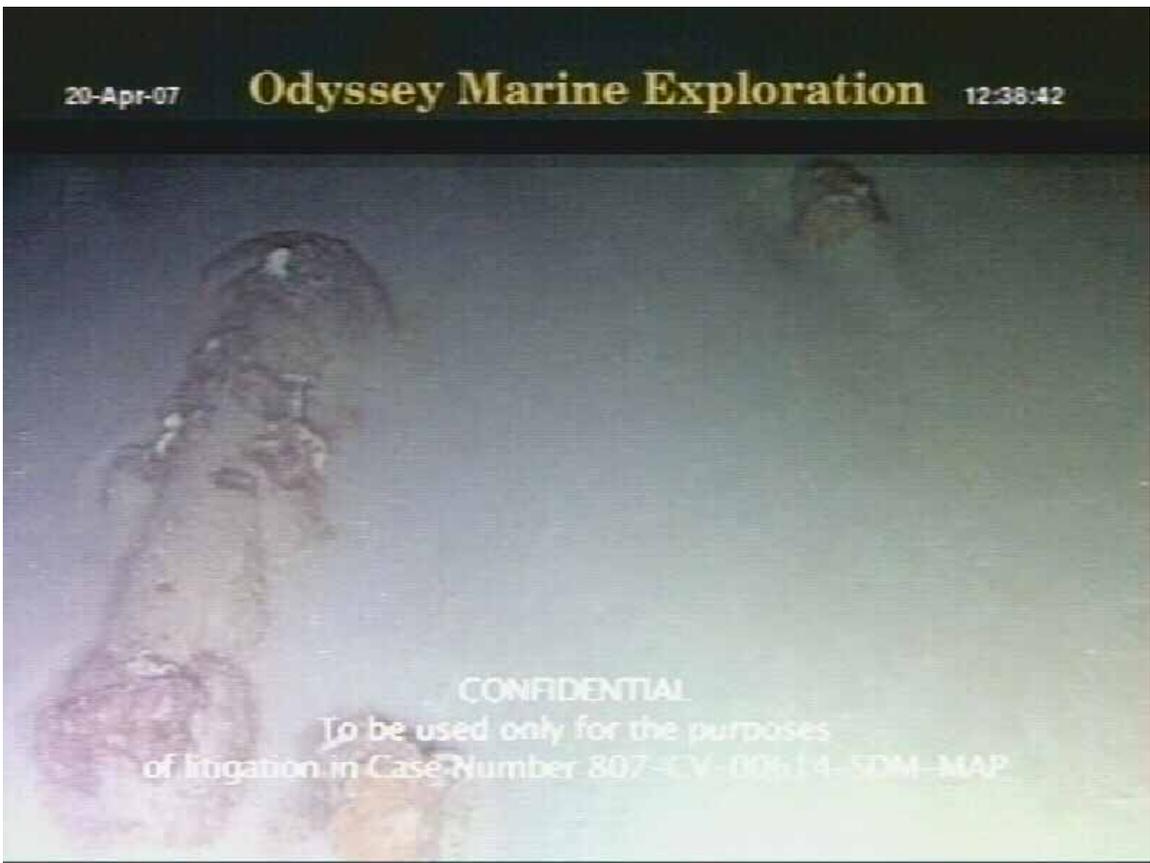
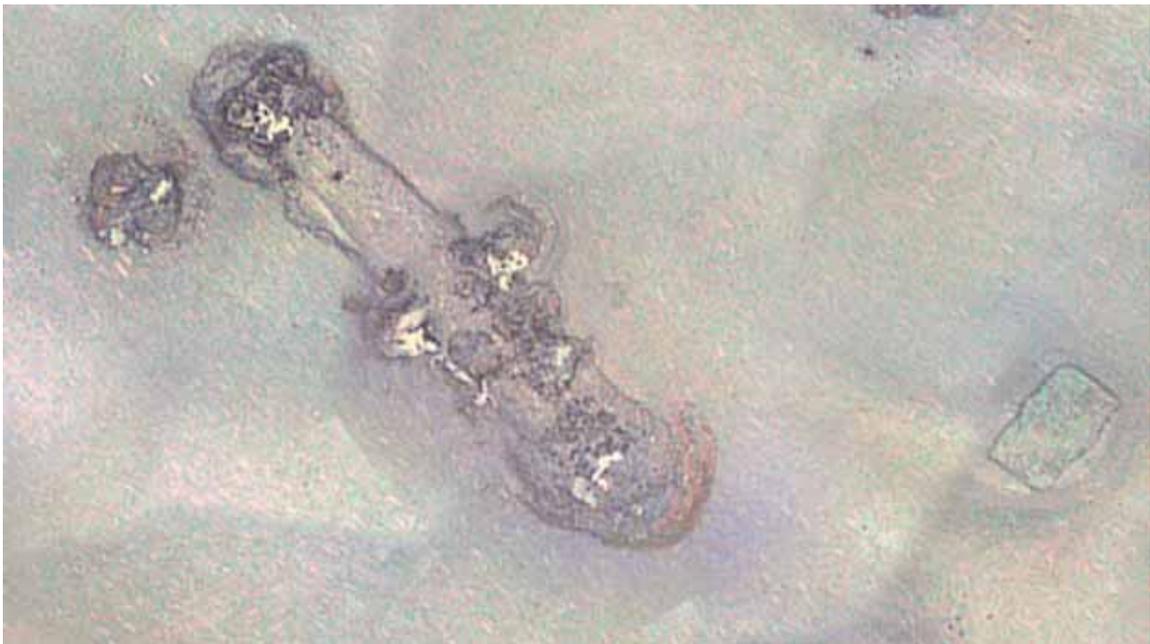
Figs. 16a-16b. Black Swan Cannon C17

Iron gun, intact concretion. Muzzle faces northwest. Narrow corrosion pedestal, mainly at northern and southern flanks. Gun L. 2.65cm; pedestal L. 3.0m.

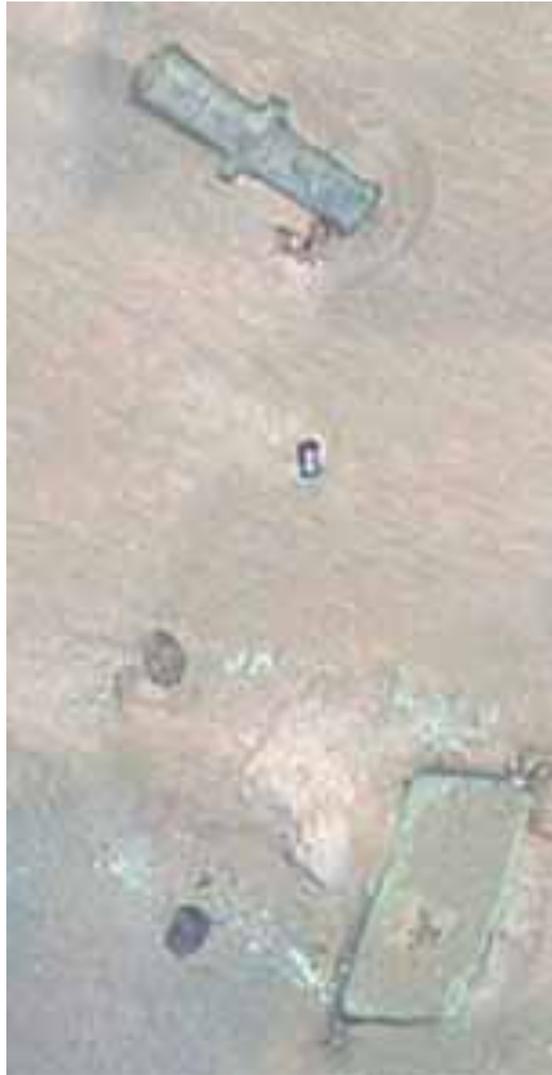
Fig. 17. Black Swan Cannon C18

Intact bronze gun, muzzle facing southeast. Impact crater to southeast. Cascable broken off (antique cannon). L. 0.65m.

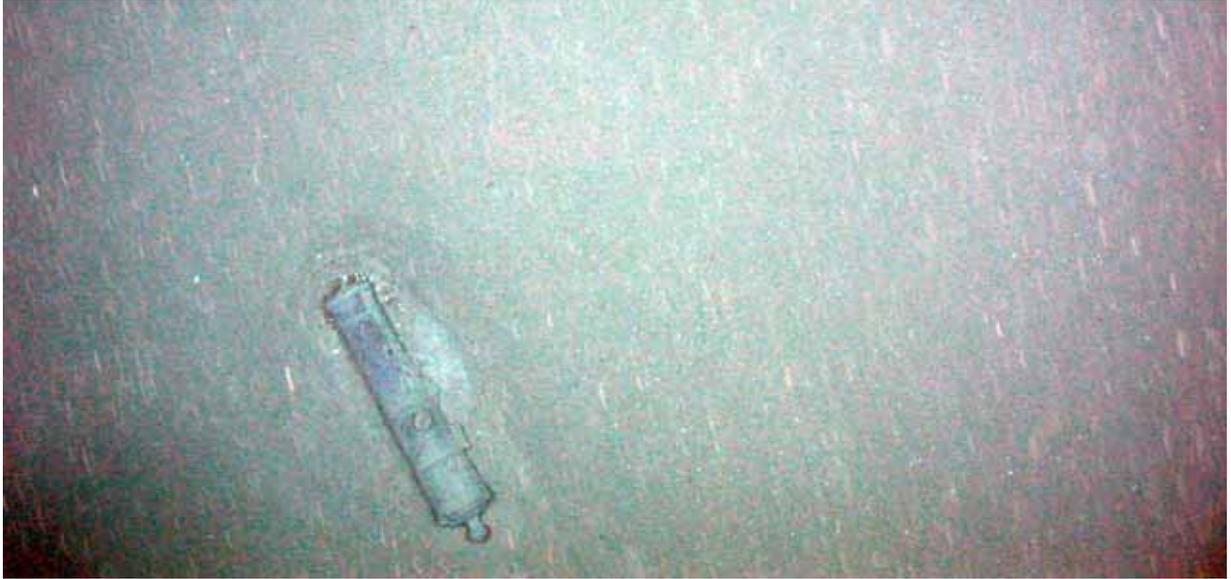
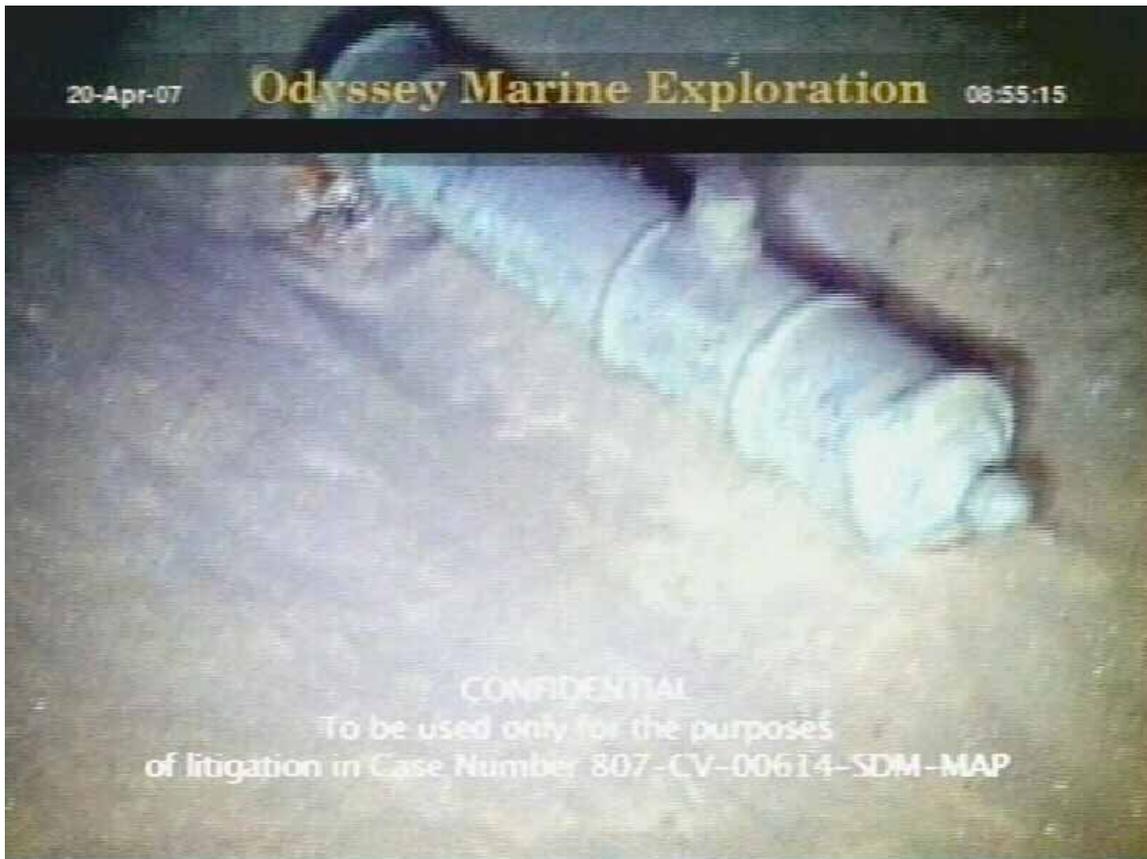
Fig. 18. Black Swan Cannon C19

Intact bronze gun, muzzle facing southeast. No context/isolated. L. 0.7m.

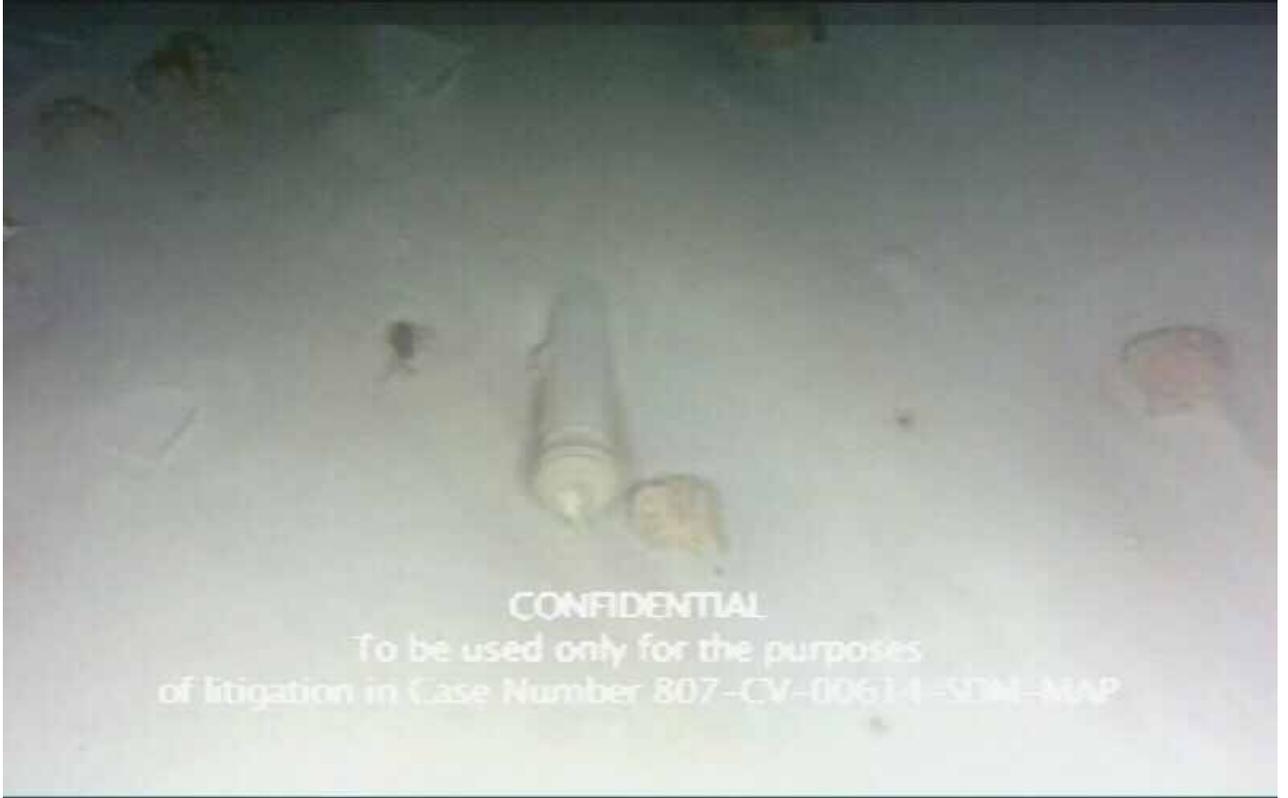
Fig. 20. Black Swan Cannon C20

Bronze cannon. Muzzle oriented northwest, southern half covered by sediment. L. 1.1m.

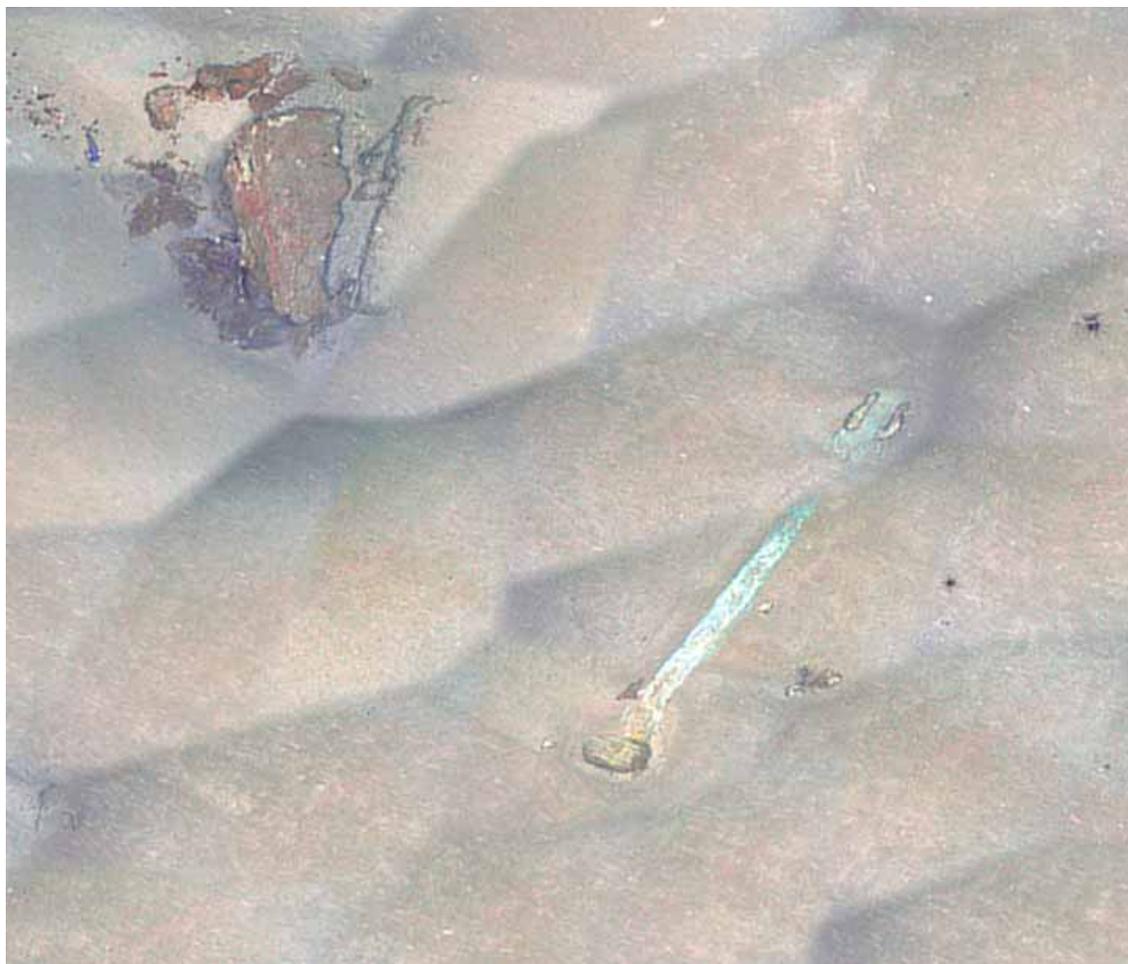
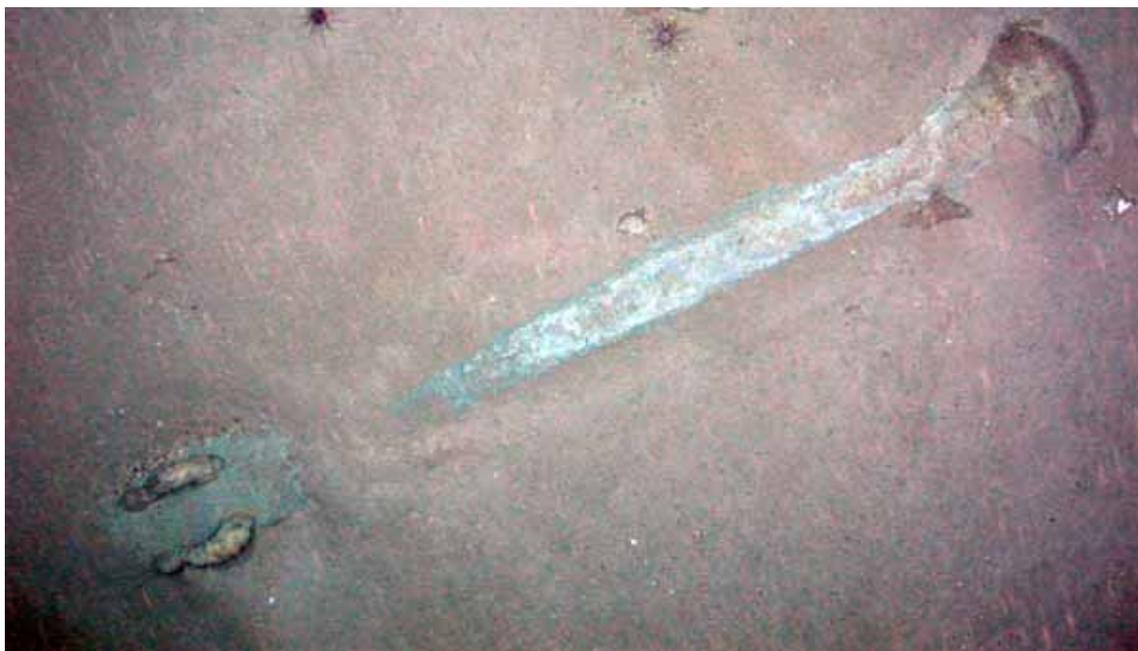
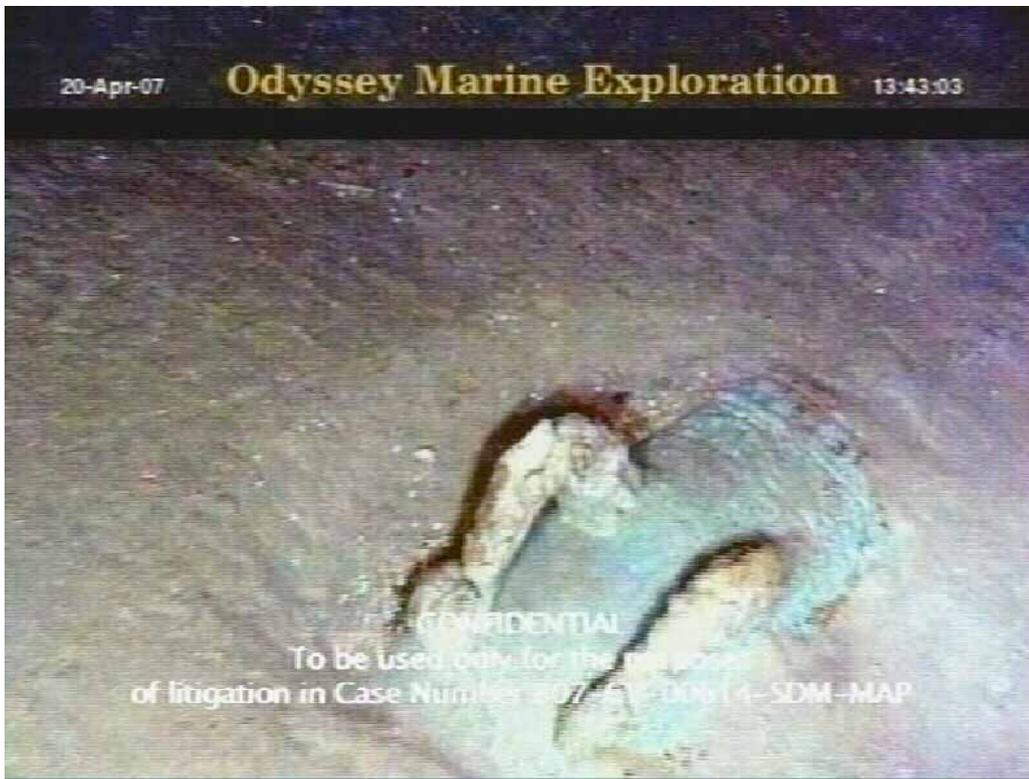
Figs. 21-22. General and close-up views of Black Swan Cannon C21

Bronze antique culverin, muzzle facing south-west. Only visible along half of length. Dolphins at north. Visible L. 2.5m.

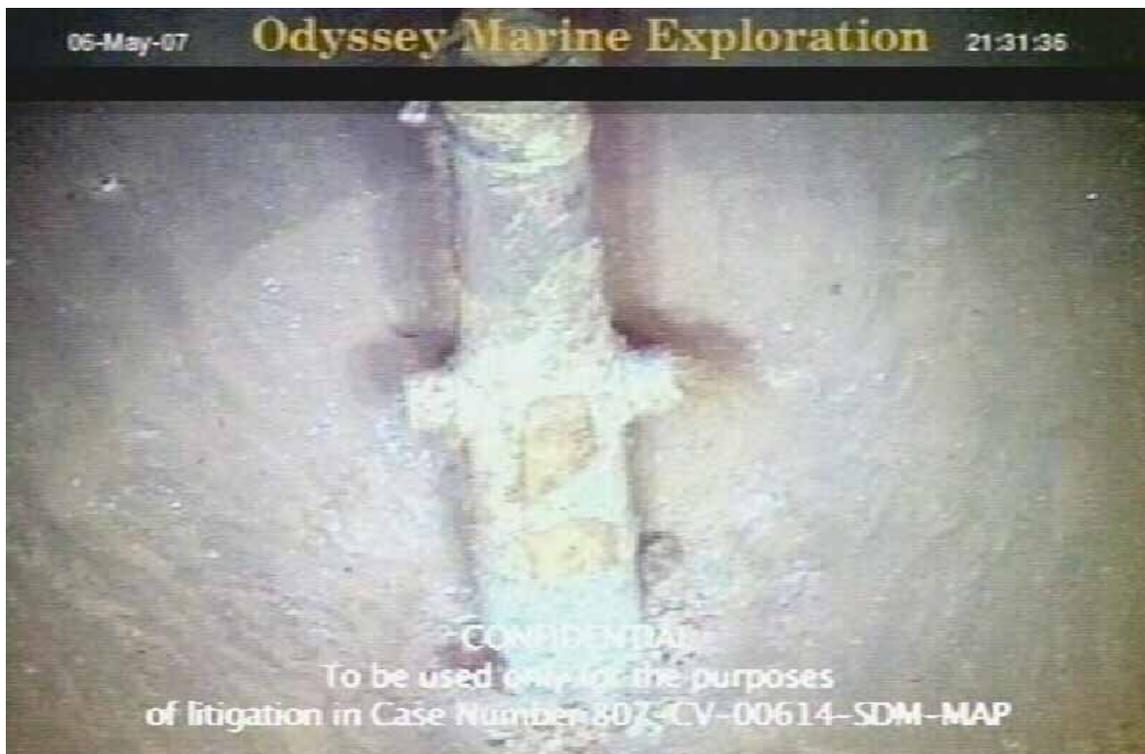
Fig. 24. Black Swan Cannon C22

Bronze cannon protruding vertically out of the seabed, muzzle upwards. Embedded for one-quarters of its length in the clay substrate.
