Expert Report of Randolph Armstrong: Evaluation of Leland Braund ICD (1861 sn214977)

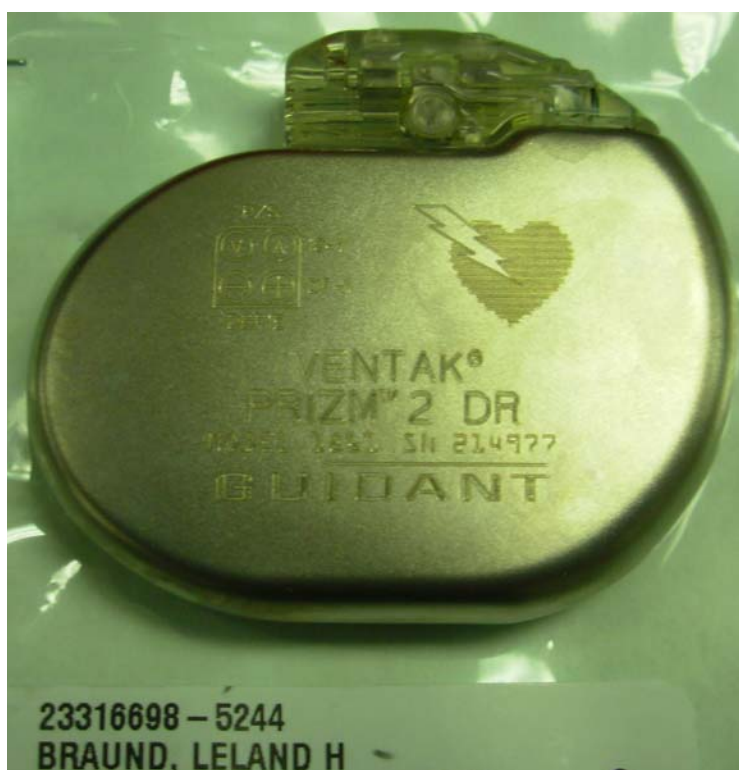
Figure 1

On 20 November 2006 I performed a visual inspection of the ICD (Figure 1) using a stereo microscope (magnification 8-50x) and digital camera.

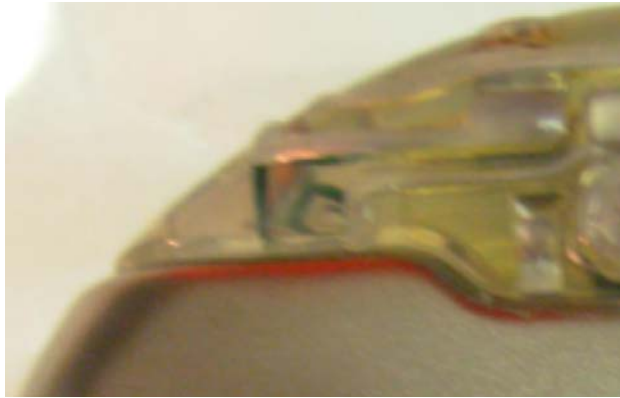
Figure 2

Even without the aid of the microscope it was evident that the DF- wire was routed directly over the backfill tube (Figure 2), which does not conform to the design specification. I have observed such defective routing (over the backfill tube) in 19 of the 20 ICDs I have visually inspected. It was also evident that moisture ingress into the header had occurred.

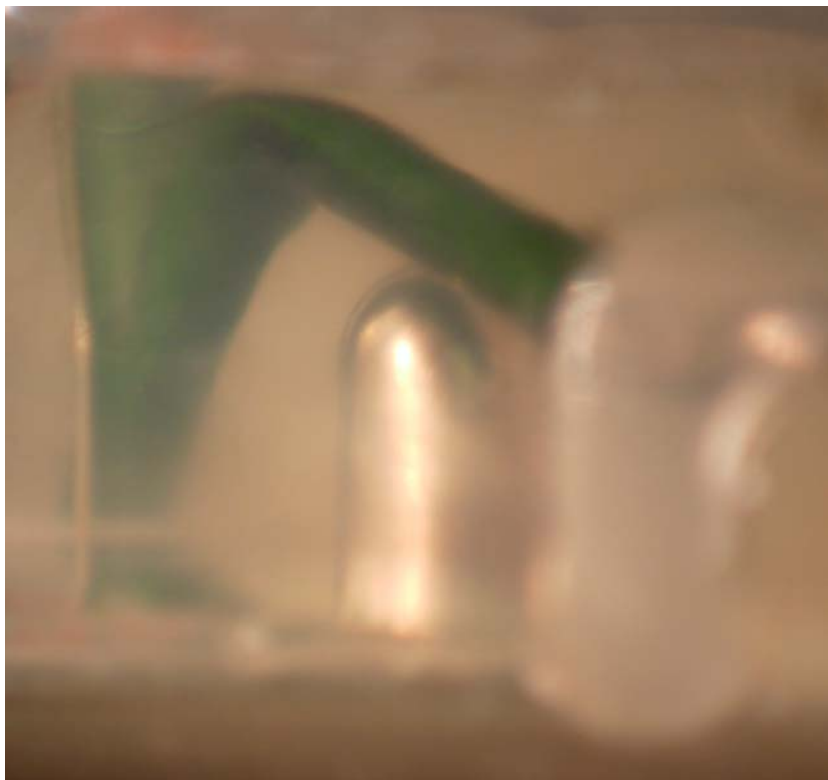
Figure 3

The routing of the DF- wire directly over the backfill tube was confirmed on microscopic inspection (Figure 3). Furthermore, severe kinking or buckling of the polyimide insulator (due to the tight bend radius of the DF- wire) was evident above and to the left of the backfill tube.

Unambiguous insulation breaching and arcing were not evident; however, based upon stereo microscopic evaluation, the tight radius of the DF- wire bend appears to violate the design specification (430394 N Header Requirement 4: “Inside bend radius of formed (tubed) wires of

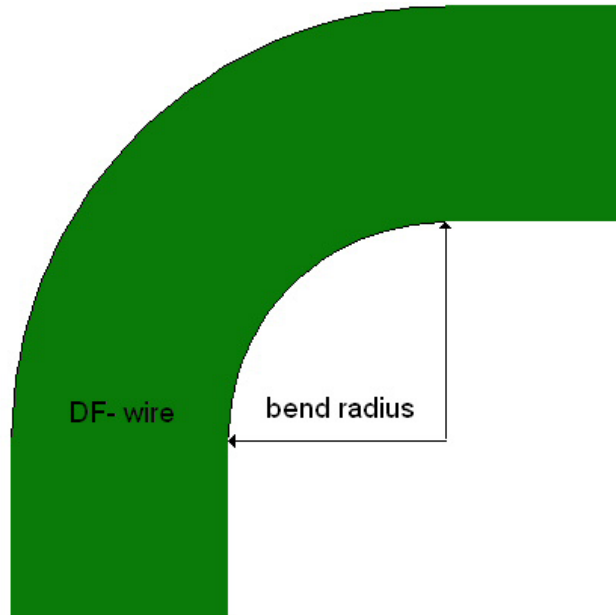
Figure 4

Feedthru (Item 13) must be R0.025 minimum”). The minimum bend radius, approximately equal to the DF- wire thickness, is diagrammatically shown in Figure 4. Exceeding the minimum bend radius places stress on the polyimide insulator (as well the feedthrough wire conductor itself).

In my opinion, this ICD was not built per design specification and clearly demonstrates a lack of control in the placement and bending of the DF- wire during manufacturing. It is my opinion that Guidant was not reasonably prudent in controlling the placement or bending of the DF- wire, resulting in this manufacturing defect.
