SAN JUAN COUNTY SHERIFF

Time Notified 1431	Time Arrived 1448	Notified By Dispatch	Supervisor at Scene Sgt Jackson	Checked By B. Dennis R13
Officer's Signature _____	Printed Officer Name Jacob Sanchez	Rank Deputy	ID No 566	Dispatch 1205
Crash Report Number 30,006,154	Case Number 2009-15885	STATE OF NEW MEXICO UNIFORM CRASH REPORT		SHEET 2
ISSUING AGENCY COPY				OF 3 SHEETS

On May 4, 2009 at approximately 1431 hours I, Deputy Jacob Sanchez was dispatched to 3761 US64 (in front of Big Rock Trading Post) in reference to a crash with injuries. Upon arrival I learned there was one fatality and one other transported to the ER for injuries. Deputy Asbc, a crash reconstructionist, was called out and completed the investigation.

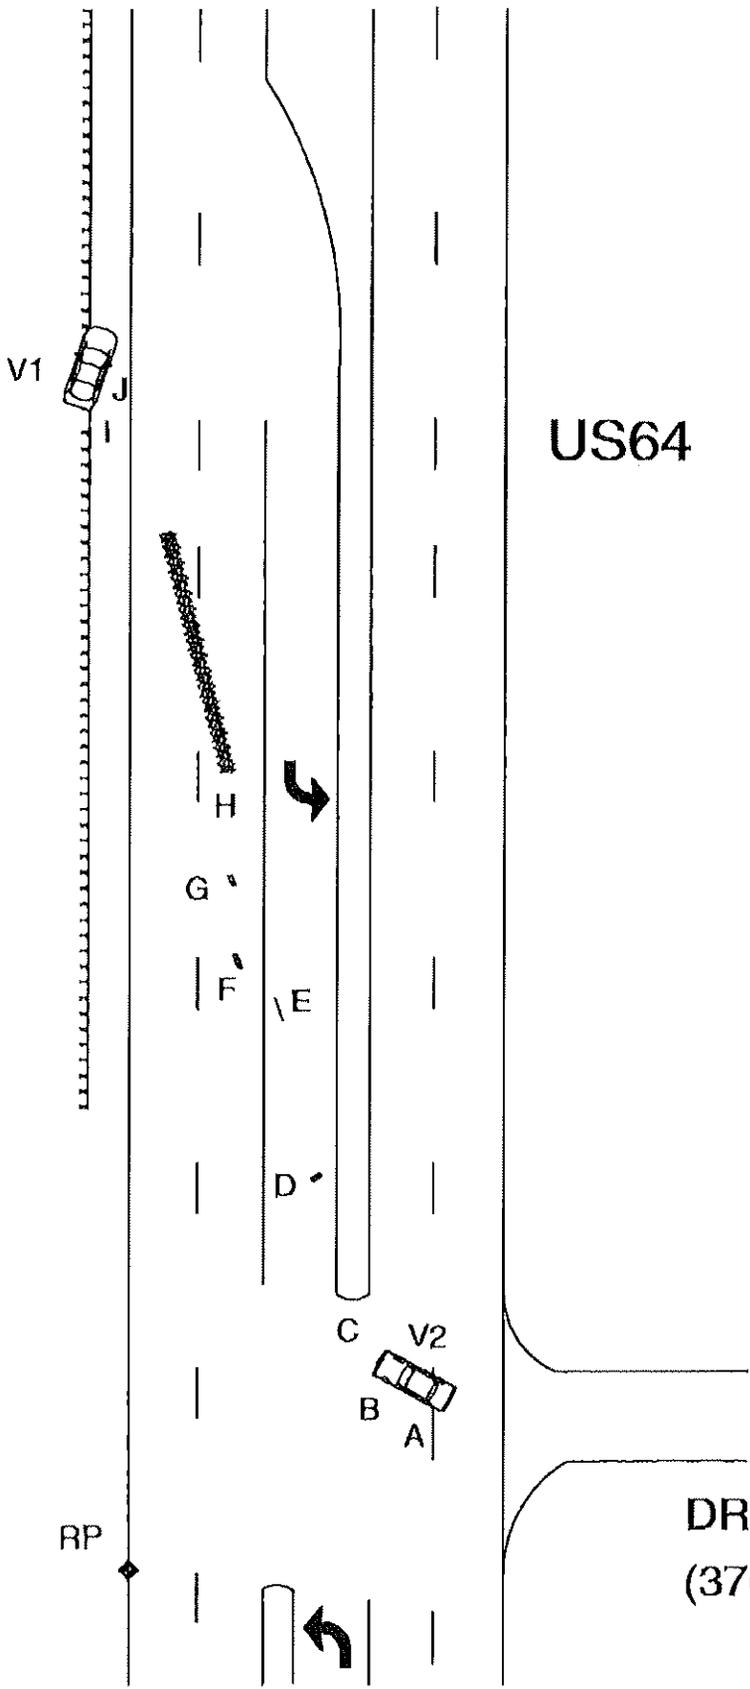
CRASH REPORT NUMBER 30,006,154	CASE NUMBER 2009-15885	DIAGRAM DRAWN BY: DEPUTY T. ASBE	MEASUREMENTS TAKEN BY: DEPUTY T. ASBE
--	----------------------------------	--	---

I observed V2 stopped in the eastbound lanes. V2 was partially blocking both lanes. V2 was facing north east across the roadway. V2 had sustained moderate front end damage. The damage was heavier on the driver's side. I observed no signs of braking prior to impact.

I observed V1 stopped on the westbound shoulder. V1 was sitting with the rear end of the vehicle on top of the guardrail. V1 was facing east. V1 had sustained heavy roll over damage. The damage was very heavy on the passenger's side of the vehicle. V1 also had sustained contact damage along the passenger's side. I was advised by Deputies that V1 had come to rest on its roof. The Deputies advised me that witnesses had turned V1 over onto its wheels in an attempt to aid the occupants.

I observed a small gouge mark on the edge of the median curbing. This gouge was located north east of V2. Approximately 24 ft. north east of the gouge I observed another gouge mark. This gouge mark was slightly curved. It appeared that this mark was caused by the edge of a vehicle rim digging into the asphalt. I observed other gouges and scrape marks consistent with V1 rolling over. I observed an area of heavy, solid scrape marks. This is consistent with V1 sliding along the pavement on its roof.

The damage to the vehicles and the roadway evidence indicates that V1 had been traveling eastbound on US64. V2 pulled out of the driveway and started to cross the eastbound lanes. V1 swerved to the left to avoid V2. V2 struck the passenger's side of V1. This caused V1 to start a clockwise spin. V1 struck the curbing as it crossed the center median. It appeared that V1 was tripped and began to roll when one of its driver's side rims dug into the pavement. From my training and experience it appears to me that V1 rolled 1 1/2 times. V1 ended its rolls upside down. V1 then slid approx. 50 ft. on its roof.
