**UNITED STATES DISTRICT COURT
SOUTHERN DISTRICT OF OHIO
WESTERN DIVISION**

Case No. 1:02-cv-107

**ORDER RE: REQUEST
FOR REVIEW BY
DG AND PG RENTAL
PROPERTIES, LLC, DANIEL R.
GERTZ & ASSOCIATES, INC.
D/B/A THE GERTZ CO., AND
BID AND WIN IT, LLC'S
REQUEST AND AMENDED
REQUEST FOR REVIEW
(DOCS. 932 AND 1867)**

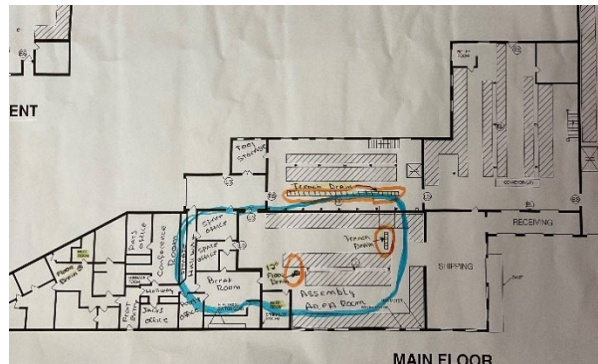
The day after the August 28, 2016 rain event, Mr. Gertz went to the Property. He smelled an odor of feces and observed remnants of toilet paper around a floor drain in the first floor assembly room. (Doc. 1964 at PAGEID 49005). Mr. Gertz observed water on the first floor in the area outlined by blue:

He did not observe water on the first floor outside that area. The area that Mr. Gertz circled to show water infiltration on the first floor encompassed the trench drains (circled in orange). The area did not encompass the restroom floor drain on the West side of the building (highlighted in yellow). (Doc. 1963 at 48835; Gertz Ex. 2A).

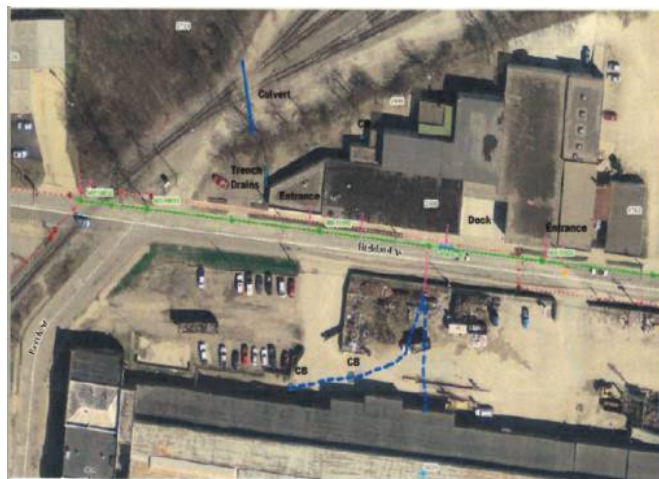
MSD attempted to trace the exact path between the catch basin pipes and the Cohen lateral using an underground camera and above ground tracking instrument, but a large steel scrap pile on the Cohen property prevented MSD from successfully tracing the path. (Doc. 1961 at 48559; Doc. 1962 at PAGEID 48700). Thus, there is no evidence of the exact configuration of the connection between the Cohen catch basin pipes and the Cohen lateral. MSD diagrammed the approximate location of the connection between the catch basin pipes and the Cohen lateral using blue dashed lines. The blue lines were intended to show connectivity of the catch basins to the lateral and not the actual physical location. (Doc. 1962 at PAGEID 48700).

(MSD Ex. 9). Mr. Pittinger testified that there must have been some bends and connections from the catch basins to the lateral because “you have multiple inlets that tie into a single point of connection, which inherently means that there are junctions and connections and bends.” (Doc. 1962 at PAGEID 48699-700).

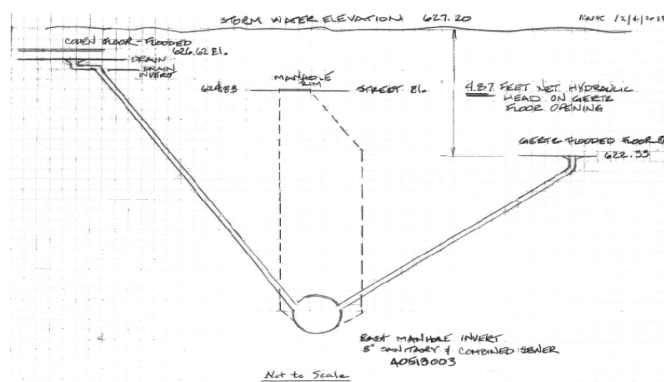
Highland Avenue, and the Gertz Property in his Original Report. (MSD Ex. 37; Doc. 1966 at PAGEID 49226). Dr. Kinman was advised the flood water rose to about seven inches in the Cohen building. (Doc. 1967 at PAGEID 49352). Dr. Kinman estimated the Cohen flood elevation at 627.2 feet by adding the Cohen floor elevation of 626.62 feet to the seven inches of flood water. (Doc. 1967 at PAGEID 49354). Dr. Kinman determined the street elevation at Manhole 40513003 to be 624.83 feet (less than three feet below the Cohen flood elevation) and the Gertz basement floor to be 622.33. Dr. Kinman depicted the relevant elevations as follows:

(MSD Ex. 37, Original Kinman Report, p. 37). Dr. Kinman’s first expert report depicted water elevation at 4.87 feet across the road to the Gertz building. In his modified report, Dr. Kinman revised his schematic of Typical Flooding Elevations, eliminating from his graphic the line indicating the storm water elevation over the Gertz property:

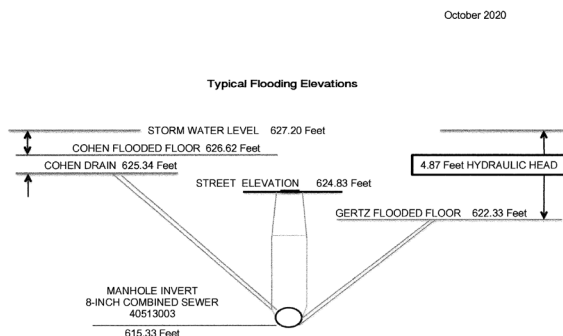
Dr. Kinman affirmed that “if the main sewer is blocked below where the Cohen lateral enters it, and it’s blocked on the other side of the Gertz lateral, the water from the Cohen catch basin is going to go down towards the Gertz building, because the Gertz building is lower.” (Doc. 1966 at PAGEID 49227).⁶ Dr. Kinman opined:

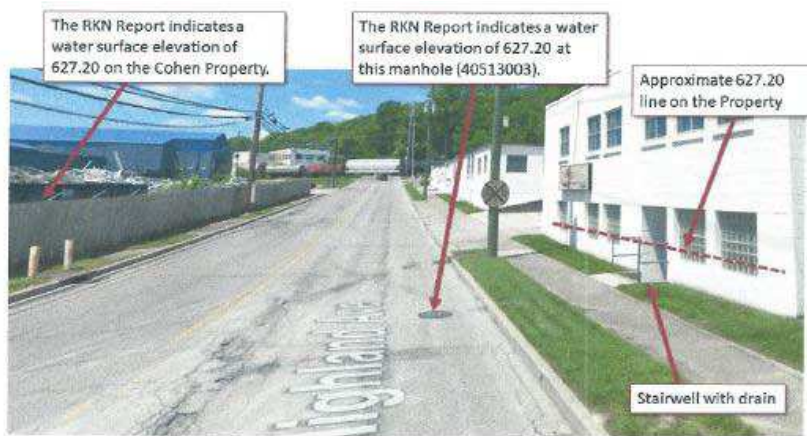
Figure 3: Closer view of hydraulic elevations shown across Highland Avenue, stairwell labeled

similarly reach two and one-half feet up the wall of the Gertz building, placing the water level near window level and filling the stairwell. (Doc. 1967 at PAGEID 49470-71).

(MSD Ex. 14, Fig. 3, street view of the Property and Highland Avenue, with Dr. Kinman's elevations noted).

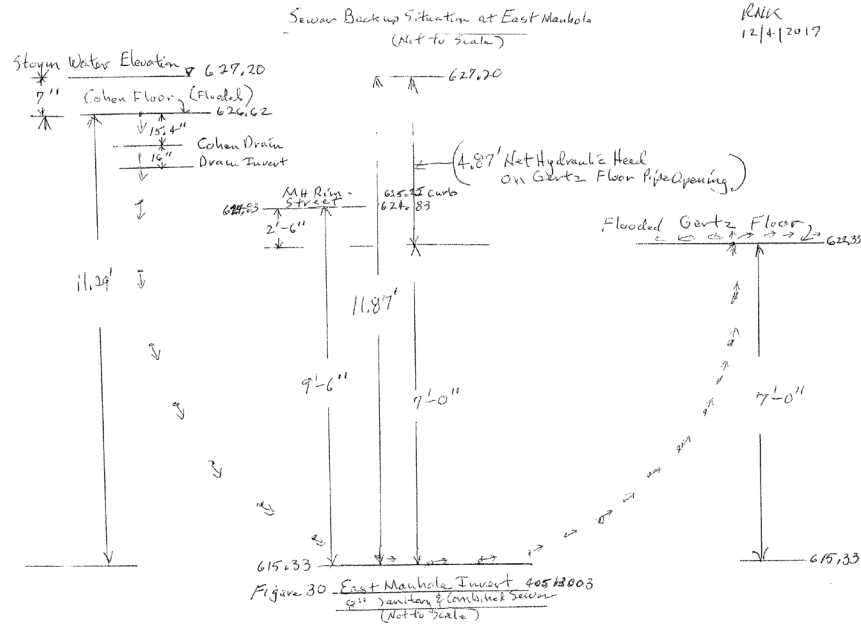
Dr. Kinman disagreed. He testified there was no indication that water ever reached the Gertz building by overland flooding. (Doc. 1967 at PAGEID 49450). According to Dr. Kinman, any ponding of water over the Cohen catch basins would flow through the Cohen lateral, into the Sanitary Sewer, and then into the Gertz building through the building lateral rather than overland (*Id.* at PAGEID 49419-20), as depicted in this graphic by Dr. Kinman:

Dr. Kinman testified that based on the elevation of 627.20 feet surrounding the ponded water over the Cohen catch basins, any water that breached the perimeter of the pond would not cross the street into the Gertz Property stairwells. Rather, based on the relative elevations of the surrounding area, the water would travel East, parallel to the building and Highland Avenue to the lower elevations and re-enter the street below the Cohen Building. (Doc. 1967 at PAGEID at 49418-22; Doc. 1971 at PAGEID 50052-53). He testified that the rainy day video supported his conclusion that the overland “flow came down and entered Highland Avenue from behind the [Gertz] building and around and did not enter the building as any overland flow.” (Doc. 1971 at PAGEID 50072).

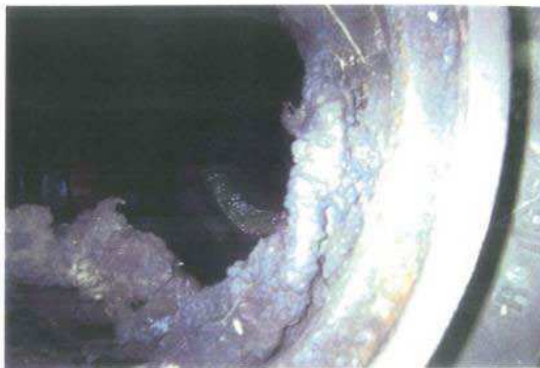
A second problem location for this 8" diameter sewer occurs downstream. The 8" is enlarged to 12" sewer at one location. A second 12" diameter sewer is connected to it from Duramed Drive. At the connecting point, the two 12" diameter sewers are directed to a 10" diameter sewer for passage under 1-71. This is an attempt to direct 24" of flow through a 10" diameter pipe. It cannot not happen if both of the 12" pipes are flowing full. The sewer will back up and this sewer backed up at 2700 Highland Ave. This back up would be expected under these hydraulic conditions.

(Gertz Ex. 9, Figure 25; Doc. 1867-2 at PAGEID 44780). Figure 25 is a photograph MH 42616009, which is located on the 10-inch section of the Sanitary Sewer at the convergence of the two 12-inch diameter sewers. (Doc. 1966 at PAGEID 49235). Dr. Kinman noted "the grease and crud on the manhole and the manhole steps from a previous backup." (*Id.*).

Figure 25: Manhole on the 10" section of the 8" sewer where two 12" diameter sewers converge to feed the 10" under I-71. Note the grease and crud on the manhole and the manhole steps from a previous back-up. July 29th, 2017. RNK DG Kevin.

Dr. Kinman acknowledged that the surcharged Sanitary Sewer depicted in Figure 25 was 2,500 feet downstream from the Gertz lateral. He testified that he examined seven other manholes in the vicinity of MH 40513003 across from the Gertz lateral, but MH 42616009 (Figures 25-27) was the only one in which he observed grease and crud from a previous backup. (Doc. 1967 at PAGEID 49398). When asked whether each intervening manhole leading upstream to the Gertz lateral would overflow or provide a point of release for the surcharging manhole, Dr. Kinman responded "not necessarily" because of "a time factor here of 2500 feet" and other variables within the system. (Doc. 1966 at PAGEID 49235-36).

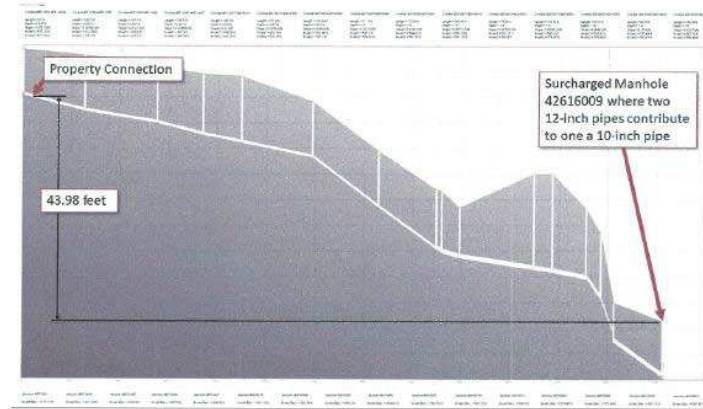
(Doc. 1866-14 at PAGEID 44712). Dr. Barton explained that the Sanitary Sewer mainline slopes very steeply from the Gertz Property down to MH 42616009:

Figure 8: Hydraulic profile showing steep pipes on the hillsides upstream of manhole 42916009.

(MSD Ex. 14, Fig. 8; Doc. 1967 at PAGEID 49496). Dr. Barton noted that MH 42616009's rim elevation is 43.98 feet below the Gertz Property lateral connection and its invert is 55 feet below the Gertz Property connection. (*See also* Gertz Ex. 13). According to Dr. Barton, there would need to be at least 30 or 40 feet of surcharge above MH 42616009's rim to back up the Sanitary Sewer line enough to reach the Gertz Property. Dr. Barton testified that given the distance and relative elevations between the Gertz Property and MH 42616009 "[i]t is impossible for a surcharge at Manhole [42616]009 to have hydraulic impact on the sewer runs along Highland Avenue. It's too far down the hill." (Doc. 1967 at PAGEID 49498). According to Dr. Barton, the 14 manholes between MH 42616009 and the Gertz Property would release any flow of sewage before it could reach the Gertz lateral. (*Id.*). Dr. Barton concluded that "sewer surcharge reported down there [at MH 42616009] is irrelevant to what happened at the Gertz property." (*Id.* at PAGEID 49499).

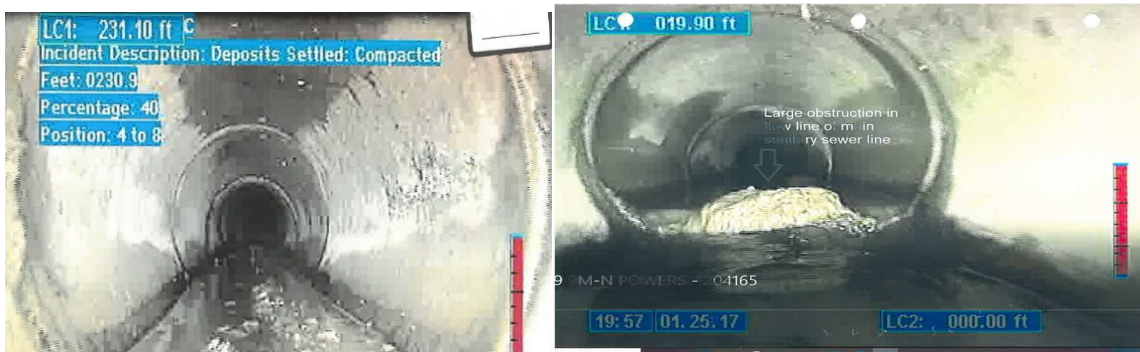
had numerous impediments to the flow of water and sewage through the pipe, including encrustations, heavy deposits, rocks, broken pipe, sags, holes, fractures, obstacles and slope changes. (Doc. 1966 at PAGEID 49221-22, 49225, 49237, 49239, 49258). For example, Dr. Kinman stated that the MSD video, as captured in these still shots, showed settled deposits and an obstruction in the Sanitary Sewer line which posed an impediment to flow:

(Gertz Ex. 37; Gertz Ex. 10, Addenda at Doc. 1867-3 at PAGEID 44853). Dr. Kinman testified that a large brick-like object in the Sanitary Sewer pipe approximately 1.5 feet below the junction of the Gertz lateral also presented an impediment to flow:

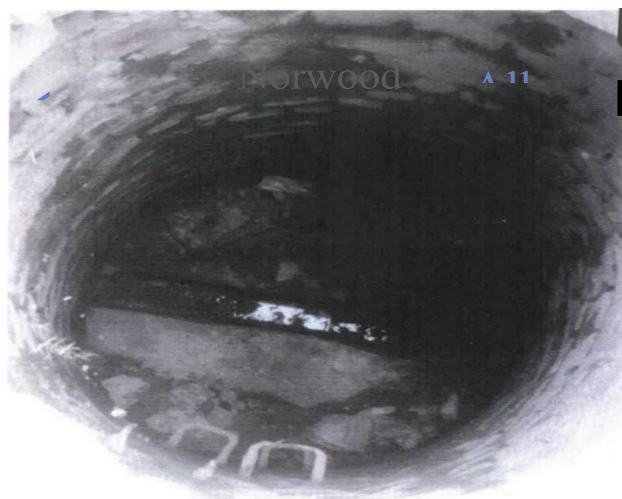
Dr. Kinman also observed “groundwater flow” in the Sanitary Sewer line on a Saturday in July of 2017, during dry weather conditions, when no one was working in the area to contribute to the sanitary flow. According to Dr. Kinman, groundwater flow filled one-fourth to one-third of the sewer capacity. (Doc.1966 at PAGEID 49222, 49260). He testified, “There is evidence of groundwater flow on that main line both in the encrustations and the holes in the pipe.” (Doc. 1967 at PAGEID 49430). Dr. Kinman also found evidence of dry weather water flow in the Sanitary Sewer line on Wednesday, October 4, 2017, during the work week.¹¹ (Doc. 1967 at PAGEID 49441). Dr. Kinman estimated that groundwater filled the Sanitary Sewer pipe one-quarter to one-third full by looking into the manhole “from the top of the manhole.” (Doc. 1967 at PAGEID 49438; Gertz Ex. 31):

Dr. Kinman did not measure the volume of the dry weather flow within the Sanitary Sewer pipe. (Doc. 1967 at PAGEID 49383).

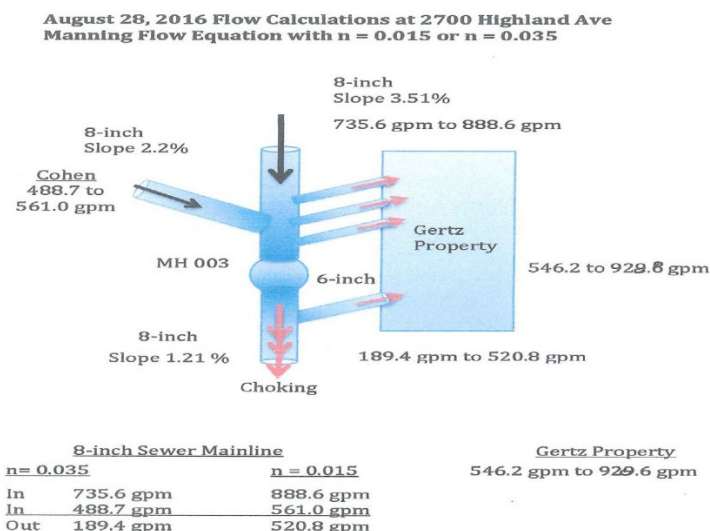
gravity flow. (*Id.* at PAGEID 49365-67). He depicted the summary of the flows in the various segments of pipe to show the amount of backup into the Gertz building as follows:

Dr. Kinman estimated the backup into the Gertz building to be between 546.2 gallons per minute to 920.6 gallons per minute using the Manning equation and the estimated “N” values. (Doc. 1966 at PAGEID 49251). He explained that the pipe segment downstream of MH 40513003 “is very heavily damaged in terms of the pipe carrying away its designated volume. And since it can’t get away and it’s coming in at higher slopes, and the opening then that’s available to it is to go up into the Gertz building.” (*Id.* at PAGEID 49252). In other words, the volume of water coming into the Sanitary Sewer pipe from the Cohen lateral and upstream of that lateral exceeded the volume of water able to flow out of the Sanitary Sewer pipe below MH 40513003 because of pipe defects, slope, and other factors. As a result, sewer water entered and backed up into the path of least resistance—the Gertz laterals. (*Id.* at PAGEID 49252).

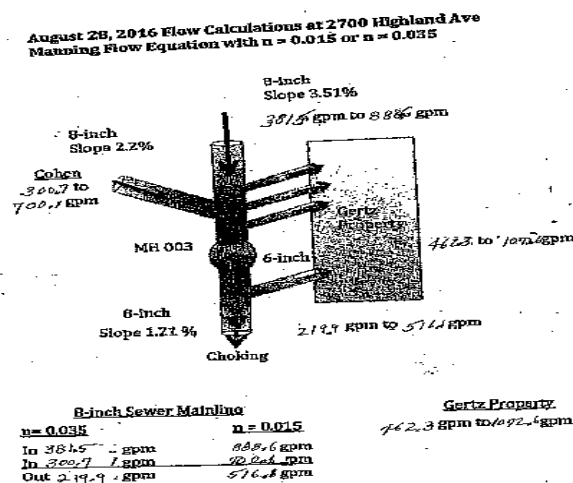
(Doc. 1925 at PAGEID 46315).

sanitary sewer at and near 2700 Highland Avenue.” (Gertz Ex. 52, Doc. 1925, Kinman Aff., ¶ 4). Dr. Kinman re-calculated the numbers referenced in his Manning equation and ensured that the new calculations were accurate. (*Id.*). Dr. Kinman stated that the calculation errors did “not affect his opinion that the flow in the main line of the sanitary sewer and the pipes leading from the Cohen building caused a back-up at the Gertz building at 2700 Highland Avenue.” (*Id.*, ¶ 5). Dr. Kinman depicted his Manning flow equation using the re-calculated numbers:

According to his Manning equation calculations, independent of any flow coming from the Cohen lateral, there were 381.5 to 888.6 gallons per minute flowing through the Sanitary Sewer pipe upstream of the Gertz property. In his expert reports, however, Dr. Kinman did not analyze how much groundwater he estimated was entering this pipe from upstream. (*Id.* at PAGEID 49372). When asked how it was possible for that amount of water to enter the pipe upstream of the Gertz property, Dr. Kinman testified, “There are possible ways for the groundwater, yes. There are not constructed¹² ways.” (*Id.* at PAGEID 49372). He did not

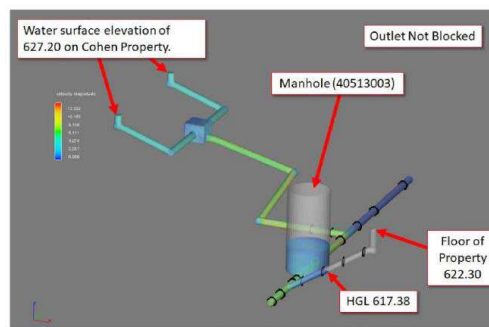
Sewer to determine the effect on the elevation of water into the Gertz lateral. According to Dr. Barton, even with a 50% blockage in the downstream Sanitary Sewer line the water would not back up high enough to reach the Gertz basement floor level of 622.30 feet. (*Id.* at PAGEID 49481).

Dr. Barton testified that his CFD model was based on two assumptions that he later learned were incorrect and that actually made him more confident in his conclusions. (Doc. 1967 at PAGEID 49552). First, his model assumed there were two separate eight-inch pipes from the Cohen catch basins to the Cohen lateral. Dr. Barton subsequently discovered from Mr. Beebe’s deposition that the Cohen catch basins were actually connected by four-inch, not eight-inch, pipes to the eight-inch Cohen lateral. Dr. Barton testified that a four-inch pipe contains one-fourth the flow of an eight-inch pipe due to hydraulic radius. Dr. Barton opined, “There’s no way this system would have backed up with two four-inch pipes.” (*Id.* at PAGEID 49489). Second, when he made the model, Dr. Barton was not aware that the Cohen catch basins were completely filled with debris, so much so that Mr. Beebe used Bobcats to clean them out the day after the storm. This further reduced the flow from the Cohen catch basins to the Sanitary Sewer leading Dr. Barton to conclude there was “no possibility of flooding to the Gertz basement.” (*Id.* at PAGEID 49490).

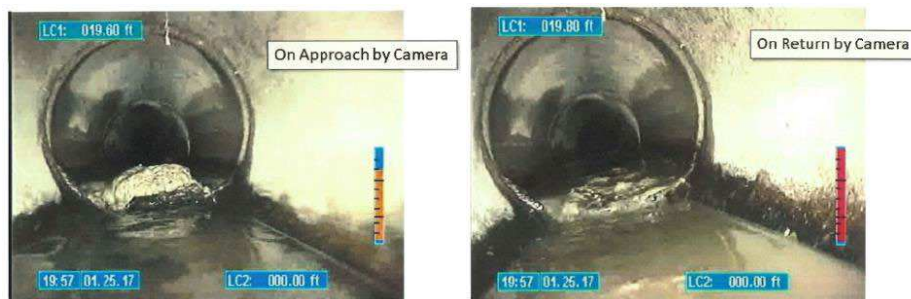
Dr. Barton also discussed what was described by Dr. Kinman as a significant obstruction downstream from the Gertz lateral. The video of the pipe showed a block-like obstruction at 19.6 feet. (MSD Ex. 38). However, when the camera truck rig was retracted and ran over the obstruction, the obstruction flattened out. Dr. Barton testified that what appeared to be a “blockage” on the video was most likely toilet paper which was easily dispersed by the force of the encounter with the video camera and did not present an obstruction to the flow of fluid within the pipe.

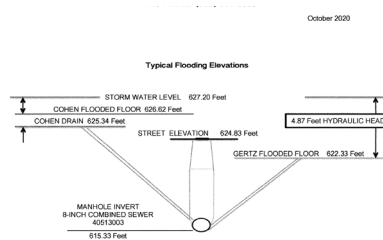
Dr. Barton addressed Dr. Kinman’s modified opinion that the hydraulic head was the same on both sides of an open, flowing pipe. (MSD Ex. 16; Doc. 1967 at PAGEID 49512).

According to Dr. Barton, Dr. Kinman’s figure does not account for losses in flow in the Cohen lateral caused by inlets, twists, turns and junctions. (MSD Ex. 16; Doc. 1967 at PAGEID 49512). He contrasted this with the CFD model, which calculated the losses from all sources. Dr. Barton also testified that the hydraulic head is never the same across an open pipe; it has to be 100% blocked in order for the head to be the same on both sides. (Doc. 1967 at PAGEID 49513).¹³ If the pipe is not 100% blocked, some amount of water will drain, producing a

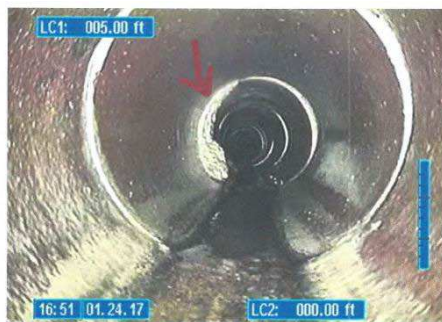
Dr. Barton also disputed Dr. Kinman’s conclusion that the Sanitary Sewer pipe was one quarter to one-third full of flow during dry weather conditions. Dr. Barton testified that if Figure 9 depicts dry weather flow of groundwater that entered the pipe, it is one-twentieth to one-fiftieth full. (Doc. 1967 at PAGEID 49503):

Figure 9: camera footage of the obstruction which prevented camera passage

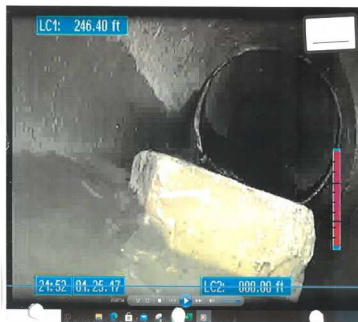
Dr. Kinman opined that the presence of a large rock or brick in the lateral just downstream of the Gertz basement lateral caused a choking of the Sanitary Sewer pipe. The confluence of the brick and water flow caused a hydraulic jump in the pipe and pushed sewage water into and up the Gertz basement and first floor laterals. Dr. Kinman testified that MSD's TV video showed a large brick-like object in the Sanitary Sewer pipe approximately 1.5 feet below the junction of the Gertz lateral, which presented an impediment to flow and a trigger for a hydraulic jump, as depicted in this still shot of the video (Gertz Ex. 38):

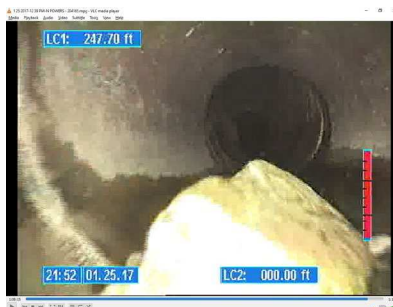
The Court has again viewed the video of this obstruction. Following the location depicted in Gertz Ex. 38, the camera pushes the brick to 247.70 feet upstream, altering the orientation of the brick:

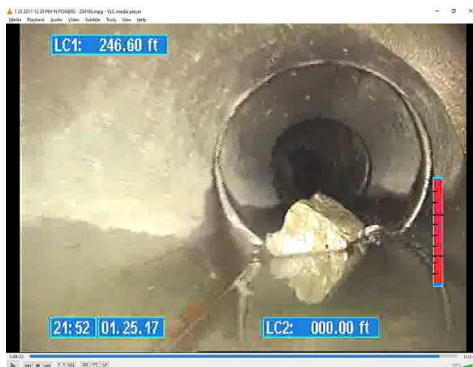
The camera then continues in reverse allowing a view of the brick at a location of 246.60 feet:

The depiction of the brick at this location visually appears to be a much less significant obstruction than that depicted in Gertz Ex. 38 and detracts from the persuasiveness of Dr. Kinman's opinion and Gertz Ex. 38.

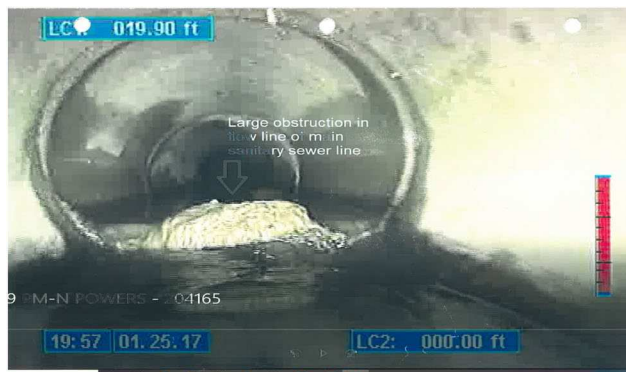
Dr. Kinman’s opinion on hydraulic jump is additionally based on the other obstructions he viewed in MSD’s videos of the Sanitary Sewer line. There are numerous still shots of MSD’s TV video inspections upon which Dr. Kinman relied for his opinion, which are attached to the Addenda to his Modified Expert Report. (Gertz Ex. 10). One is a screen shot of the sewer line between MH 40513003 and MH 40513004 depicting what is labeled as a “large obstruction in flow line of main sanitary sewer line”:

(Gertz Ex. 10, Addenda at Doc. 1867-3 at PAGEID 44853; Gertz Ex. 37, page 2).¹⁶

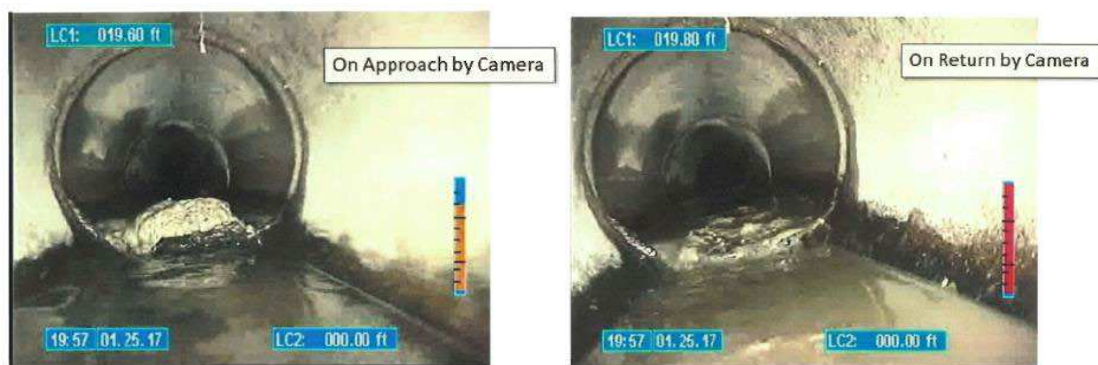
The identification of this “large obstruction” in the still shot is misleading. As MSD points out, the video shows that when the camera truck rig retracted and ran over the obstruction, the obstruction flattened out. Dr. Barton testified that upon retraction of the camera truck rig over the obstruction, what appeared to be a “blockage” on the video was most likely toilet paper which was easily dispersed by the force of the encounter with the video camera and did not present an obstruction to the flow of fluid within the pipe:

(MSD Ex. 38). Dr. Kinman’s overstatement of the significance of this “obstruction” detracts from the overall credibility of his opinion.
