JUAN F. CHARLES & ASOCIADOS
FORENSIC ENGINEERING SERVICES AND CONSULTANTS
CERTIFIED FIRE AND EXPLOSION INVESTIGATOR AND INSTRUCTOR
INTERNATIONAL EXPERTS

June 24, 2013

REF: CIVIL CASE No. 12-1225- (GAC)
ANA MELENA SITU vs. JEROME O'NEIL

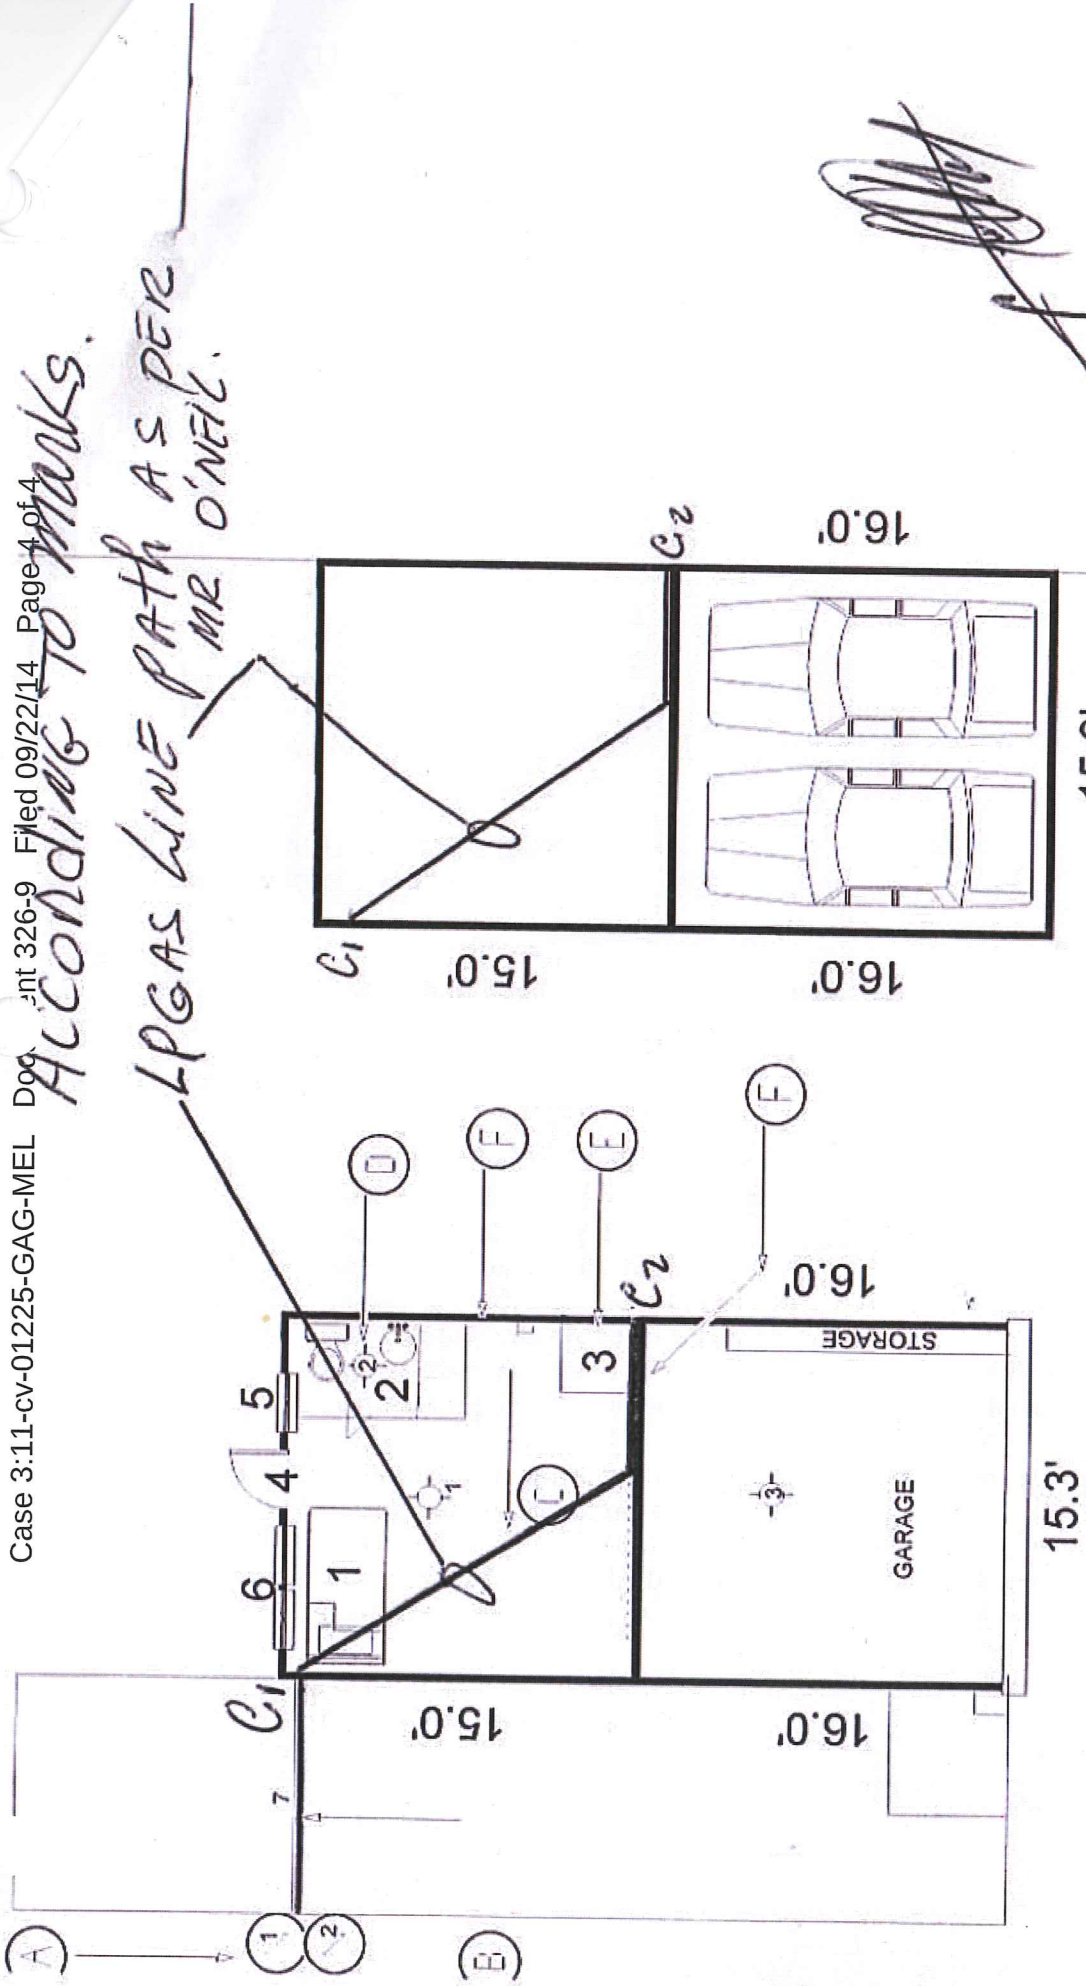
According to marks.

LPGAS LINE PATH AS PER MR O'NEIL.

EXCAVATION WILL BE MADE FROM C1 - C2

IN ORDER TO DETERMINE IF THERE EXIST ANY PHYSICAL EVIDENCE OF GAS PIPING WHICH WAS IN PLACE DURING DATE OF FIRE WITHIN THIS SPACE

Please be advised that in order to find any physical evidence at place of the incident it is required that an excavation be made. This excavation will be made making two parallel horizontal cut with 4 inches wide and approximate 4 inches deep from point C1- to C2- as shown in the attached sketch.
