UNITED STATES
DEPARTMENT OF LABOR
MINE SAFETY AND HEALTH ADMINISTRATION

REPORT OF INVESTIGATION

Fatal Underground Coal Burst Accidents
August 6 and 16, 2007

Crandall Canyon Mine
Genwal Resources Inc
Huntington, Emery County, Utah
ID No. 42-01715

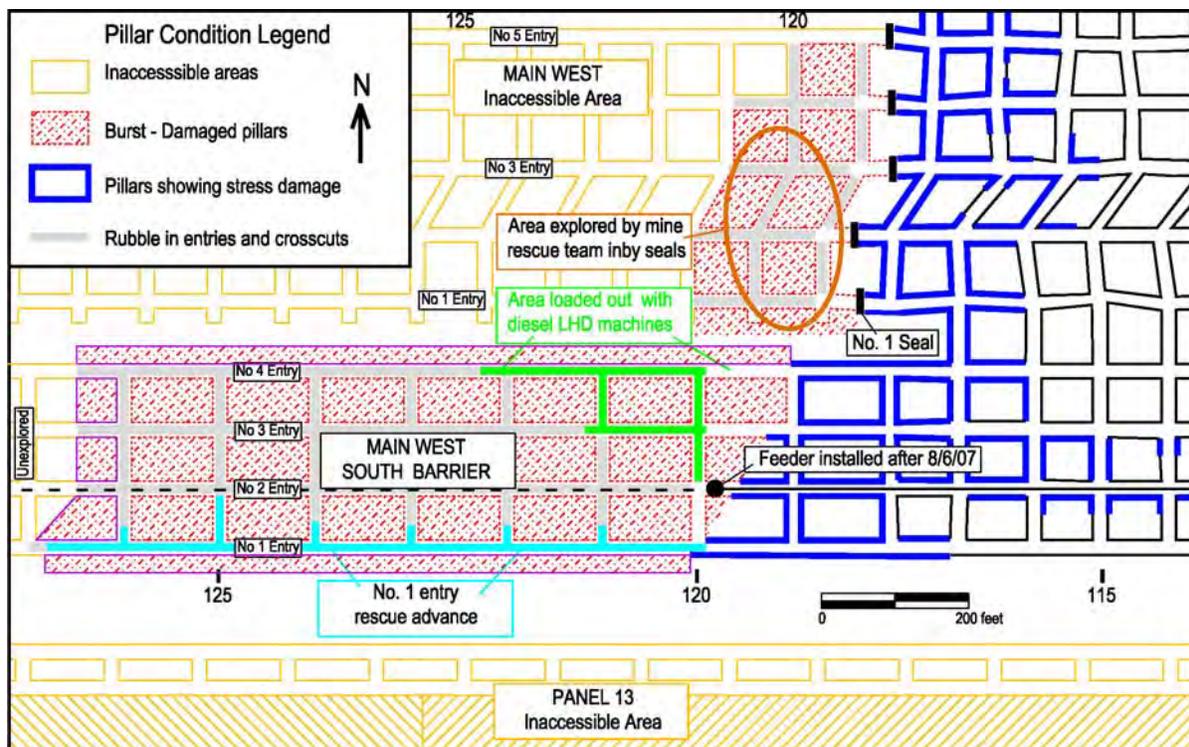
**Figure 3 - South Barrier Section Rescue Area
Showing Ground Conditions and Rescue Attempts.**

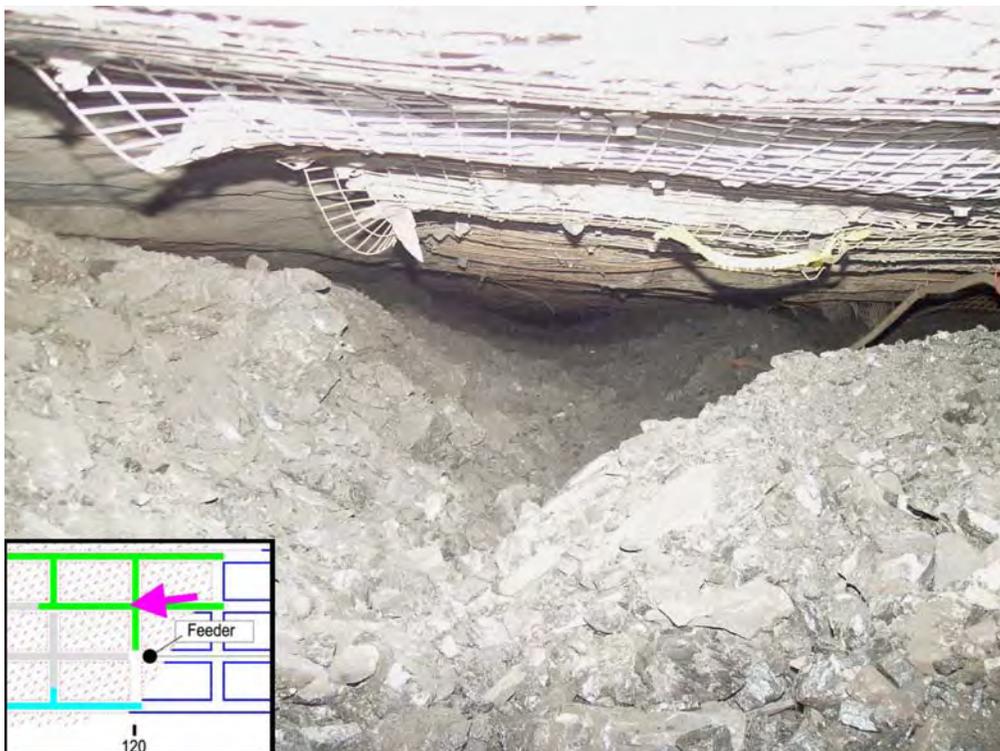
On August 7, 2007, a burst occurred in the clean-up area. UUSS registered a magnitude 2.8 seismic event at 1:13 a.m., which coincided with the approximate time of the burst. Ron Paletta (MSHA coal mine inspector) was standing near the feeder breaker with Benny Allred and Gale Anderson. The burst knocked Paletta to the ground and again damaged or destroyed ventilation controls to crosscut 93. The burst put a large amount of dust into suspension throughout the area and limited visibility to only a few feet. There were no injuries associated with this event. However, the burst partially refilled approximately 300 feet of entry that had been cleared (see Figure 4). Neither LHD was in the area refilled by burst material. One LHD was loading loose coal near the feeder between the Nos. 2 and 3 entries and the other LHD was outby the feeder in the No. 3 entry. All miners were withdrawn to crosscut 109 and accounted for.

Figure 4 - View of No. 3 Entry after August 7 Burst
Entry cleaned by diesel loaders refilled with rubble (view indicated by arrow in index map insert).

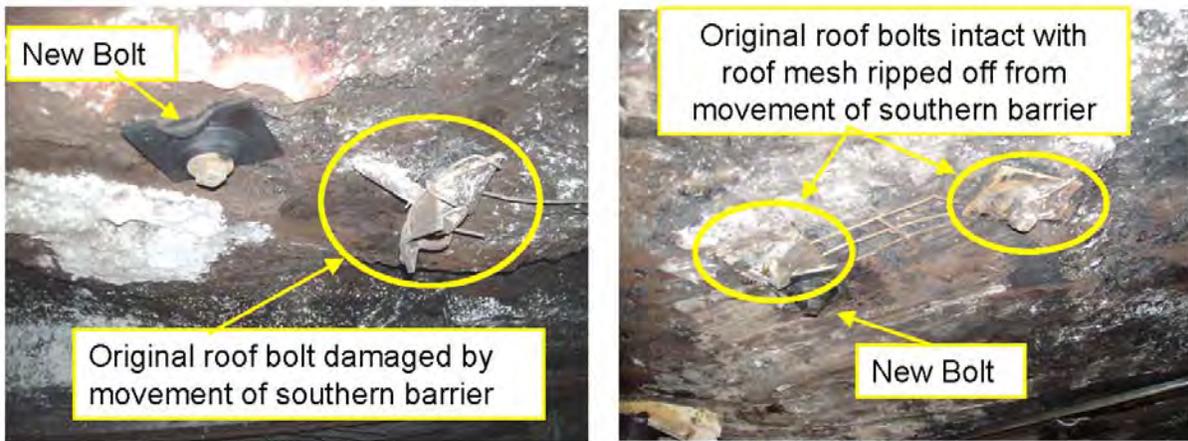
As loading advanced inby crosscut 123, rescuers observed that part of the barrier south of the No. 1 entry had moved northward as a result of the initial August 6 ground failure. The barrier rib had shifted northward as a unit, as much as 10 feet. In some areas the displaced barrier slid along the immediate roof and tore loose the original roof mesh (see Figure 7). In other areas, the immediate roof was carried northward and damaged the original installed roof bolts (Figure 8).

Figure 7- Damaged Roof Bolts and Torn Mesh after August 6 Accident Resulting from Northward Movement of Southern Barrier

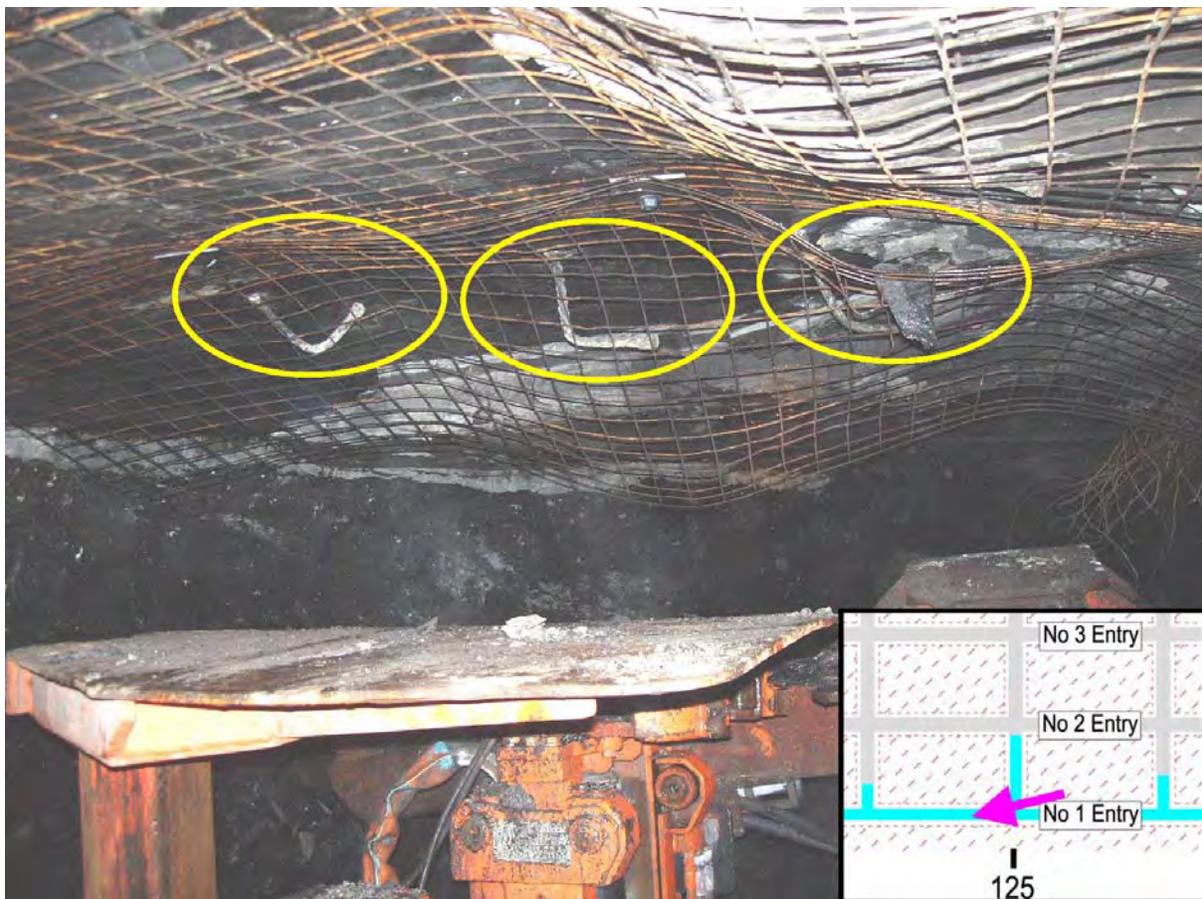
Figure 8 - Damaged Roof Bolts in No. 1 Entry after August 6 Accident Resulting from Northward Movement of Southern Barrier. Mesh shown was installed during rescue operations, over damaged original roof bolts. Camera view is indicated by arrow in index map insert.

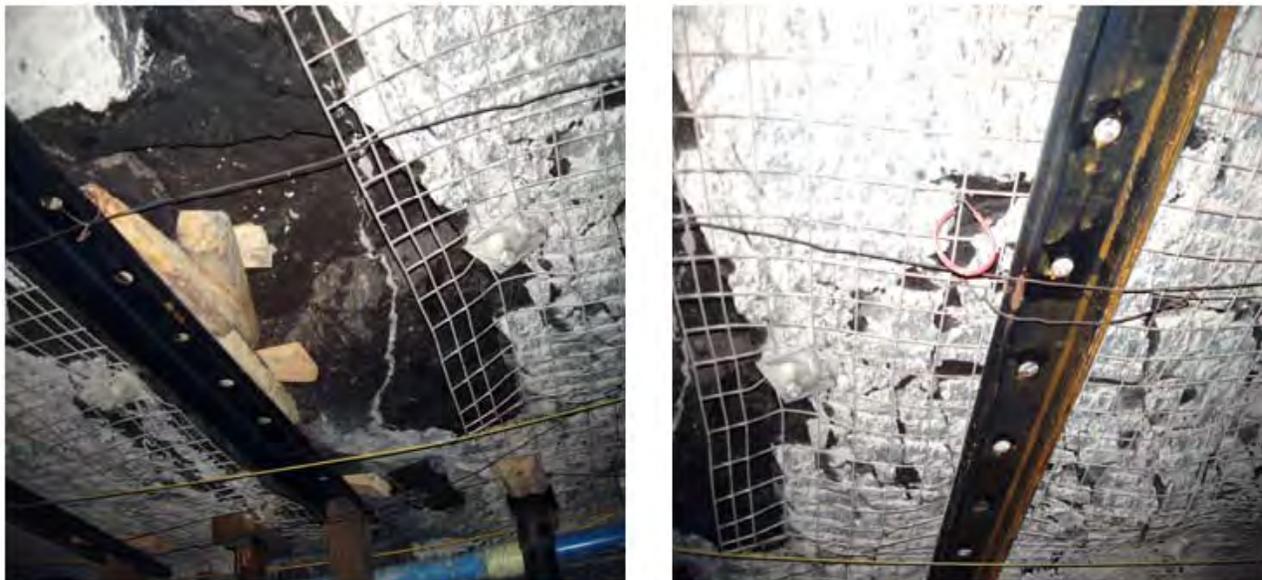
On August 12, roof deterioration was observed near crosscut 115 in the No. 1 entry. Steel channels were installed for additional support in this area (see Figure 9). The channels were supported on both ends with hardwood posts. At the time, clean-up in the No. 1 entry had advanced just inby crosscut 124. The No. 1 entry was packed with rubble the full width and height of the original mined opening. The continuous mining machine was loading from a rubble pile that resembled an unmined coal face (see Figure 10 and Figure 11). Observations of RocProps tilted from vertical prompted MSHA to install a measurement point to monitor horizontal movement between crosscuts 123 and 124.

Figure 9 - Steel Channels Installed in No. 1 Entry to Support Deteriorated Roof

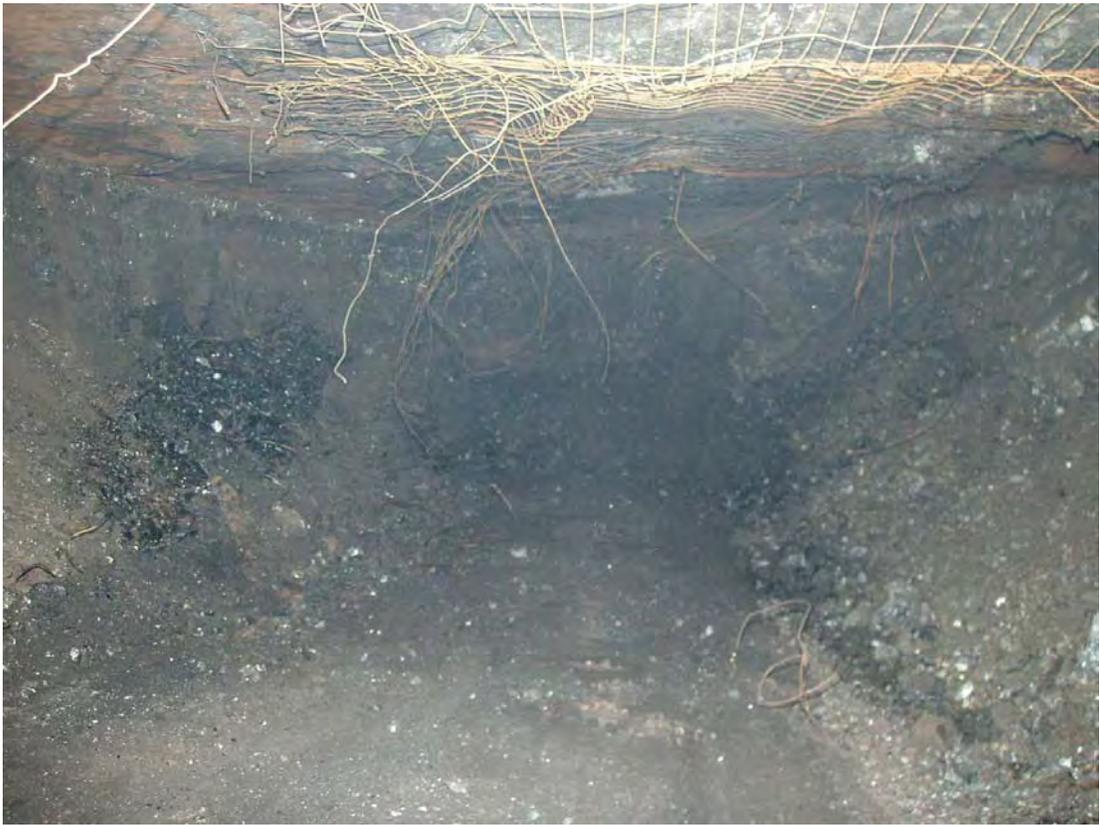
Figure 10 - No. 1 Entry Packed with Coal Rubble Inby Crosscut 124

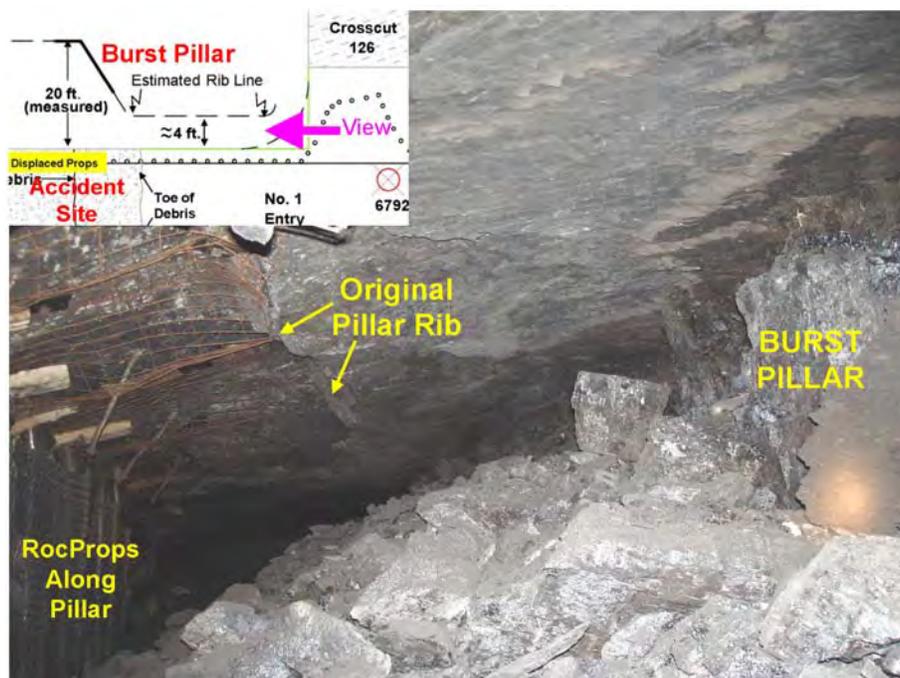
At 6:38 p.m., as the crew completed installing ground support in the clean-up area, the coal pillar between the No. 1 and No. 2 entries burst. Coal was thrown violently across the No. 1 entry during the magnitude 1.9 seismic event. The burst created a void up to 20 feet deep into the pillar at the roof line (see Figure 12 and Figure 13, view indicated by arrow). The dislodged coal threw eight RocProps, steel cables, chain-link fence, and a steel channel toward the left side of the entry, striking the rescue workers and filling the entry with approximately four feet of debris (see Figure 14). Heavy dust filled the clean-up area, reduced visibility, and impaired breathing. Oxygen deficient air from the inby area migrated over the miners. The dust and oxygen deficiency were slow to clear due to damaged ventilation controls.

Figure 12 – Damage to Outby Portion of Pillar on Right Side of No. 1 Entry (Outby August 16 Accident Site)

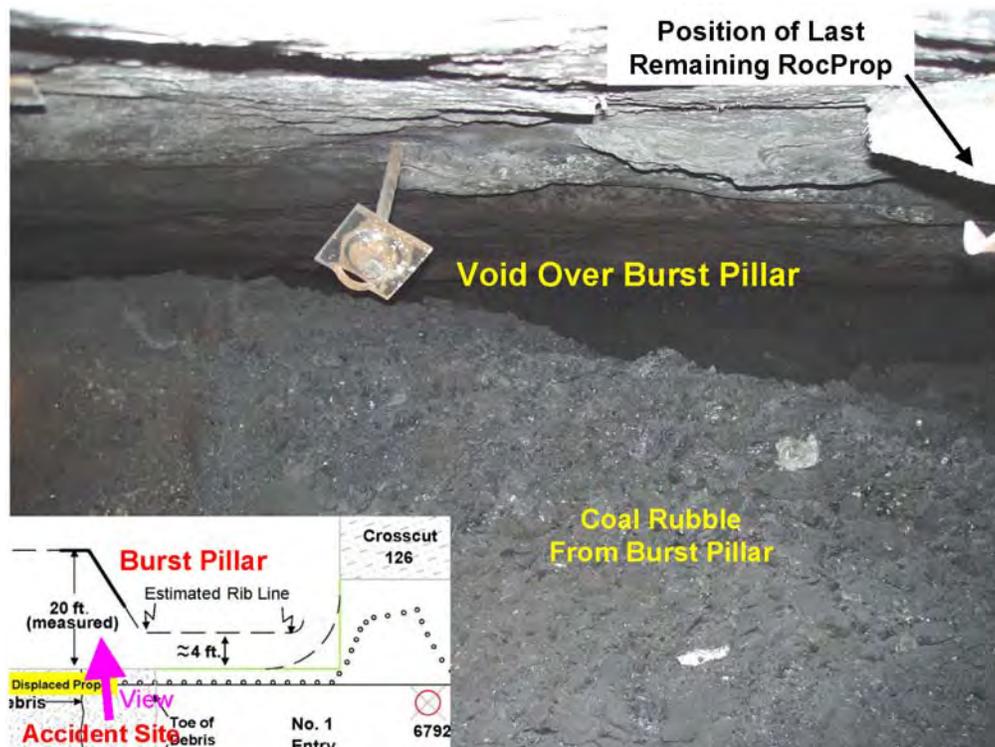
Figure 13 - 20-foot Deep Void over Pillar on Right Side of No. 1 Entry following August 16 Accident

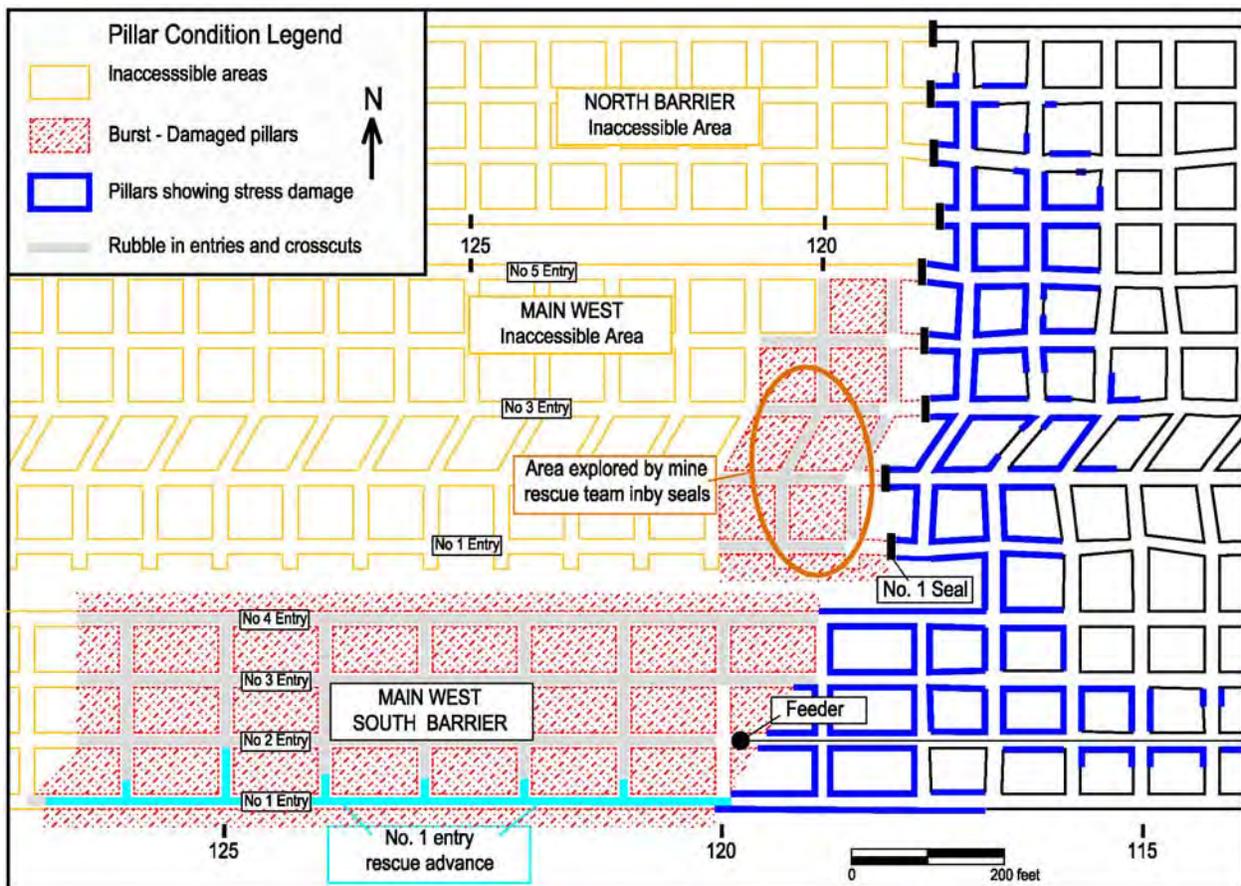
Within minutes of the accident, mine workers attempted to reach the South Barrier section to assist their coworkers. These initial efforts and additional attempts in the following days demonstrated that bursting had damaged pillars as far outby as crosscut 119, approximately ½ mile outby the entrapped miners. Debris from the outburst blocked access to all South Barrier entries inby crosscut 126 (see Figure 26). Attempts to reach the miners by breaching a seal and entering the Main West entries revealed poor ground conditions there as well. Inby the seals at Main West crosscut 118, the ground was working and bounces were occurring. Pillar deterioration (rib sloughage) had narrowed walkways to no more than 2 to 3 feet. Roof bolts were showing signs of excessive loading.

Figure 26 - Extent of Pillar Rib Damage Outby Crosscut 119

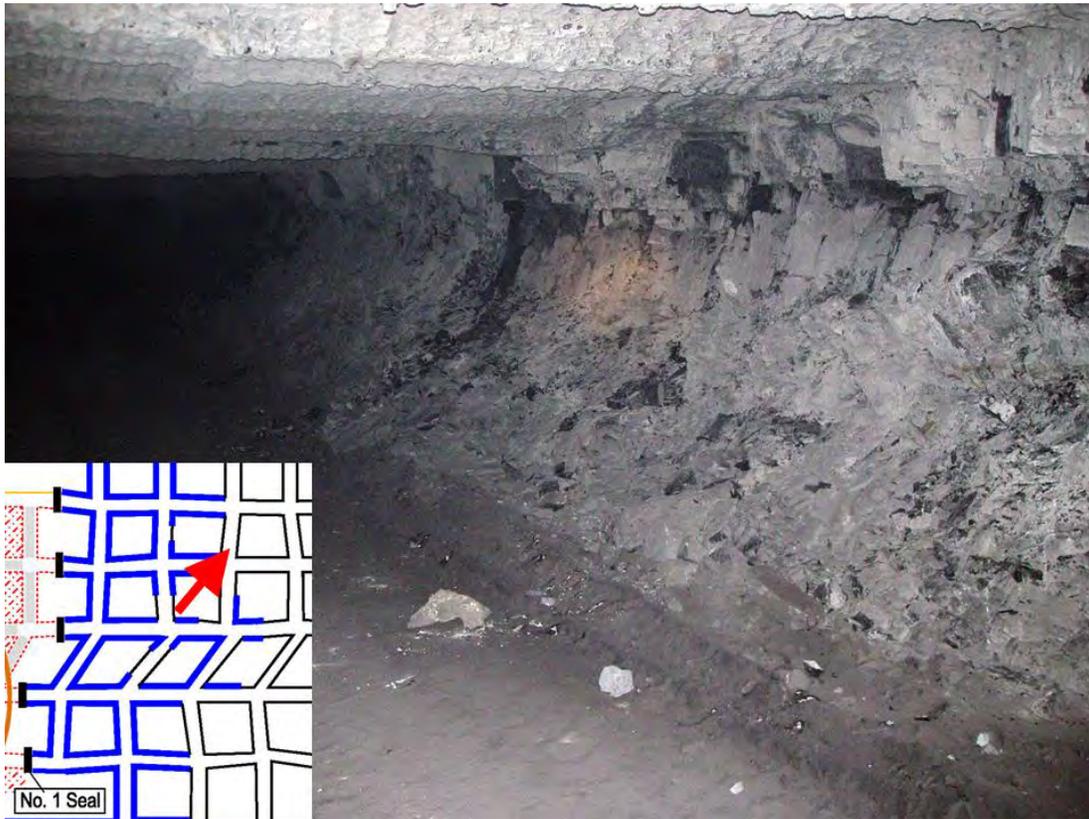
Figure 27 - Normal Main West Pillar Rib Conditions

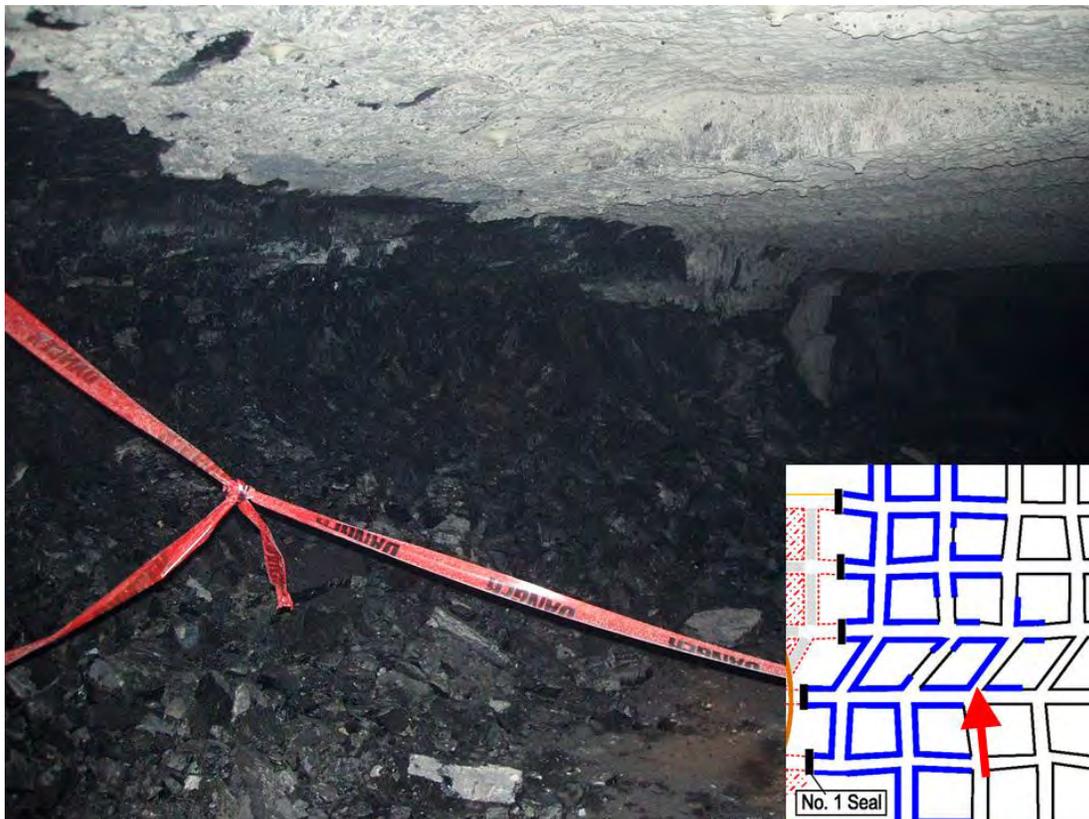
On August 11, 2007, ground conditions were mapped in the Main West entries and the North and South Barrier workings outby crosscut 119. Pillar damage was noted up to three crosscuts outby the seals (see Figure 26). The damaged ribs did not appear to be the result of bursting. Rather, the damage appeared to be associated with abutment stress transferred from inby the seals. Figure 27 and Figure 28 illustrate the difference between damaged and undamaged pillar rib conditions. Figure 27 shows normal Main West pillar rib conditions and Figure 28 shows recent pillar rib sloughage from abutment stress.

Figure 28 - Main West Pillar Rib Condition showing Recent Sloughage from Abutment Stress

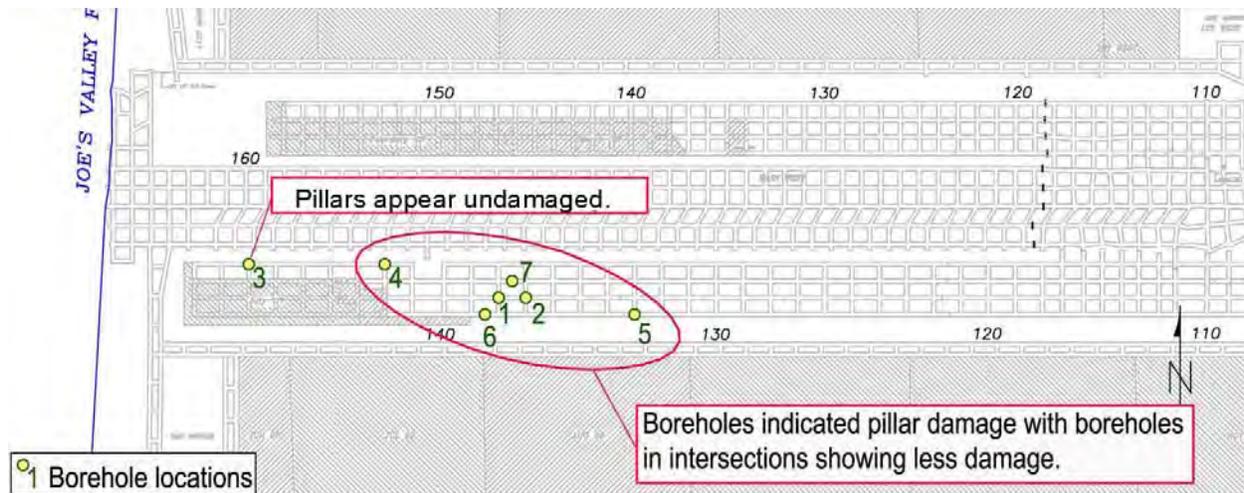
Conditions determined by the boreholes and visual observations from borehole cameras set the western boundary of the collapse between Borehole Nos. 3 and 4. Borehole No. 4 and others to the east of that location indicated that the mine openings contained rubble. Boreholes in the entries were filled or nearly filled with rubble while boreholes in the intersections contained less rubble. Figure 29 depicts the borehole locations.

Figure 29 - Borehole Locations and Conditions Observed

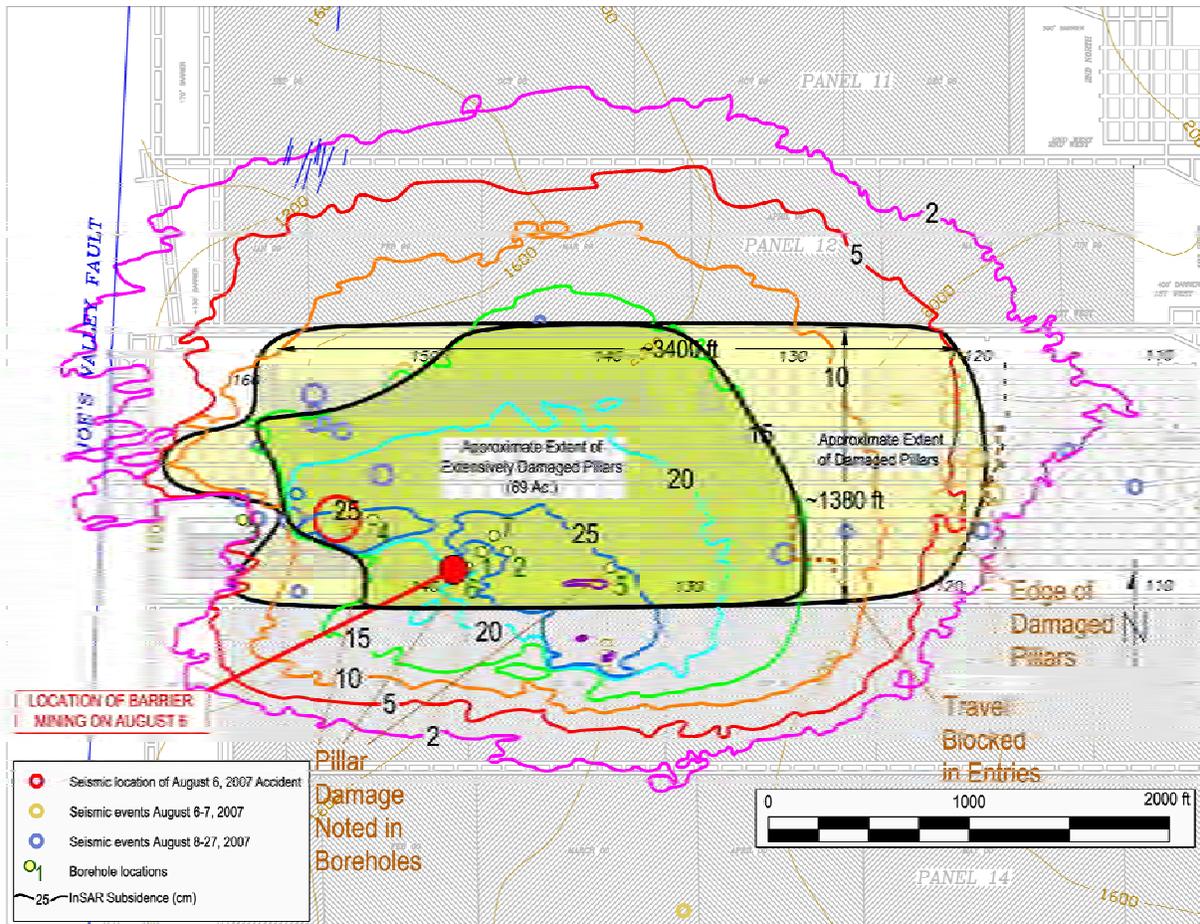
Figure 33 superimposes a variety of data used to determine the extent of the collapse, including: the seismic data from the time of the August 6 accident to August 27, 2007, the borehole locations, the InSAR subsidence contours, and the likely extent of damaged pillars. The eastern boundary of the pillar failures was based on the underground observations and InSAR subsidence data and is consistent with residual seismic activity. The western edge of the pillar failures was based on the borehole observations and InSAR subsidence data and is consistent with the seismic location of the accident and the additional seismicity later in August 2007.

Figure 33 - Combined Data and Likely Extent of Collapse

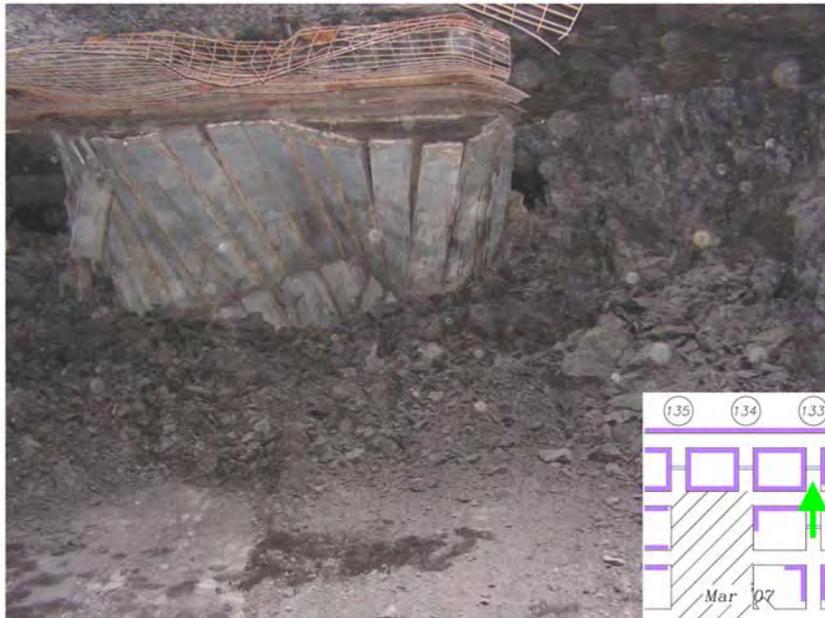
Figure 38 – Stopping Damaged during March 2007 Coal Outburst Accident on North Barrier Section

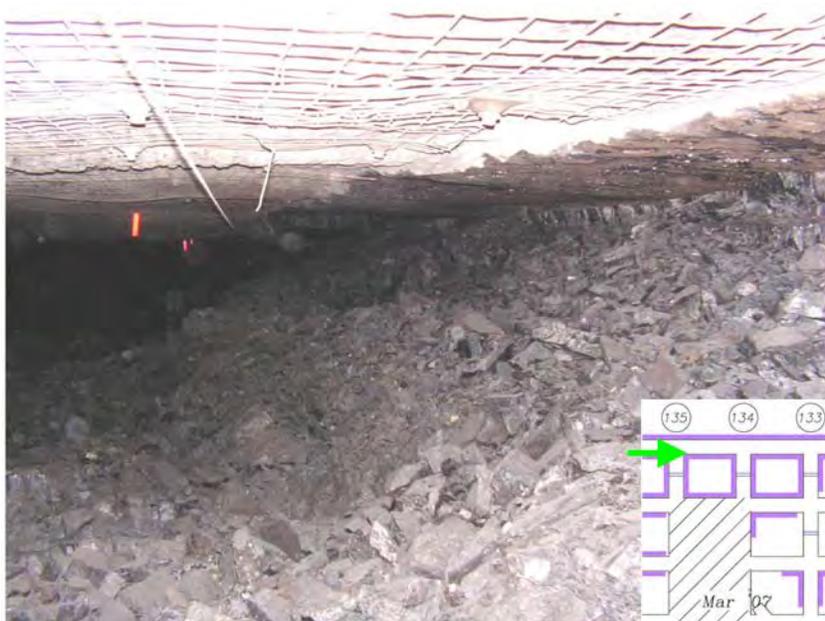
Figure 39 –Damage in No. 4 Entry after the March 2007 Coal Outburst Accident on North Barrier Section

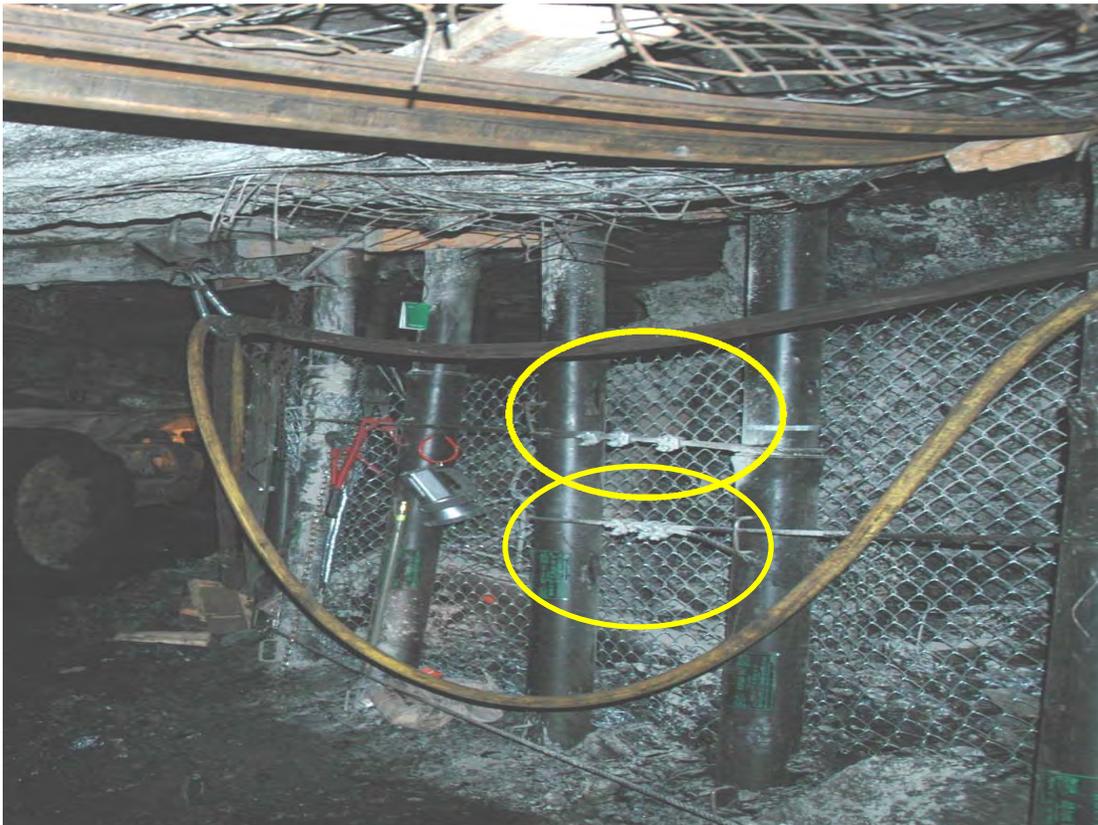
Figure 88 – Steel Cables Connected to RocProps

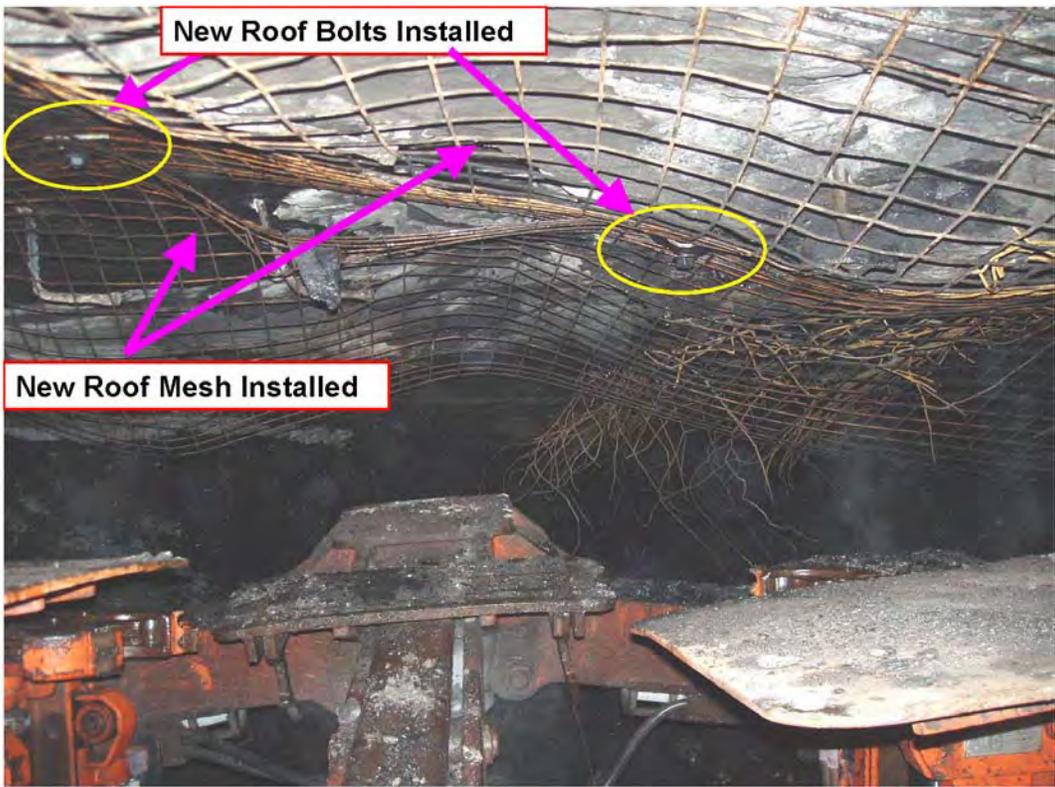
Figure 89 - New Roof Bolts and New Wire Mesh Installed in the No. 1 Entry
