EXHIBIT A-6

ANNEX 12

Select images of supposed wooden hull structure from Delgado annex 9 to exhibit D.

***La Trinidad Valencera*: an Armada invasion transport lost off Donegal**

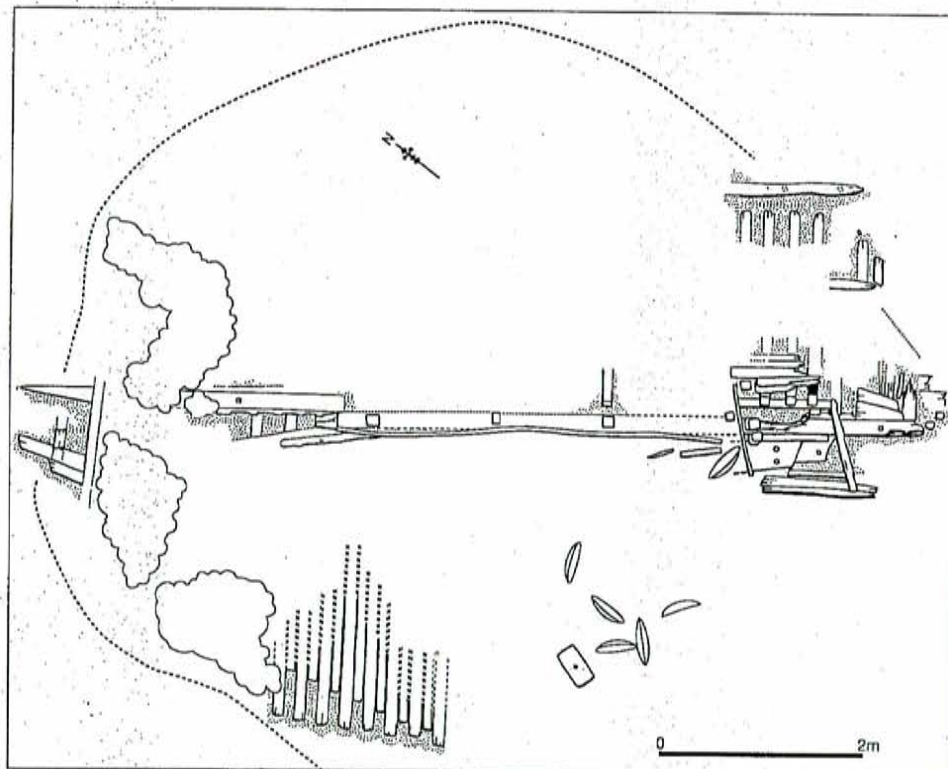
53 Site plan, showing the timbers of the *Santa Maria de la Rosa*. After Wignall, 1982

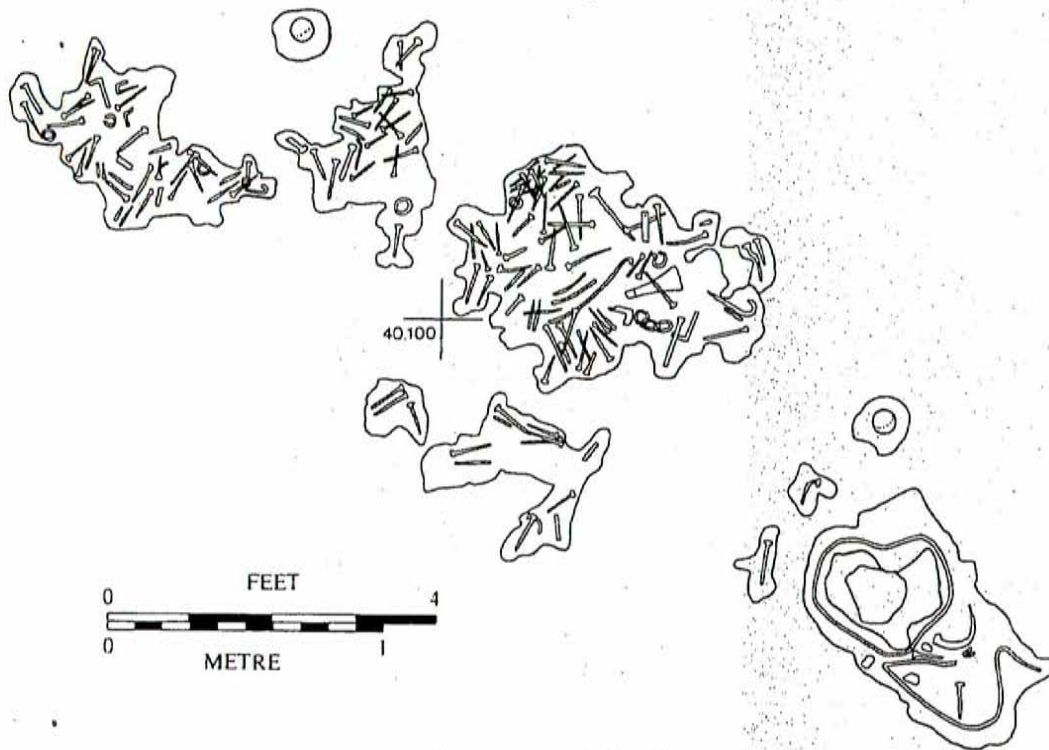
Figure 8. Concretions in Area 1.

excavation in 1973. The target proved to be a complex of iron concretions, which lay on a hard grey shingle substratum between 1 ft (0.25 m) and 18 in (0.38 m) below the surface. The concretions were tagged *in situ* and lifted for reassembly against a corresponding grid on land. They were then excavated with hand tools, and their contents plotted to a scale of 1 : 6. This method had been used successfully by

Bass at Cape Gelidonya (Bass, 1967), where the concretions had contained solid bronze objects: in the present instance, however, almost all of the metal had migrated, leaving only hollow casts within the concretion, and while it was possible to record a general statement of the contents (Fig. 8) this method involved the destruction of the matrix and hence of the primary evidence. The deposit appears to derive

from a spill of nails and other ironwork, perhaps once contained in the barrel represented by the two hoops at the right.

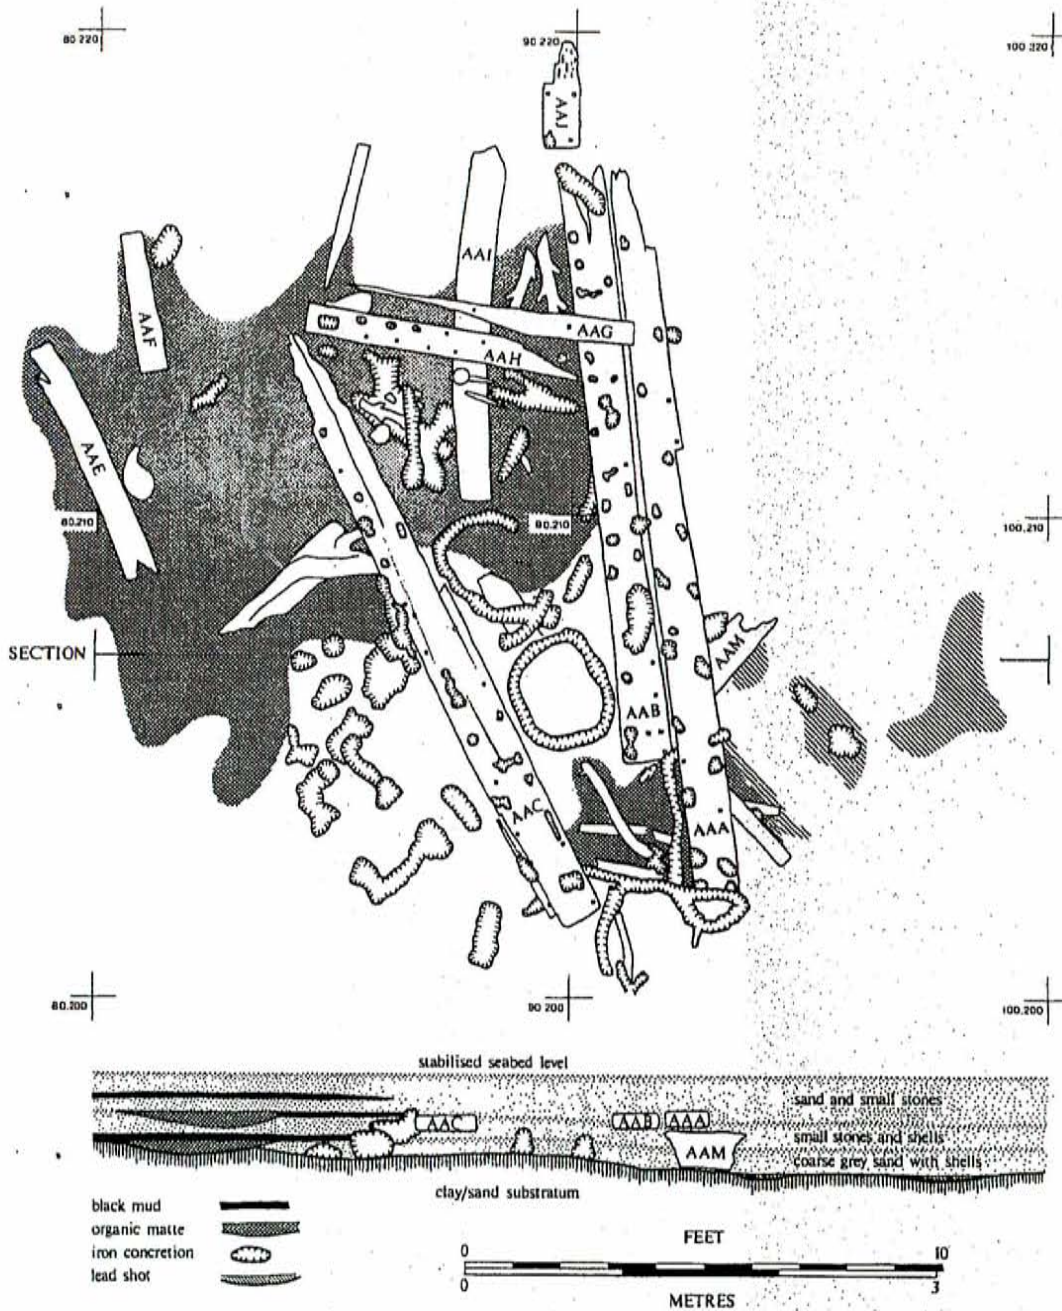
Figure 11. Ship timbers, concretions, and organic matte in Area 4.

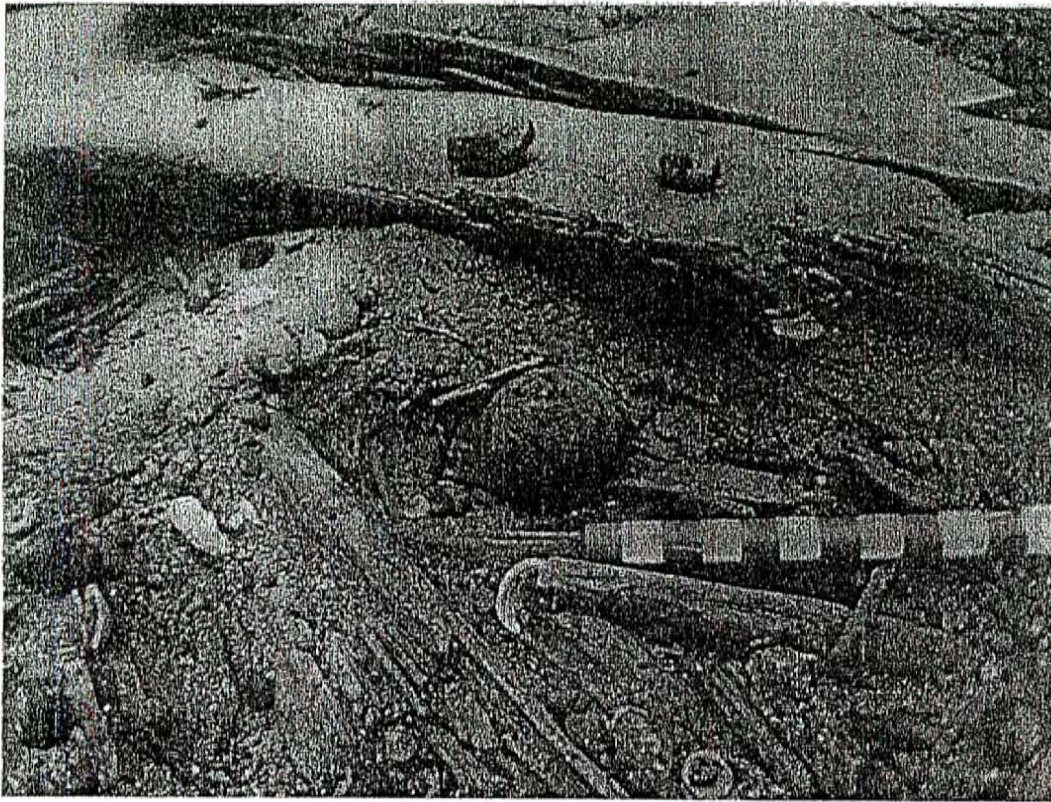
Figure 13. Organic deposit at Grid 88.213. Scale 1 ft.

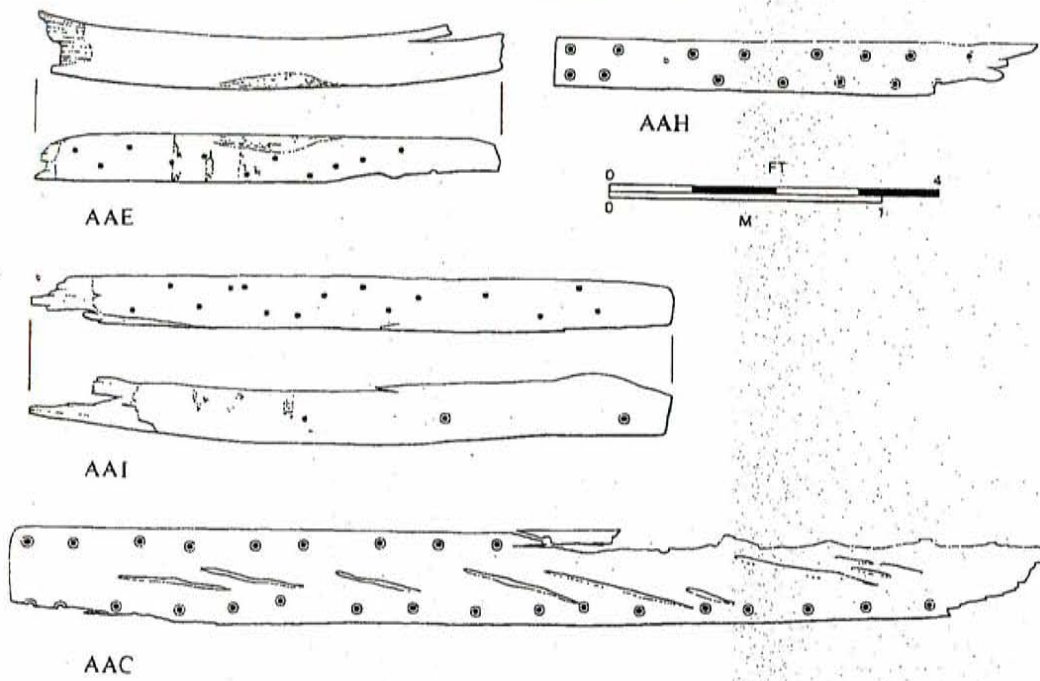
Figure 14. Hull timbers.

surviving length of 12 ft 6 in (3.81 m). One end is intact, showing a simple squared butt. Half-inch (0.013 m) iron fastenings had been used throughout, though in all cases these had completely corroded away, leaving only the concretion casts. On what is presumably the outer side of the plank the bolt heads, which were 1 in (0.025 m) in diameter, had been countersunk flush with the timber surface, no doubt so as to ensure a smooth underwater skin. The fastening holes are set in pairs which are set on average 8 in (0.20 m) apart. Except for the holes next to the butt, which are squarely opposite one another, the pairs are set obliquely, so that they would clamp the frame behind fore and aft.

The pattern of the fastenings is extremely regular in appearance, in contrast to the apparently haphazard patterning of fastenings more normal on wooden hulls of the early modern period. As observed in the case of the *Dartmouth* (Martin, 1978: 48), such irregularity was clearly intentional, so as to avoid as

far as possible setting up weaknesses along the line of the grain. No such attempt has been made in placing the *Valencera's* fastenings, and the weakness thus occasioned is evident in the lines of split and breakage which have in fact occurred. The impression is one of routine mass-production rather than the intuitive work of a skilled shipwright.

AAH carries much the same pattern of fastenings as AAC, though it is considerably narrower and thicker [7 in and 5.5 in (0.18 m and 0.14 m)]. The countersunk bolt heads suggest an outside surface, and the piece may well be part of a strengthening wale. One squared end is evident.

AAE and AAI appear to be sections of framing. Both are some 8 in (0.20 m) wide, which accords with the spacings indicated by the plank fastenings and suggests that the hull was solid framed (cf. the *Santa Maria de la*

Rosa, Martin, 1973: 447). On both these frame sections the inner (i.e. concave) faces show traces of pitch caulking apparently brushed on before the ceiling planking was placed. AAI has a butt end and three lateral fixing holes.

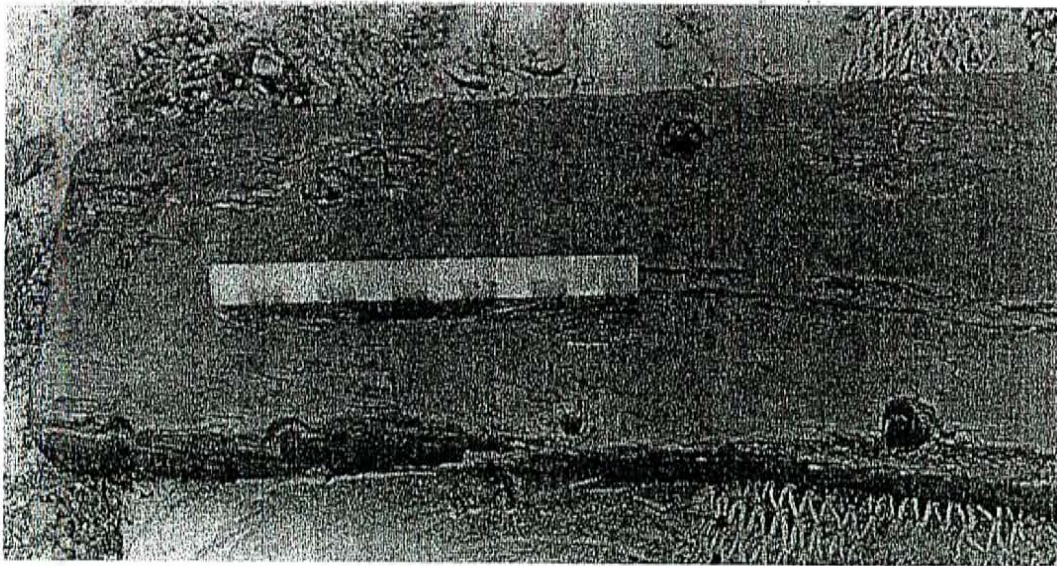
Figure 15. Butt end of AAC. Note the countersunk bolt holes and the deep gouge running from beneath the scale rod. Scale 1 ft.

A series of deep gouges running across the plank suggests damage caused by scraping a rough bottom, possibly at the time of wrecking.

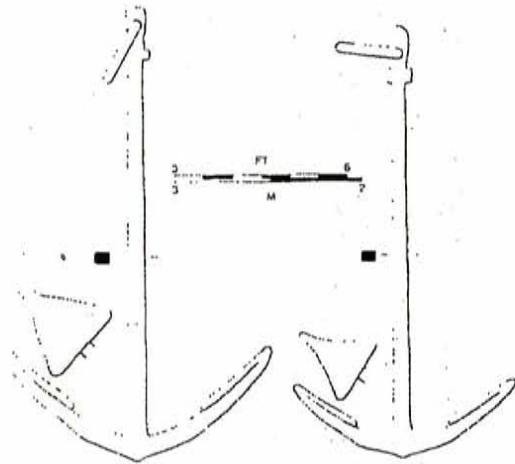
Figure 16. The iron anchors: a provisional drawing. The northern anchor (left) is the larger.

Two wrought-iron anchors have been recorded *in situ* at Grids 54.49 and 54.185. Figure 16 is a provisional drawing of them in which due allowance has been made for concretion growth, and with the missing fluke of the northern anchor restored. They are 15 ft and 15 ft 9 in (4.57 m and 4.80 m) long respectively, with spans of 8 ft and 9 ft (2.44 m and 2.74 m) and rings 2 ft 6 in (0.76 m) in diameter. The sizes are closely comparable with the anchor discovered near the wreck of the *Santa Maria de la Rosa* (Wignall, 1973: 469), which was 15 ft 6 in (4.72 m) long and spanned 8 ft (2.44 m), and rather larger than the 14 ft x 7 ft 3 in (4.15 x 2.20 m) anchor found close to the *Gran Grifón* wreck site (Brooks and Muckelroy, 1975). During the 17th century three anchors measuring 18 ft, 15 ft, and 10 ft (5.48 m, 4.57 m, and 3.05 m) were recovered from the wreck of the *San Juan de Sicilia* in Tobermory Bay (Miller, 1683).

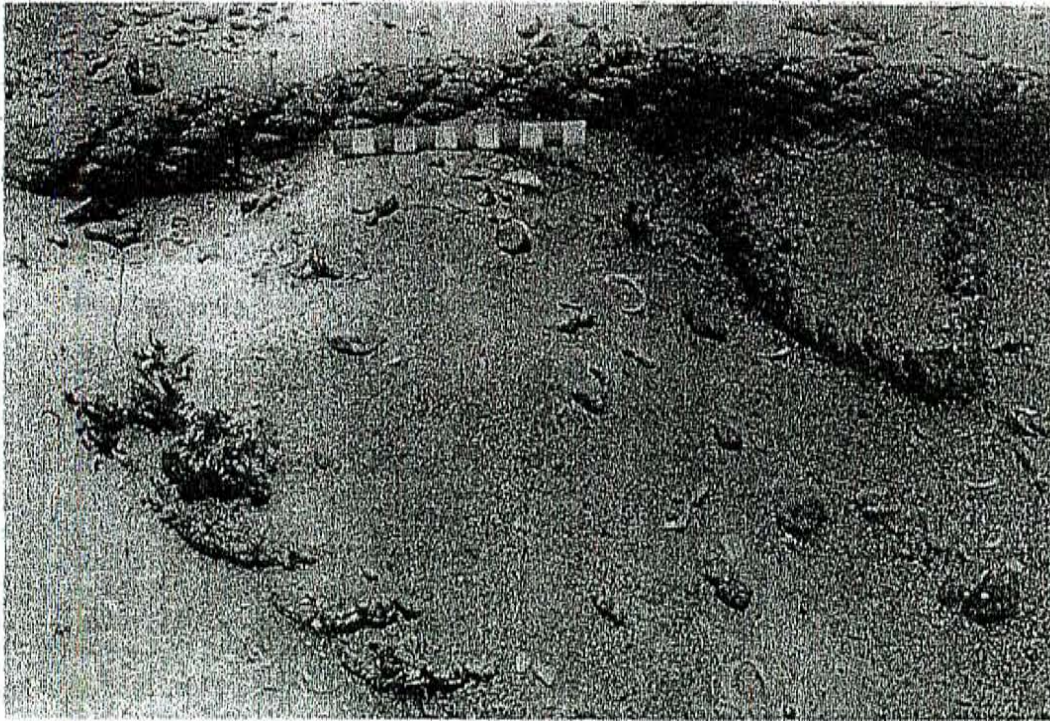
Figure 17. A length of anchor cable *in situ* at 59.29, overlying a rope strop. Scale 1 ft.
