EXHIBIT A-8

ANNEXES 13.4 TO 13.7

- 13.4. Wooden hull remains of the *Nuestra Senora de Balvaneda*, Florida, 1733.
- 13.5. Wooden hull remains from the Spanish galleon off the Dry Tortugas wreck, Florida, 1622: Kingsley, S., 'Odyssey Marine Exploration and Deep-Sea Shipwreck Archaeology: the State of the Art', *Minerva* 14.3 (2003), figs. 12, 14.

The Arade 1 Shipwreck: Preliminary Results of the 2004 and 2005 Field Seasons

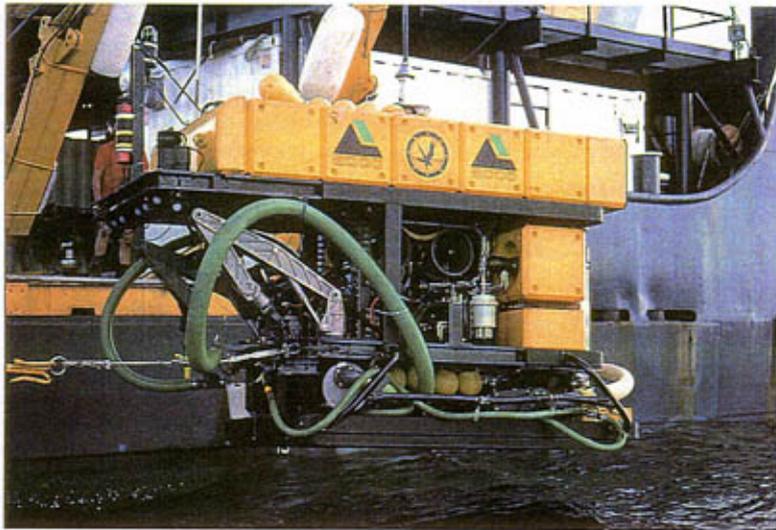
Fig 6 (left). Merlin, a 3.7m-long, 3-ton Ametek ROV equipped with six hydraulic powered positioning thrusters, titanium manipulator arms, video and still cameras, and various complex excavation tools (the tubing is attached to suction heads for air-lift excavation). This ROV was the mechanical brain behind the Tortugas excavation. © Odyssey Marine Exploration, Inc.

The brain of the operation was a 3.7m-long 3-ton Ametek ROV called Merlin (Fig 8), equipped with titanium manipulator arms, video and still cameras, and various mechanical interfaces designed for complex excavation techniques. Six hydraulic powered positioning thrusters enabled Merlin to retain its position on site without stirring up sand or damaging the archaeology, even when lifting a 115kg object. Video camera fibre-optics relayed live images to monitors on the mother ship above the site, where Merlin's movements were directed automatically using joysticks.

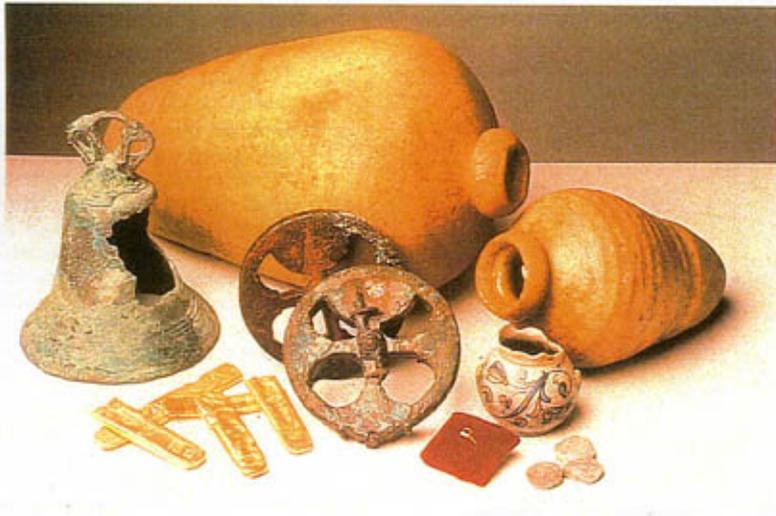
Fig 10 (below). One of several key innovations developed by Odyssey for the Tortugas shipwreck excavation included a suction limpet system. By automatically adjusting suction pressure, artefacts as varied as an olive jar or glass beaker could be successfully lifted. © Odyssey Marine Exploration, Inc.

The Tortugas shipwreck excavation witnessed a number of important innovations. Fixed acoustic transponders on the seabed constantly measured rates of sound-waves communicating between each other, enabling a transducer on Merlin to deduce its precise co-ordinates every five seconds and to thus record relative artefact positions contextually to an accuracy of 10cm. The team also utilized a 1m grid system that was incorporated into the computerised site database, enabling Merlin to excavate and record as on land within well-defined stratigraphic units. Suction heads attached to the ROV were operated automatically, offering greater sensitivity than is possible on shallow-water wrecks because air pressure could be changed immediately according to the condition and nature of artefact or structure being excavated. Rather than relying on ROV manipulator arms to lift artefacts (and possibly damage them), the team utilised a specialised suction limpet system capable of lifting objects as varied as a glass or a complete olive jar by changing suction pressure (Fig

10). Finally, an inertial filtering system was derived to enable all sediment excavated from the shipwreck to be screened for missed small finds.

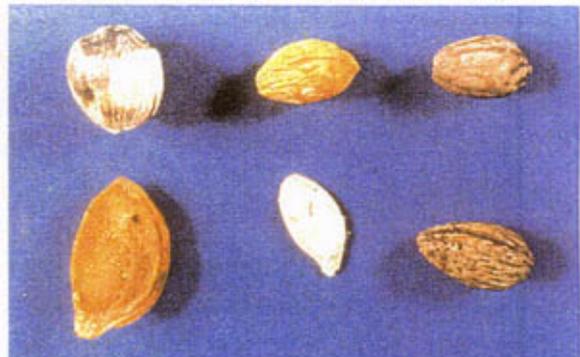
Fig 9 (above). The seed assemblage from the Tortugas wreck included hazelnut and olives (top row) and plum and squash (bottom row). This material suggests that Spanish historical documentation of appalling living conditions at sea may have been exaggerated. © Odyssey Marine Exploration, Inc.

Finally, the archaeobotanical and faunal assemblages have revealed some unparalleled evidence for life at sea at the time. A pig tooth and tusk hint at the presence of live animals on-board. The 565 seeds sampled include peach, woody palm nut for carving beads, four intact coconuts, olives, hazelnut, a grape seed, almonds, and one melon seed (Fig 9). It is this kind of detail, alongside the inkwell and shaker excavated (indicative of a literate person on the ship), and the ability of the olive jars dated to 1622 to improve chronologies of this vessel type, that make the excavation of the Tortugas wreck scientifically significant.

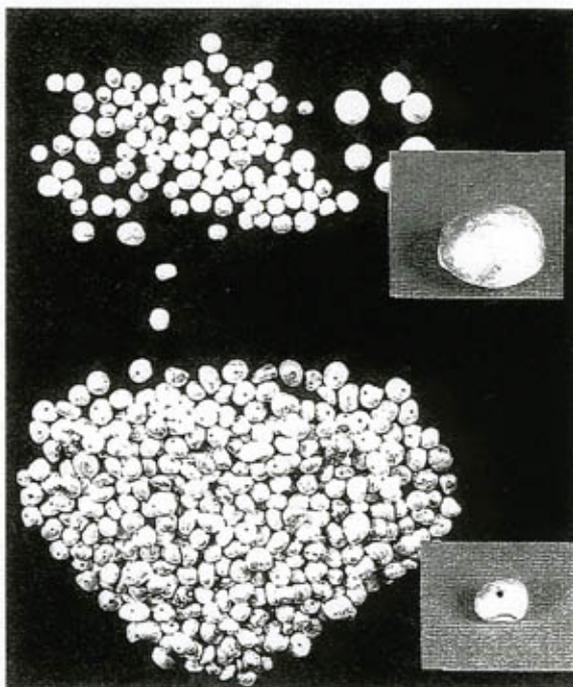
Fig 13. Excavation of the Tortugas shipwreck recovered 6639 pearls of 1-8mm diameter using an innovative inertial filtering system that enabled all sediment excavated to be screened and studied. © Odyssey Marine Exploration, Inc.

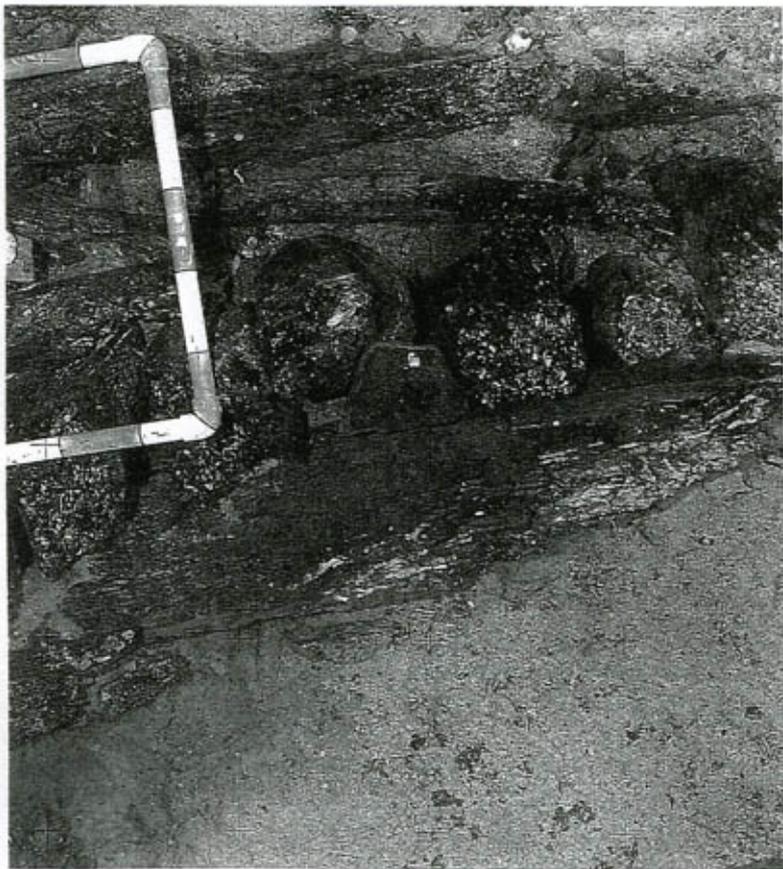
Fig 14. Section of wooden hull planking from the bow section of the Tortugas shipwreck. © Odyssey Marine Exploration, Inc.

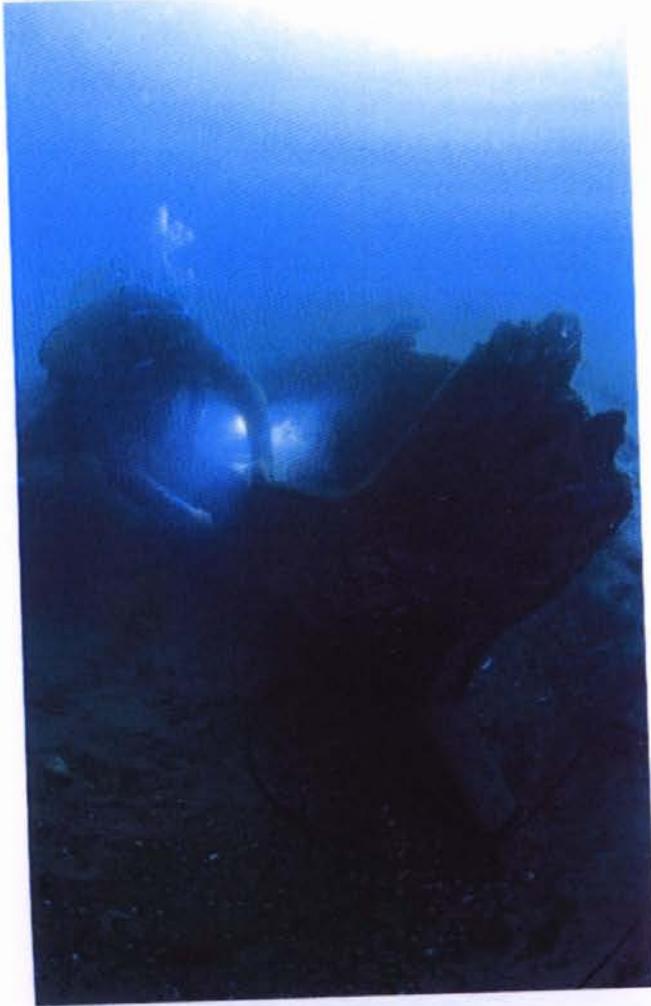
Figure 5.5 The Angra C shipwreck, Angra bay, Terceira Island, Azores

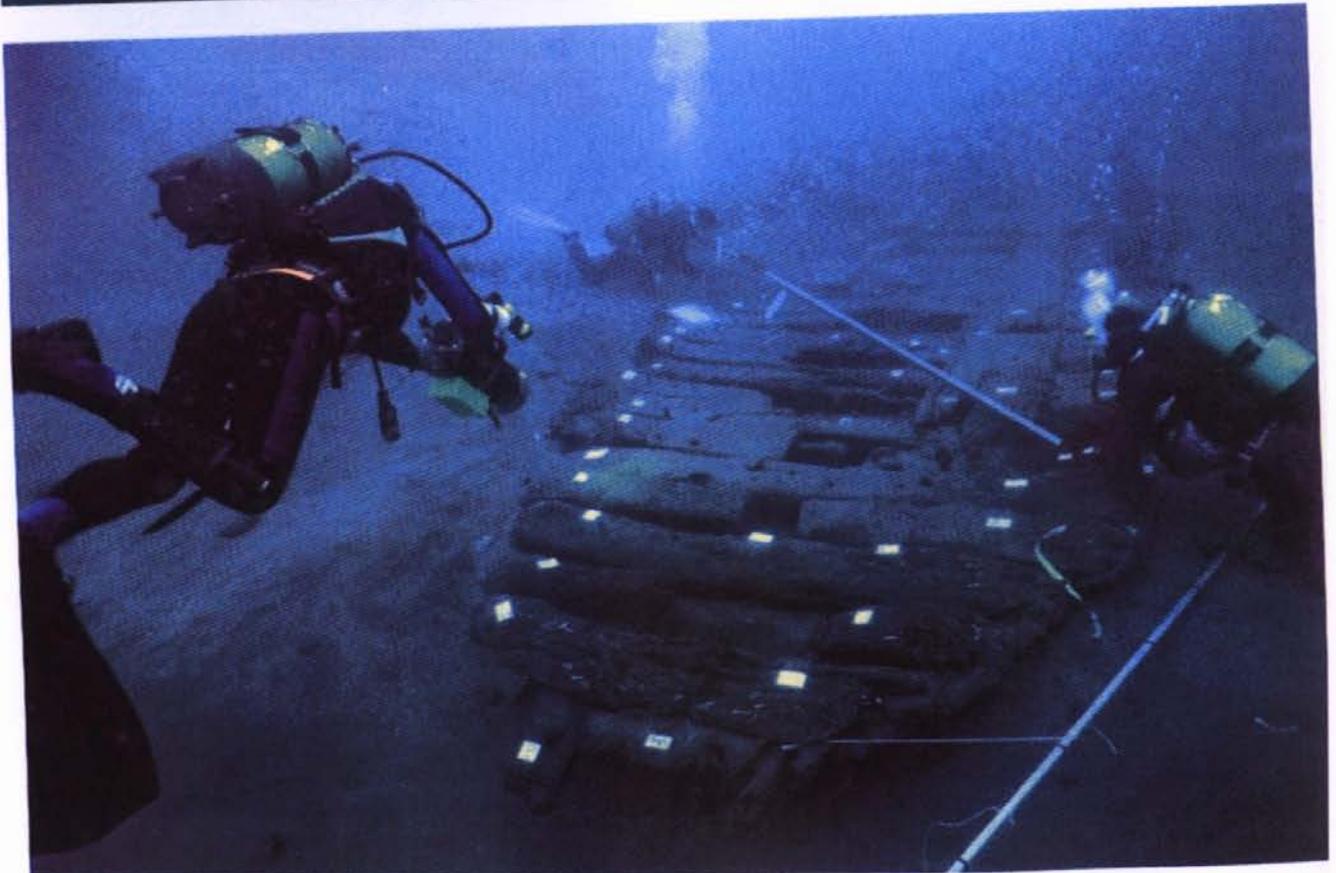
Figure 5.6 The Angra D shipwreck, Angra bay, Terceira Island, Azores

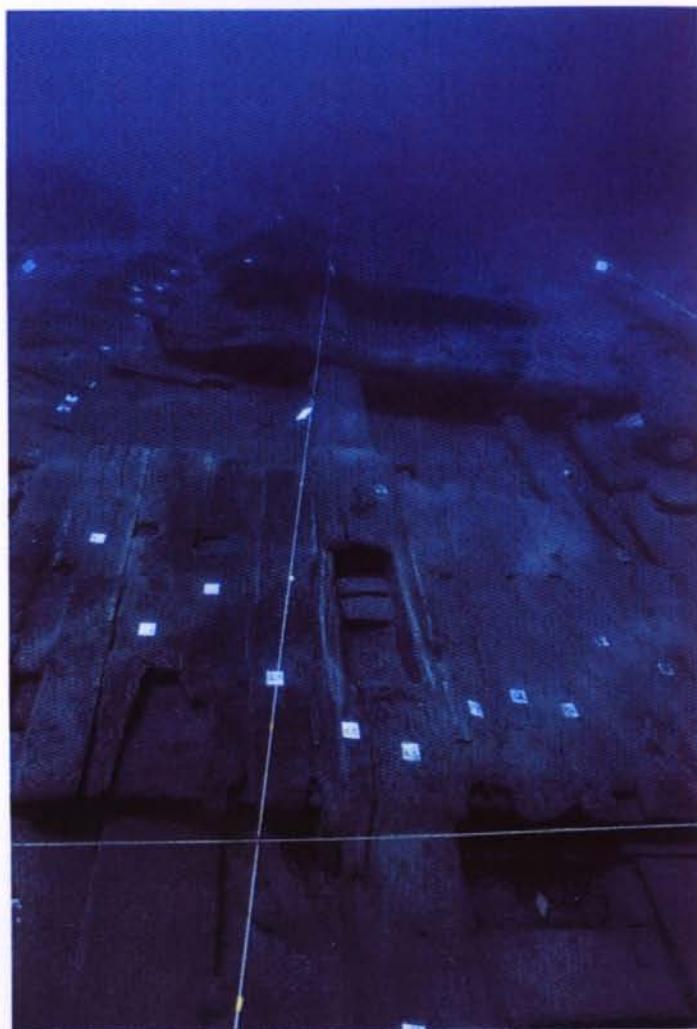
Figure 5.7 The hull remains of the presumed Indiaman *nau Nossa Senhora dos Mártires* (The Pepper Wreck), lost in 1606 in the Tagus bar, off Lisbon

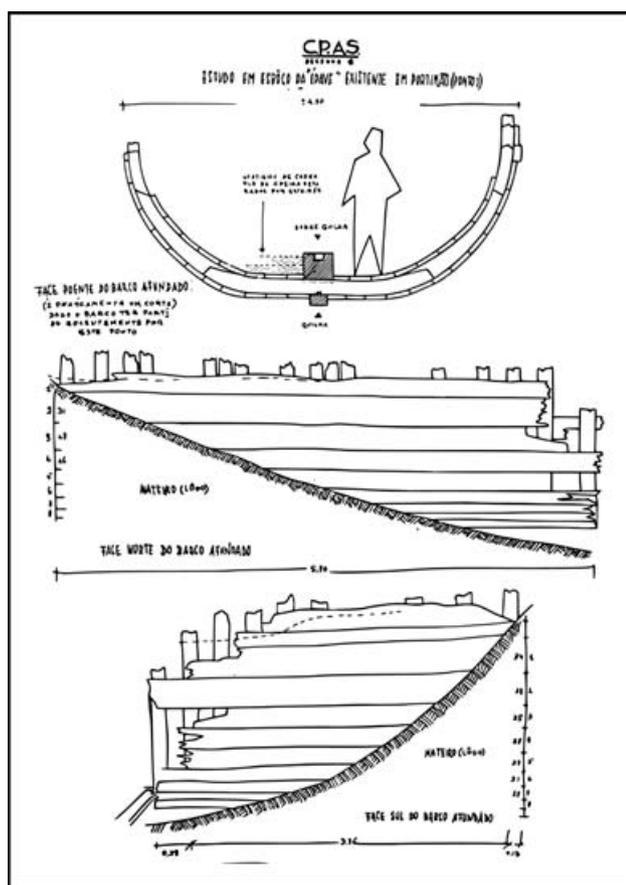
Figure 2. *Arade 1* shipwreck sketches made in 1970. (Farrajota, 1970)

According to the finders (Farrajota, 1970), the shipwreck seen in 1970 had smooth planking and robust construction, and was found broken in two parts: one stuck in the sandbank in a good state of preservation as if it had been sectioned; the other completely separated, lying horizontally, in front of the first, still connected to it by some planks. The frames had a rectangular section of 13 × 16 cm, while the hull planks, approximately 5 cm thick, were fixed to the frames by treenails of 3 cm diameter. Photographs taken at the time also show the existence of relatively well-preserved ceiling planking. However, neither in 2001 nor in the archaeological campaigns which followed were any remains found of the keelson seen in 1970,

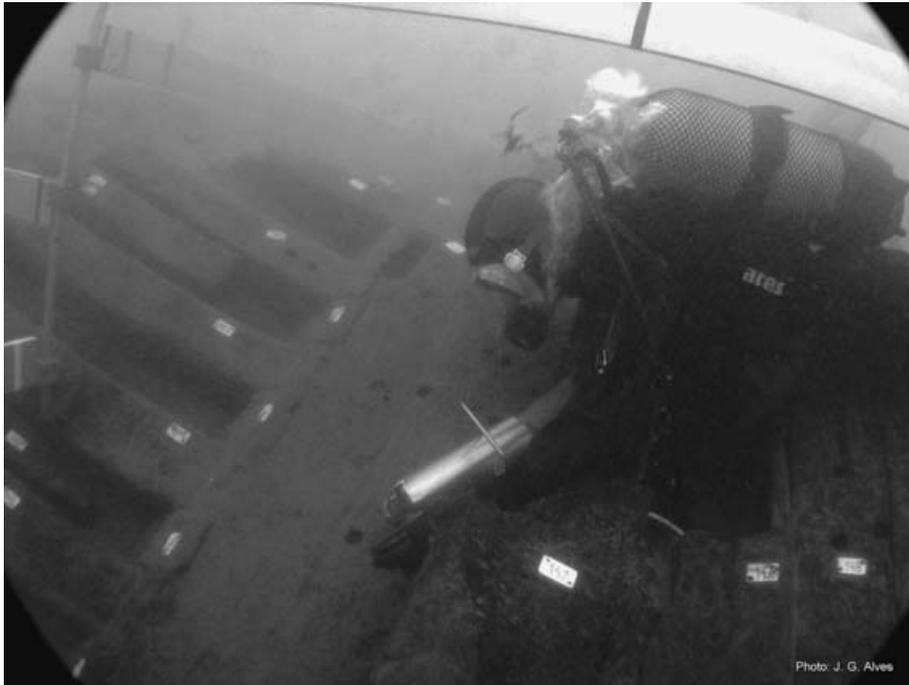
Figure 3. General view of the site. (J. G. Alves, 2005)

wreck. An extremely well-preserved and coherent nucleus was found, deeply buried in the silt, about 4 m long and 3.8 m wide. Over the surrounding area, mainly to starboard and south-west, was a spread of wooden pieces displaced from their original context, but in excellent condition (Fig. 3).

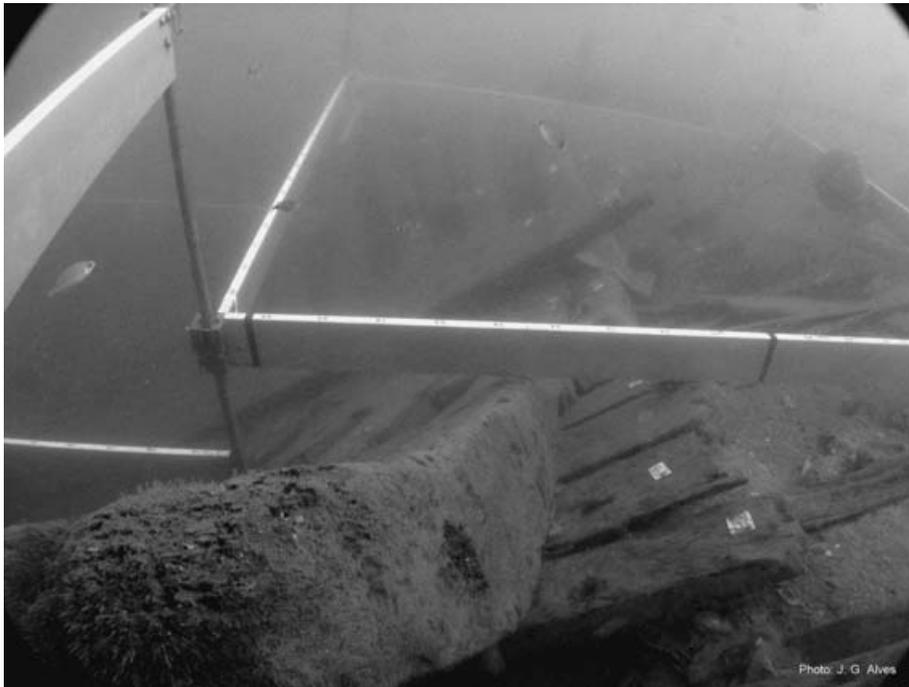
Figure 4. Excavation works, 2005 field season. (J. G. Alves, 2005)

The hull is broken at both extremities. This may be the result of the two consecutive dredgings in 1970, and this appears to be confirmed by scratched fibres on the hull planking. The deterioration of the port and starboard edges, on the other hand, appears to be the result of time and the conditions in which they lay. The remains lay between 6 and 12 m deep on a slope formed by the dredges in the 1970s. Thus they show a NE/SW orientation stern and aft, with an inclination of about 40°, and SE/NW port/starboard. The entire starboard keel area lies on the NE/SW slope, while the port hull found support on the SE/NW slope. It is the nature of this positioning which explains the excellent state of preservation of the keel. In contrast, a large part of the starboard planking was not resting on the slope, having become displaced, which explains the dispersion of the planks in the starboard area (Figs 4 and 5).

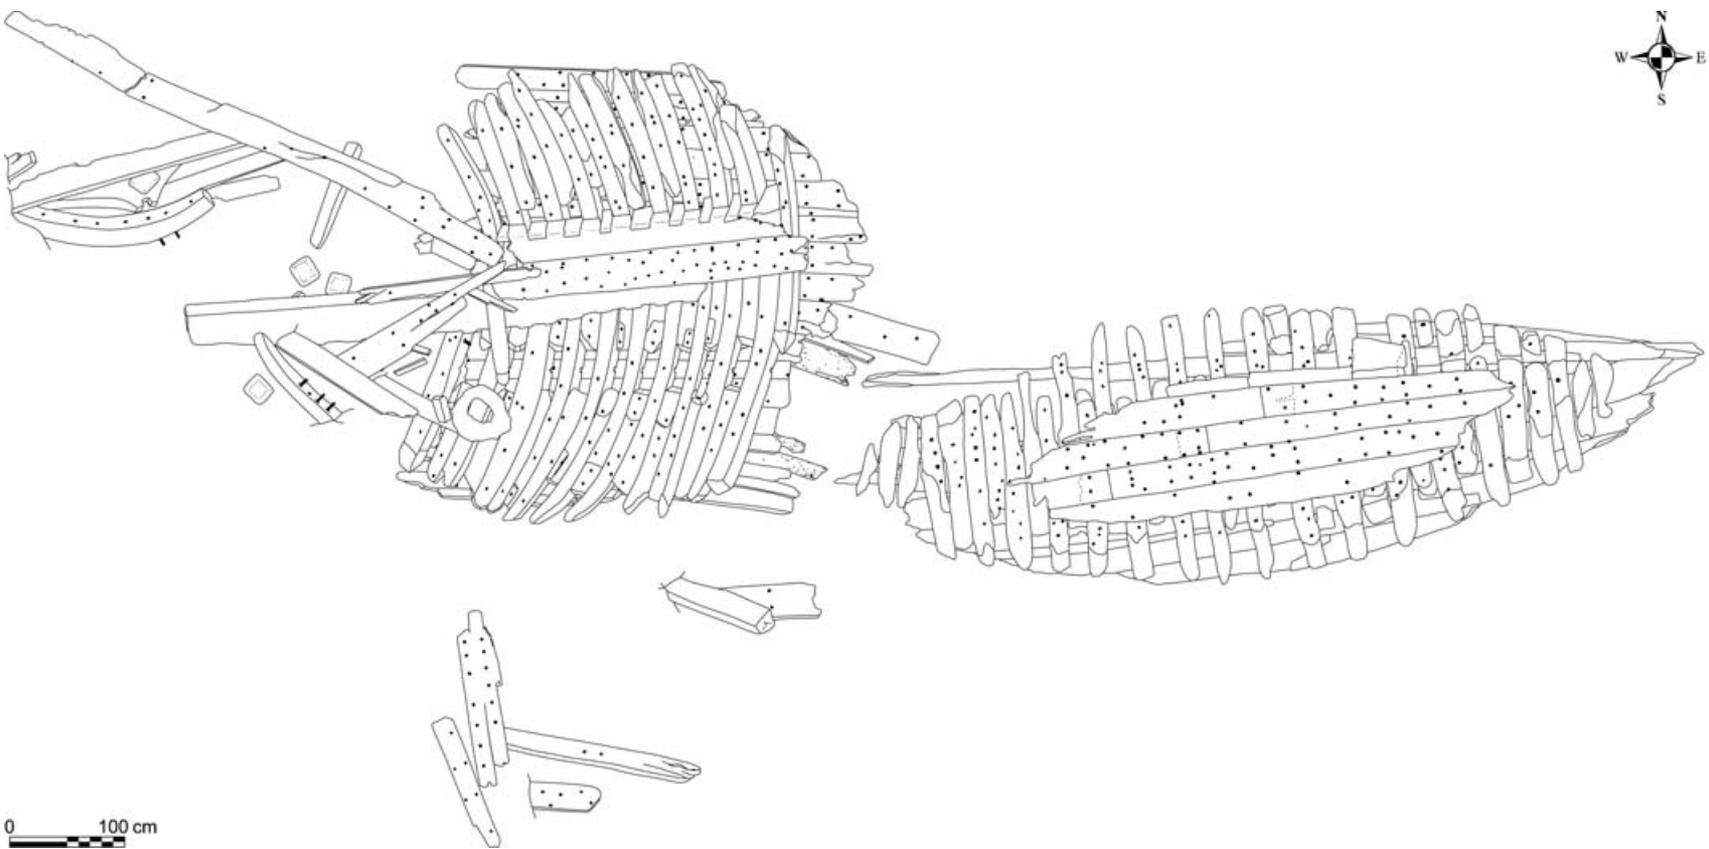
Figure 5. Arade 1 shipwreck plan made during the 2005 season. (V. Loureiro and J. G. Alves)

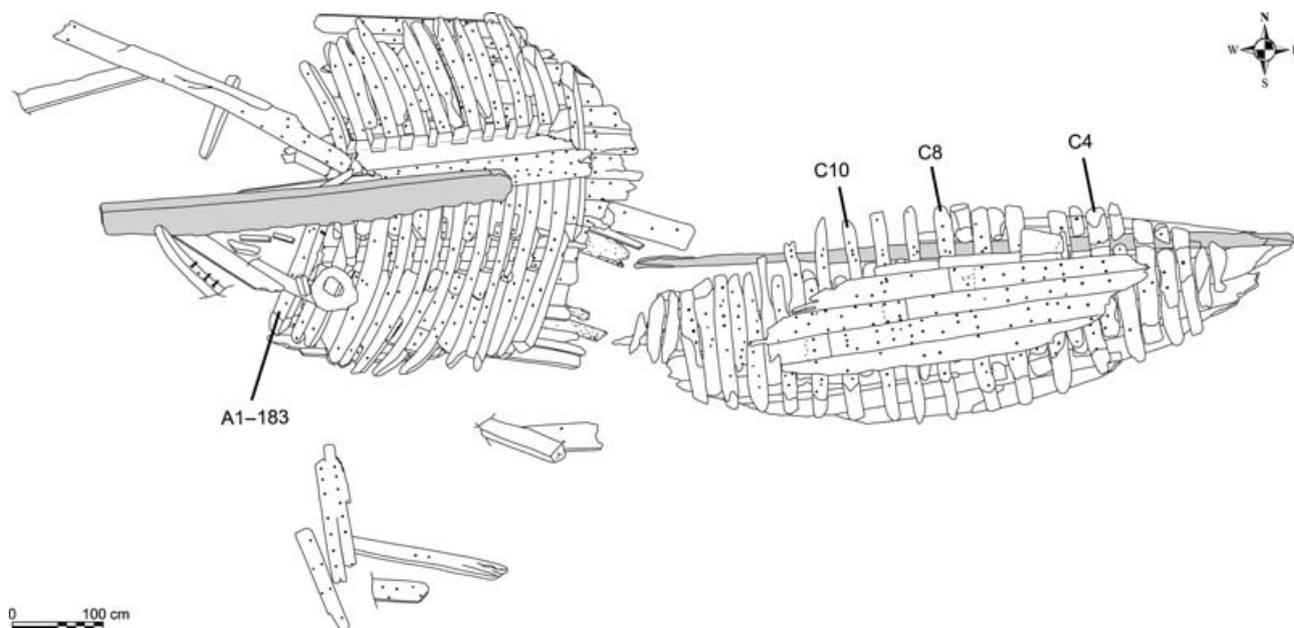
Figure 6. Identification of the keel and keelson in the Arade 1 shipwreck plan. (V. Loureiro and J. G. Alves)

The surviving keel, which is in an excellent state of preservation, is in one piece, *c.*4 m long, and

in its aft end are the remains of a flat vertical scarf.¹ It has a rectangular section, about 17 cm high and 15 cm wide. These dimensions do not significantly differ between floor timbers C8 and A1-183, though from C8 the section tends to increase gradually until the area where it joins the sternpost.² The keel appears to be rabbeted throughout its length (Fig. 6).

The keelson was found separated from its original position, lying on its side. It is 4.4 m long and in the area of the mast-step has a section of 35 cm wide and 33 cm high. The 'dent' continues almost throughout its whole length, disappearing in the last 80 cm, where the dimensions of the section itself reduce. It is possible that this reduction is the result of erosion and not its construction. On the upper face of the keelson two large iron concretions are still visible, evidently iron bolts which connected it to the keel. The fragment of keel recovered in 2003 also has three large concretions on its underside, which were noted in the 2002 report, with the hypothesis that the keelson was bolted to the keel (Castro, 2003a).

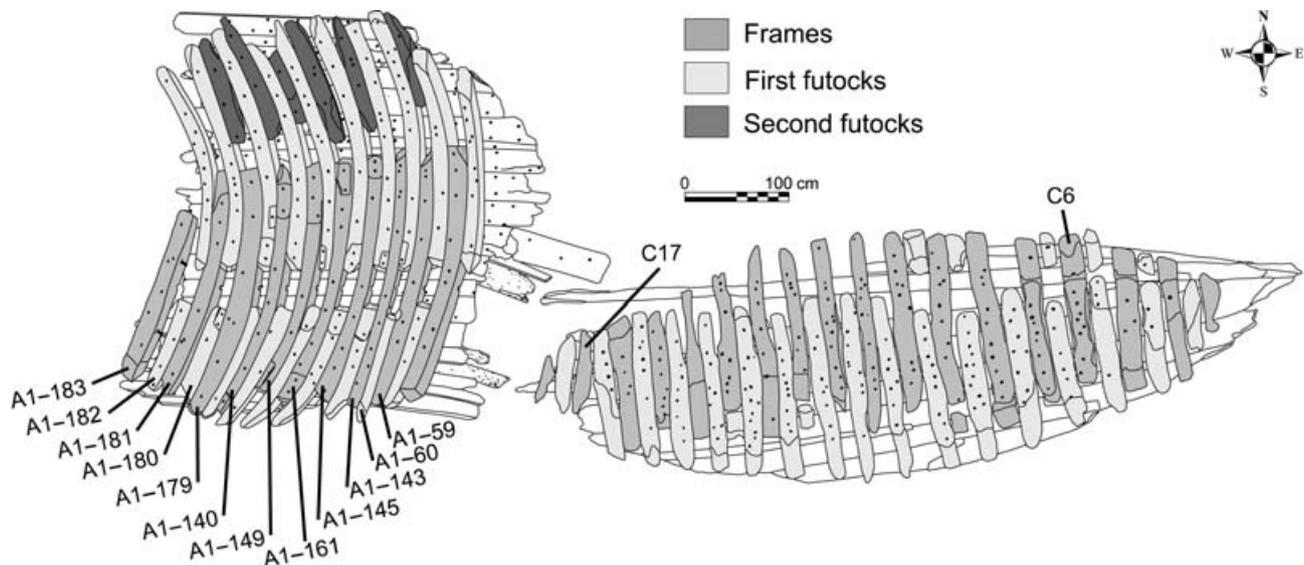
Figure 7. Identification of the frames, first-futtocks and second-futtocks in the Arade 1 shipwreck plan. (V. Loureiro and J. G. Alves)

The coherent structure, recorded in 2004 and 2005, preserved ten frames, nine starboard first futtocks, ten port first futtocks, and six second futtocks also from port (Fig. 7). The assembly pattern of the transverse frame on the keel does not allow any spacing between the frame/first futtock pairs,

in a clear continuation of the observations made at the extremity of the stern (Loureiro, 2004: 60). The frames have a shape in process of opening until A1-59 and closing from A1-149. The frames between these two pieces have a flat bottom, with the point at which the rods start to curve to join the curvature of the first futtocks being clearly visible. An interesting fact is that these frames have the same shape as the master-frame illustrated in the *Liuro da Fabrica das Naos* (Oliveira, 1580: 107-08).

The floor timbers are carefully cut and shaped, with a rectangular section and exceptional robustness. They all have a trapezoidal limber-hole and are connected to the keel by one or two pegs, inserted vertically into the upper side of the frame. The timbers have identical dimensions, the only exceptions being A1-161 and A1-179, substantially thicker than the others (in fact almost double). This dimensional homogeneity has already been noted in timbers C6 to C17, which like the pieces just referred to, are also pegged to the keel. Timbers C2 to C5 have dimensions which do not comply with any standard, as well as a more ample and robust structure and a less careful cut. These timbers are further distinguished from the others as they do not have any system connecting them to the keel. Some timbers still have small, thin fitting-boards on the port extremity (A1-145) or on both extremities (A1-161, A1-149 and A1-140), which enable the levelling of the framing, possibly to fit the stringers better.

The pump sump is carved between frames A1-59 and A1-143, reaching the end of the first futtock A1-60. The first futtocks have a section identical to the floor timbers, reaching lengths greater than 2 m on the port side. Only the first futtock of A1-180 has a more delicate appearance and is narrower than the average, and breaking with the assembly pattern of the framing on the keel—that is, only at this point is there spacing between the two pairs. Like the floor timbers, the first futtocks are carefully cut and almost all of them, from the surviving upper ends to the keel, have small thin fitting-boards. The horizontal connections between the floor timber and the first futtock were made by wooden pegs with an average of 4 or 5 per pair. This rhythm is interrupted at frames A1-143 and A1-161, where the pegging is more frequent.

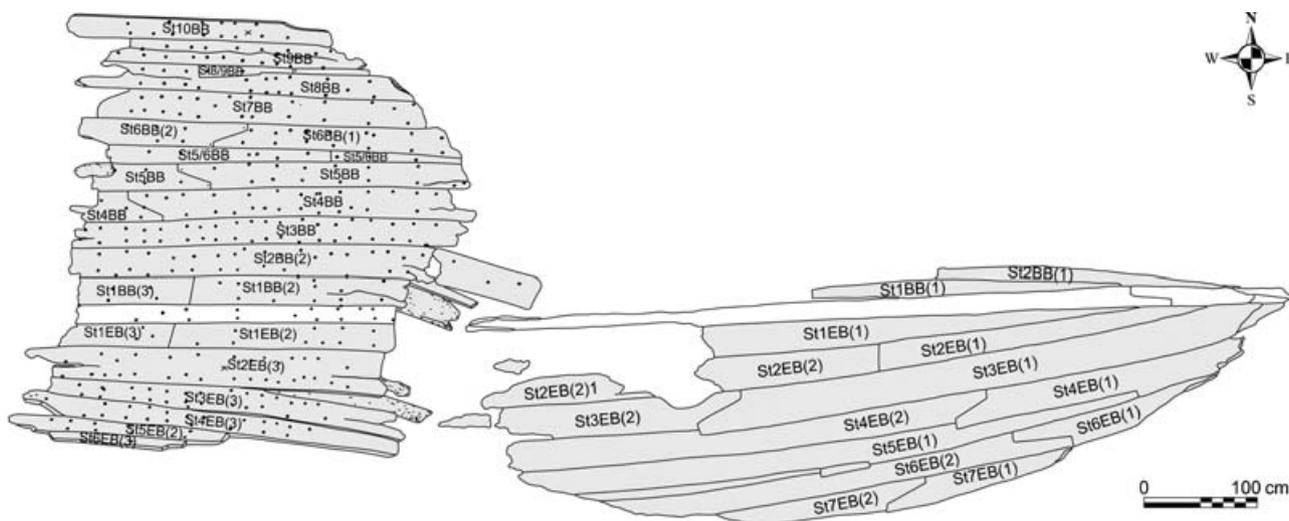
Figure 8. Identification of the hull planking in the Arade 1 shipwreck plan. (V. Loureiro and J. G. Alves)

The hull is carvel planked, with no fixings between one plank and the next. That is, the ship has a smooth hull, common throughout the Atlantic and Mediterranean regions since Classical Antiquity. The planks are straight and only connected to the transverse frame of the ship with a system of two pegs per frame, first futtock or second futtock. There are ten strakes on the port side of the keel, with a total of 19 pieces, and six on the starboard, with a total of seven pieces (Fig. 8). The relationship between the two halves of the hull is demonstrated by the dimensional homogeneity of the planks—that is, although the pieces all have distinct dimensions, plank St1 Bb has the same width as St1 Eb, St2 Bb matches St2 Eb and so on.

The connection between planks of the same run is made edge against edge. Although the hull planks are normally fixed to the frames by wooden pegs, at the scarfs there are, without exception, two iron nails, a clear reinforcement of the connection between the planks, and a similar situation is seen at the extremity of the stern (Loureiro, 2004: 77). The planks vary in length, reaching up to 3.2 m (St4 Eb). Their widths range between 250 and 315 mm, although the most common dimension is around 280–290 mm. The thickness varies from 45 to 55 mm. The existence of

two narrower sets of boards should also be mentioned: filling pieces or stealers between planks St8 Bb and St9 Bb (St8/9 Bb) and between planks St5 Bb and St6 Bb (St5/6 Bb). A similar arrangement was also evident on the starboard side of the stern area (Loureiro, 2004: 77). On the exterior starboard side of the wreck two strakes were found of double the normal thickness.

The garboard strakes have identical characteristics to the rest of the strakes, although they are slightly thinner. There is no connecting scarf between the planks, which are simply butt-joined. These are not connected to the keel, but are bevelled to fit snugly into the keel rabbet. This suggests that iron nails were only used to fix the garboard strake to the keel as the planks rise towards the extremity of the ship's stern (Loureiro, 2004: 79). In this area, the remains of ceiling planks are scarce, with only a port stringer and the board immediately following still *in situ*. The pieces accumulated in the SW area appear to include many ceiling planks, but their positive identification has still to be made.

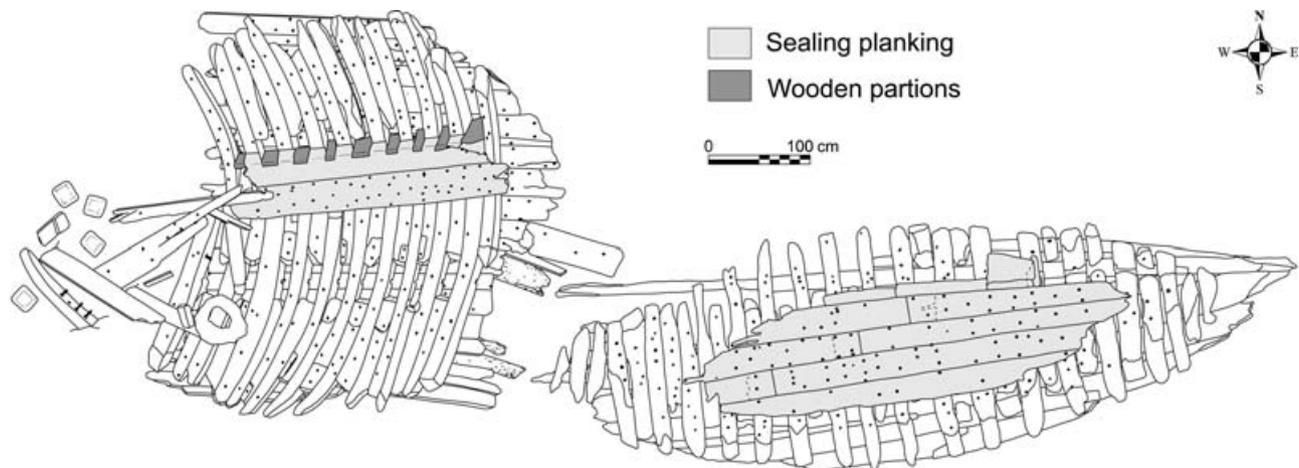
Figure 9. Identification of the ceiling planking in the Arade 1 shipwreck plan. (V. Loureiro and J. G. Alves)

The stringer is 3.5 m long and of identical thickness to the adjacent plank (6 cm). The stringer preserved on the left side of the lower portion of the hull covers the floors' extremities and presents notches where filler pieces were inserted. These filler pieces located between the first futtocks prevented the infiltration of debris among the transverse frame. This piece was found still connected to the first futtocks by a peg or an iron nail inserted into the tooth of the stringer—many of the teeth were broken during the process of

dismantling the ship because of difficulty in sawing the pegs. There are still nine wooden partitions *in situ*. These were not connected to any piece, and by their oblique orientation and perfect notching between the first futtocks, show that they had to have been hammered into position. As for the board from the ceiling planking, there is nothing to mention except for the pattern of the timber and the first futtocks' pegging, which is in perfect union, in contrast to what was seen during the dismantling of the ceiling planking from the extreme aft of the ship in 2002 (Castro, 2003a) (Fig. 9).
