EXHIBIT A-10

Examples of ballast heaps defining shipwreck sites.

The Legare Anchorage shipwreck site—Grave of HMS *Fowey*, Biscayne National Park, Florida

Excavation versus sustainability *in situ*: a conclusion on 25 years of archaeological investigations at Goose Rock, a designated historic wreck-site at the Needles, Isle of Wight, England

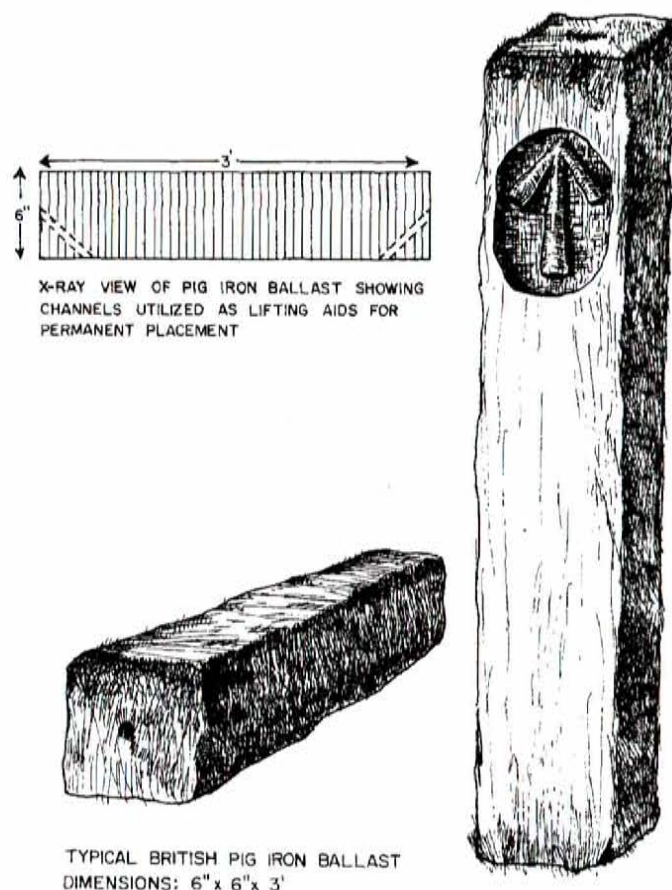
Figure 3. Rendering of iron ballast blocks found at BISC-UW-20.

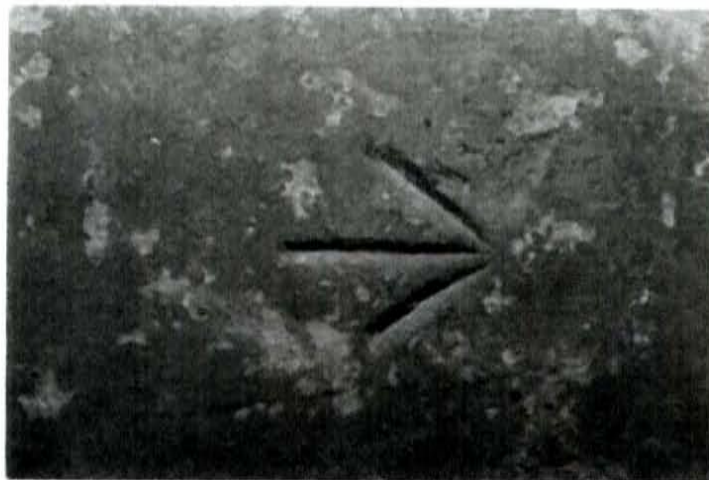
Figure 6. Broad Arrow found on the first reinforce of a nine pounder gun.

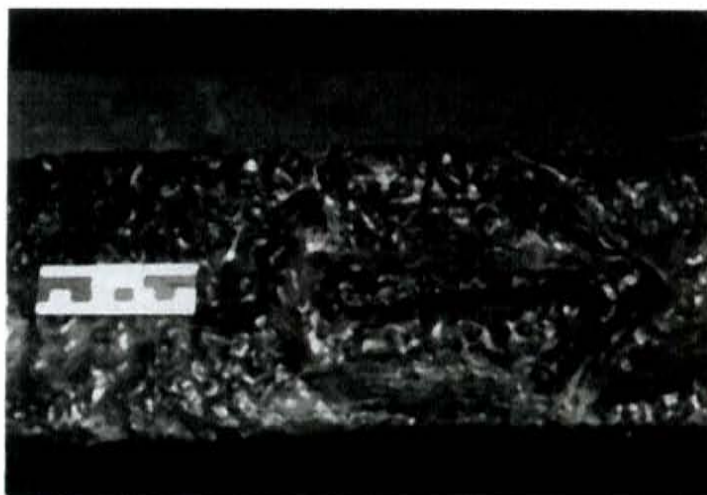
Figure 7. Incuse cast Broad Arrow found on cast iron ballast block.

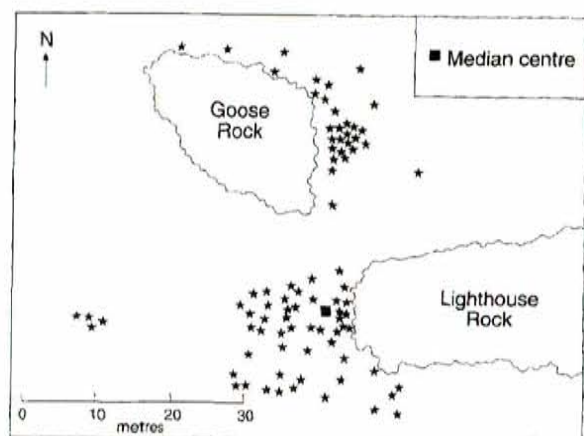
Figure 13. Discontinuity in the distribution of *Pomone*'s copper sheathing at Goose Rock. (Drawing: PS)

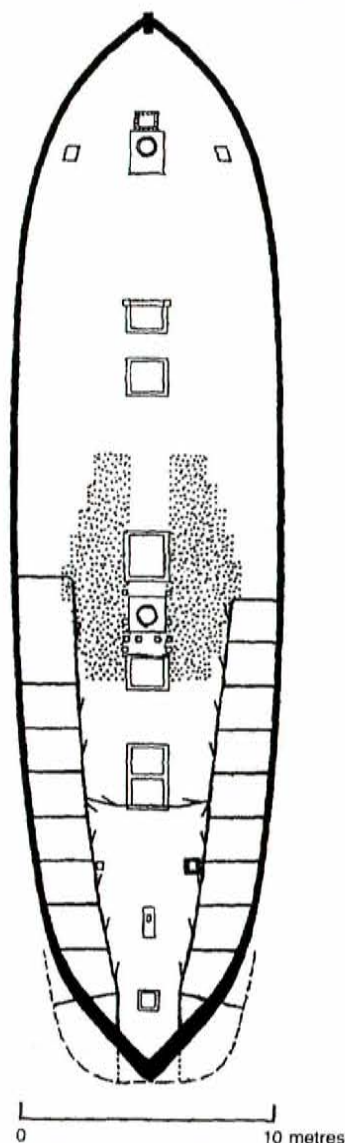
Figure 14. The approximate position of iron ballast blocks (stippled) in a contemporary frigate. (Drawing: DJT after *Artois* 1794 in Lavery, 1987)

artefacts' might be used to reconstruct the plan and character of the ship purely upon archaeological principles. In the first instance, the former position of the keelson of the ship might be sought amongst the distribution of iron ballast blocks. A comparison with the extant *Trincomalee* had shown that standard 2 cwt blocks were generally laid longitudinally in an orderly arrangement on each side of this central member. Contemporary ballast plans for the frigates *Artois* (1794) and *Barrosa* (1812) suggest that none or few of these blocks were normally laid aft of the pump and mainmast foot while the mass was spread alongside the ship's well and the shot-lockers. From here, smaller quantities of blocks would extend forward beneath the water casks of the hold (Lavery, 1987: 190–191). Given their heavy weight and obvious lack of mobility, the position of the blocks on the seabed should closely reflect the final position and orientation of the wreck (Fig. 14).

An incongruity in *Pomone*'s conjectured second lodging position was ballast dump 2. The comparative evidence offered by the frigates *Artois* and the *Barrosa* had shown that iron ballast was normally assembled forward of the chain pump (Fig. 14). The evidence strewn at the foot of Lighthouse Rock was contrary to this for it

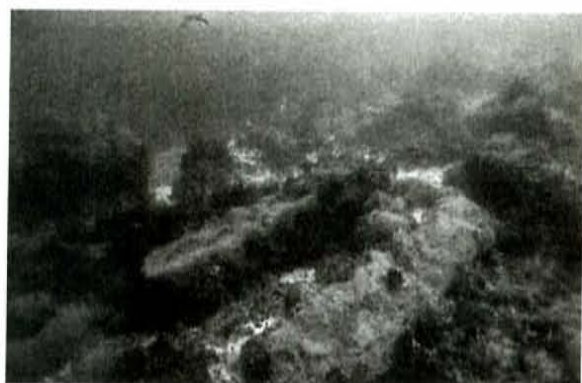
Figure 15. *Pomone's* 2 cwt iron ballast blocks *in situ* in ballast dump 1. (Photo: Garry Momber)

It was conjectured that a detached and compact group of 17 ballast blocks, discernible on the west side of the general distribution, had probably been shed during the initial impact of the ship (Fig. 15; Appendix 3). These blocks were attributed to the first grounding of the ship at 'lodging position 1' (Fig. 16). This evidence suggested that

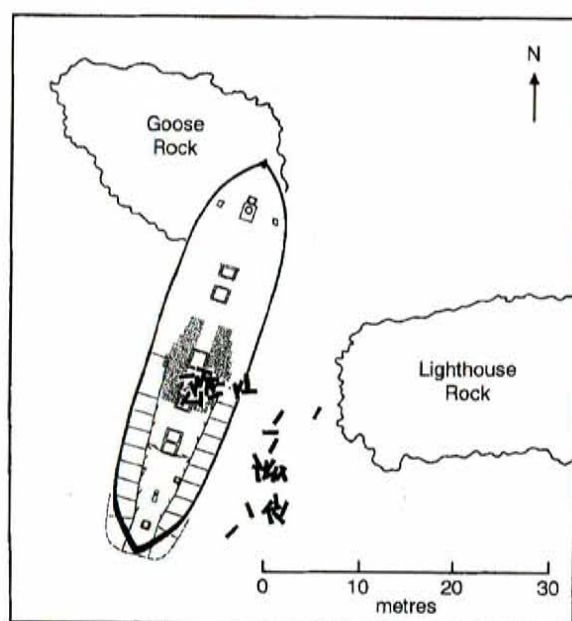
Figure 16. The calculation of *Pomone's* first lodging position centred on ballast dump 1. (Drawing: DJT)

during the very first stage of the disaster the bow of *Pomone* had ridden up on to the Goose. Such an action would drive the mid and stern sections of the ship down on to the ridges and corrugations of the wave-cut platform. Some broken and buckled links of the chain pump were found near this first dump of ballast blocks and these suggested that initial and critical damage had been sustained amidships and that the floor of the hold and the well had been immediately perforated.

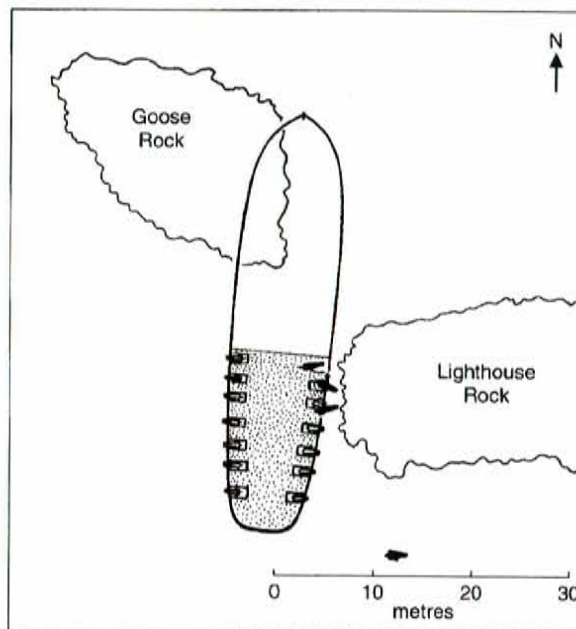
Figure 18. *Pomone*'s second lodging position and the loss of her quarterdeck carronades. (Drawing: DJT)

during its descent to the seabed. Particularly revealing was the distribution of carronades. These ordnance pieces had been arranged in a complement of 14 on *Pomone*'s quarterdeck. Their final resting position at the foot of Lighthouse Rock provided further persuasive evidence to demonstrate that the ship had been trapped for some time in lodging position 2 (Fig. 18).

The evidence offered by the heavy ordnance had long suggested to the archaeological team that although some 76% of it had been recovered, the ship had listed significantly to starboard in its second position so that the remainder of the guns had been shed on this side of the craft. This listing position for *Pomone* was proposed in 1988 yet it was not until 1993 that the paintings of Sir James Sutherland were to provide precise confirmation of the archaeological conjecture.
