ANNEX 17
TO
EXHIBIT A

Bronze pintle and copper tubing from HMS *Pandora*, Great Barrier Reef, 1791:
Henderson, G., 'Finds from the Wreck of HMS *Pandora*', *International Journal of
Nautical Archaeology* 9.3, 1980.

Finds from the wreck of *HMS Pandora*

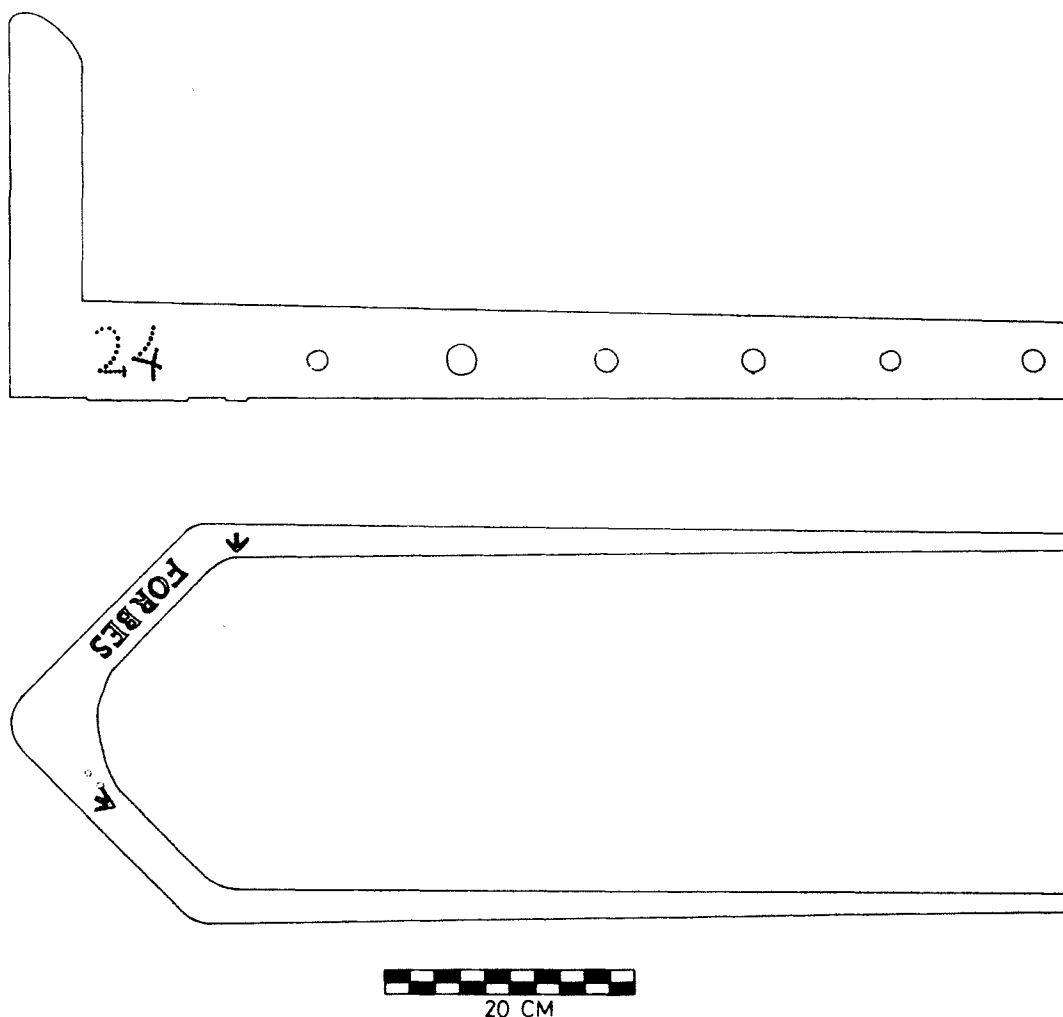
Figure 1. Detail of the cleaned pintle showing markings. Photo: Pat Baker.

The second pintle (Fig. 1) raised from the site has undergone treatment at the Western Australian Museum's Department of Materials Conservation. On cleaning it proved to have been well preserved and bore a number of significant markings:

1. The presence of two raised broad arrow marks shows that the pintle was made for the British Government, and indicates that the wreck is that of a British naval vessel.

4. Two punched dots, of larger diameter than those forming the number 24, appear on the lower edge of the pintle. It is likely that this denotes the second pintle position on the rudder.

The overall length of this pintle is 0.85 m, and the pin diameter is 0.058 m. It has longer jaws than the pintle at the Queensland Maritime Museum, and would have had a lower position on the rudder.

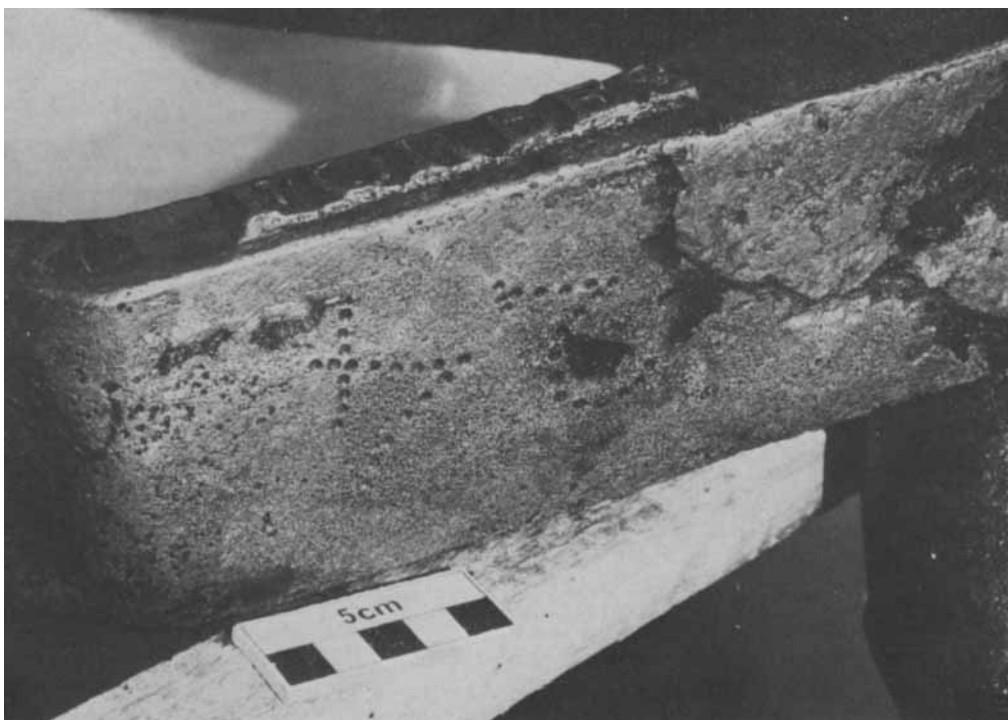
Figure 2. Detail of punched numeral 24. Photo: Pat Baker.

2. A series of small dots have been punched into the piece to form the number 24 (Fig. 2). The *Pandora* was a 6th rate, but there was some variety of type within this rating. The number of guns was therefore a more precise way for those in the ship-building industry to refer to a particular class of vessel. *Pandora* was a 24-gun, 6th rate, and the number on the pintle would refer to this class.

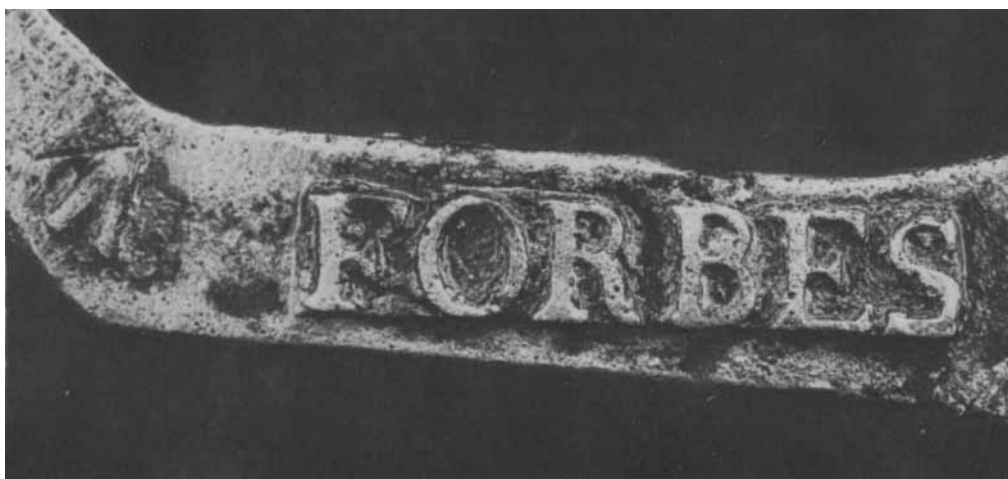
Figure 3. Spectacle plate from the rudder. Photo: Pat Baker.

3. The name 'Forbes' (Fig. 3) in raised lettering appears very clearly on the pintle. A typically Scottish name, it may be expected that it refers to either a copper founder or other contractor who supplied the pintle to the Navy.

A similar but slightly smaller piece, with a band 0.409 m by 0.698 m and eyes of approximately 0.022 m, was found in 1977 on top of the shallow reef adjacent to the *Pandora* wreck site. When the *Pandora* struck the shallow reef, damage was incurred to the sternpost and the rudder, resulting in sections being torn away (Thomson, 1915). The presence of the spectacle plate on top of the reef indicates that the damage extended to the higher sections of the rudder.

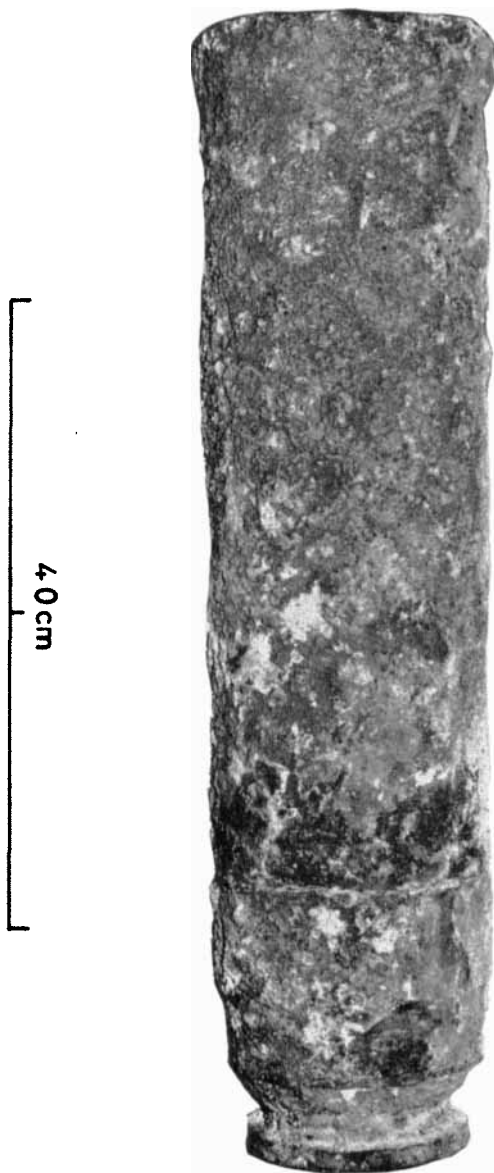
Figure 4. Section of copper tubing from the bottom section of a pump. Photo: Pat Baker.

The copper pump chamber section raised from the wreck site is 0.73 m in length, with an internal diameter of 0.17 m (6.7 in). The lower end of the tube has a shoulder and an everted lip to facilitate the connection with the lowest section or nozzle of the pump (Fig. 4). At the time of raising, divers reported seeing indications of canvas near the shoulder

of the tube, and this may originally have facilitated the sealing of the connection. A similar connecting metal piece with shoulder and lip (pipe diameter of 0.123 m) has been found on a wreck site in Western Australia dating to about 1810 (Henderson, 1980).

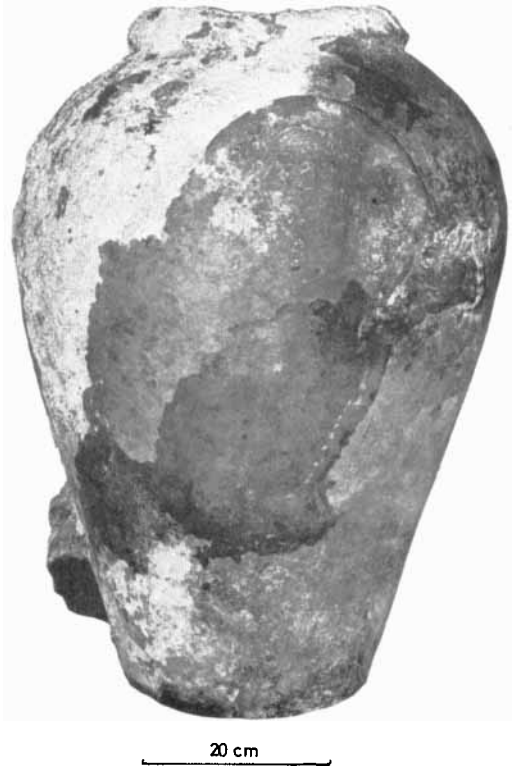
Figure 5. An earthenware jar bearing an applied plaque. Photo: Pat Baker.

Three large jars of apparently similar shape have been observed on the site and one of these was raised when the wreck was found (Fig. 5). This jar 0.75 m high, shows no sign of glazing and is made of pink earthenware. It has a thickened rim and two vestigial arched handles enclosing, on at least one side (the other remaining obscured by coralline encrustation at present), an applied plaque with the raised letters T M F under a Lorraine cross (Fig. 6).

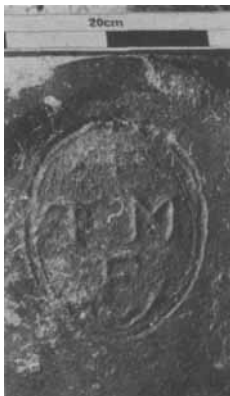
Figure 6. Detail of the plaque beneath the arched handle. Photo: Pat Baker.

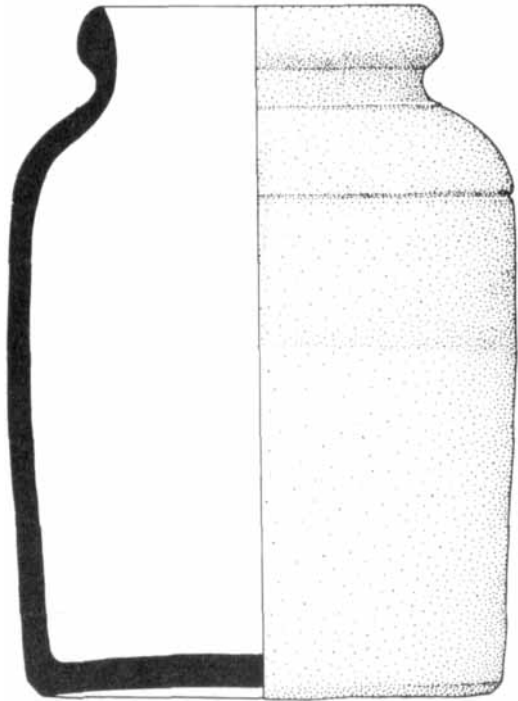
Figure 7. A saltglazed jar raised from the wreck. Drawing: Myra Stanbury.
