FIRE INVESTIGATION Report One

INSURED: Stutte, Laura & Carol
LOSS LOCATION: 2715 Highway 360
Vonore, Tennessee 37885
DATE OF LOSS: September 4, 2010
Claim/File NO: 41-H-25N023
Policy NO: 41-H-V669657
EFI File NO: 94216-08643

Report Date: December 10, 2010
Prepared For: The American National Property & Casualty
Insurance Company
1949 East Sunshine
Springfield, MO 65899
Attention: Stacey Jennings

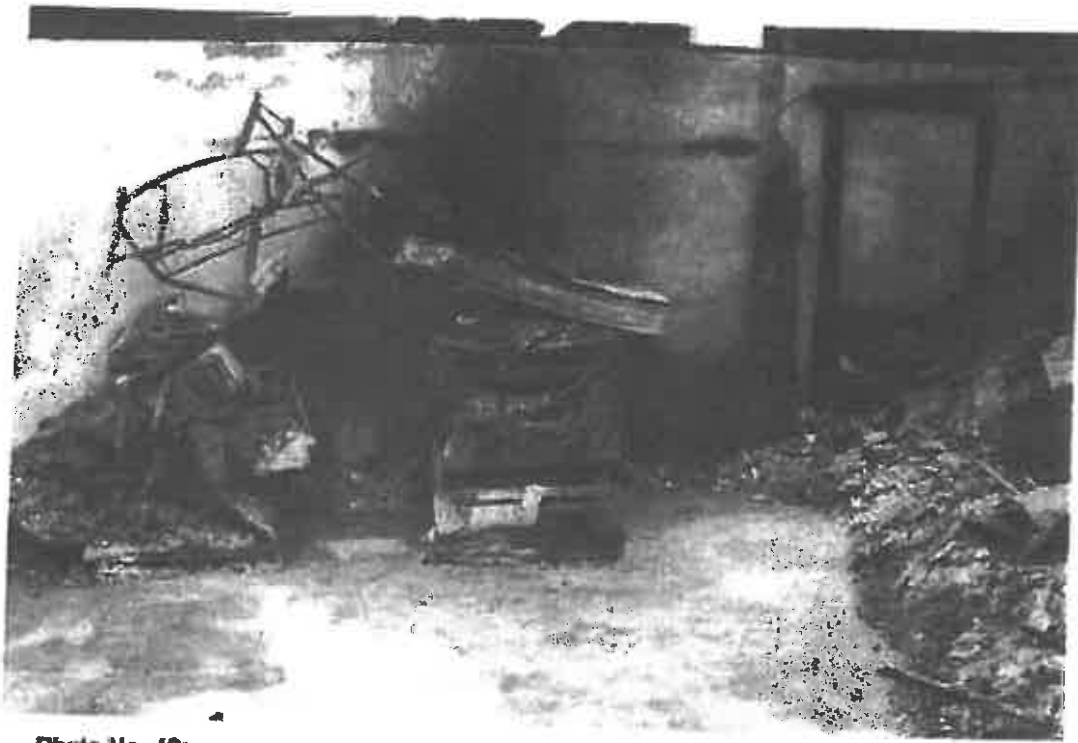
Photo No. 49:

- 49-50) Views of the kitchen area after debris
- 52) Views of the left end of the residence where the fire originated
- 53) Shows some of the concrete spalling trails spanning across the kitchen portion of the basement floor up to the left end door threshold
