**IN THE UNITED STATES DISTRICT COURT
FOR THE SOUTHERN DISTRICT OF TEXAS
GALVESTON DIVISION**

No. 3:19-cv-207

**MEMORANDUM OPINION AND ORDER
ENTERING FINDINGS OF FACT AND
CONCLUSIONS OF LAW**

This maritime action arises from a collision in the Houston Ship Channel between a large liquified-gas carrier and a tug pushing two tank barges. The collision caused one barge to capsize and the other to hemorrhage a great deal of reformate into Galveston Bay. The reformate spill, in turn, caused environmental damage which led to an abundance of third-party claims.

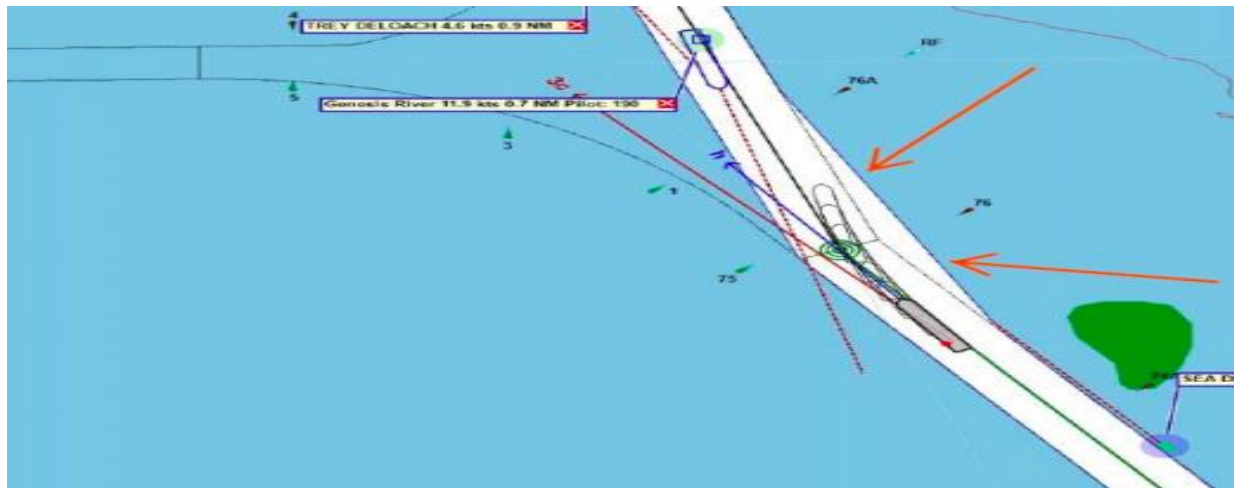
Figure 5. Widener at the Bayport Flare

The Bayport Flare is a highly trafficked area near the intersection of the Houston Ship Channel and the Bayport Channel. To accommodate the high traffic and promote safer meetings between ships in the area, a “widener” has been

dredged at the elbow of the channel, which provides an additional width of suitable water depth for inbound vessels.

In making the turn at the flare, Captain Barton opted against steering the *BW Oak* through the widener on the red side. If he had, Captain Barton testified, the two vessels would have been temporarily pointing directly at each other, an “uncomfortable” heading for them both.

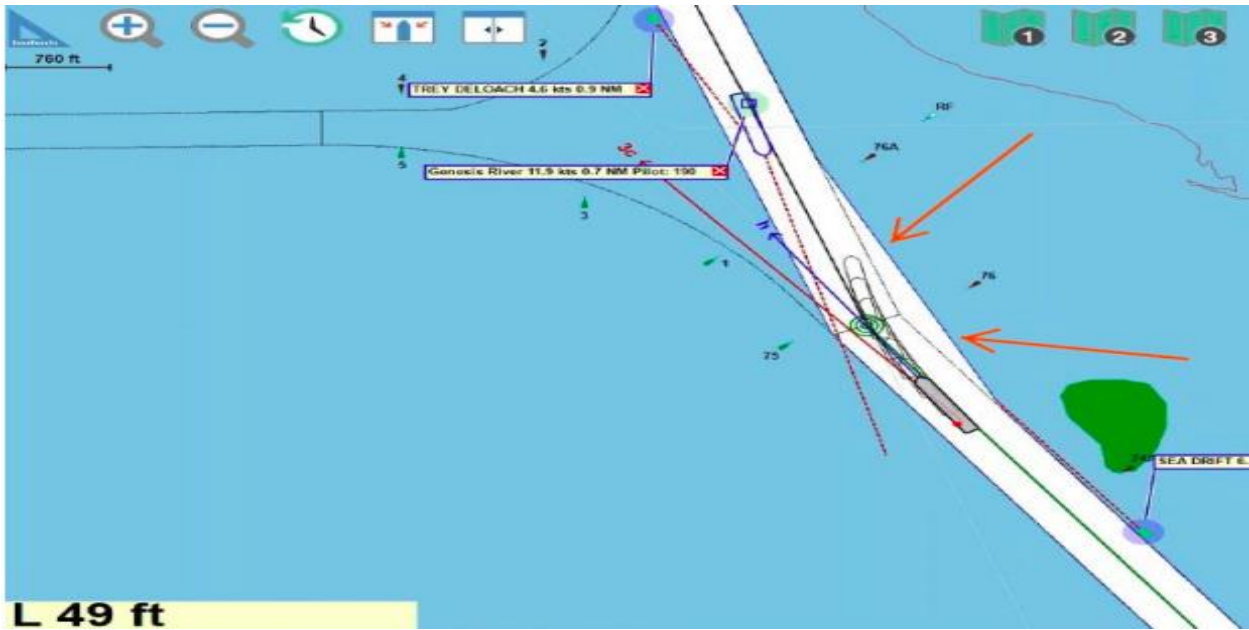
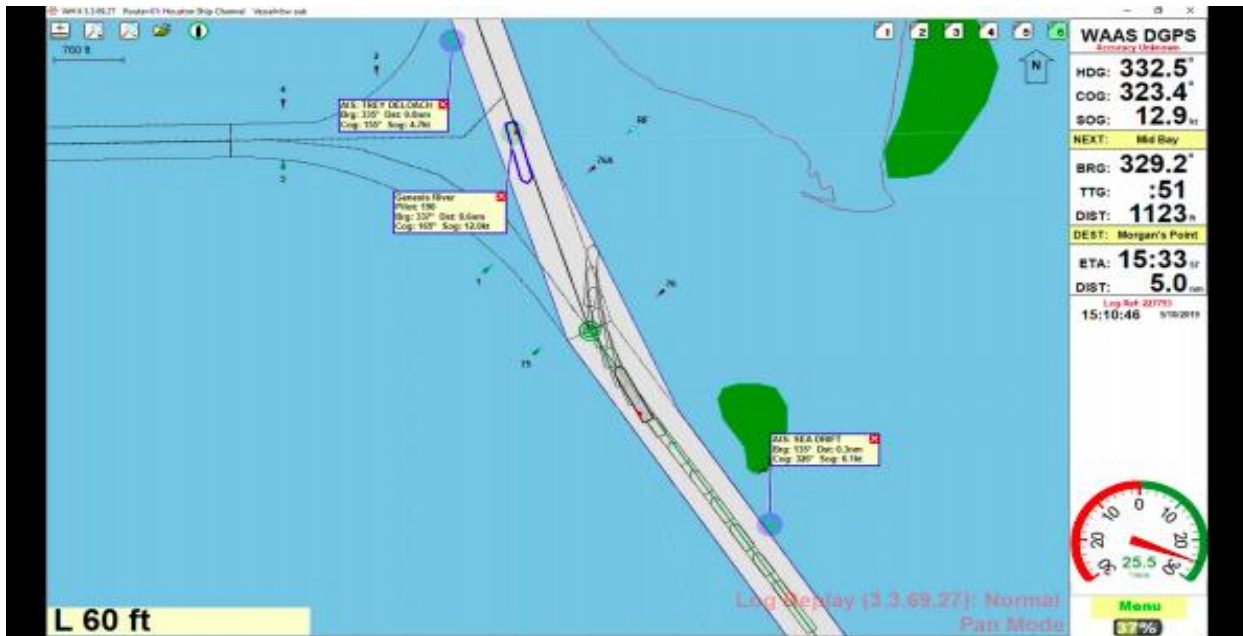
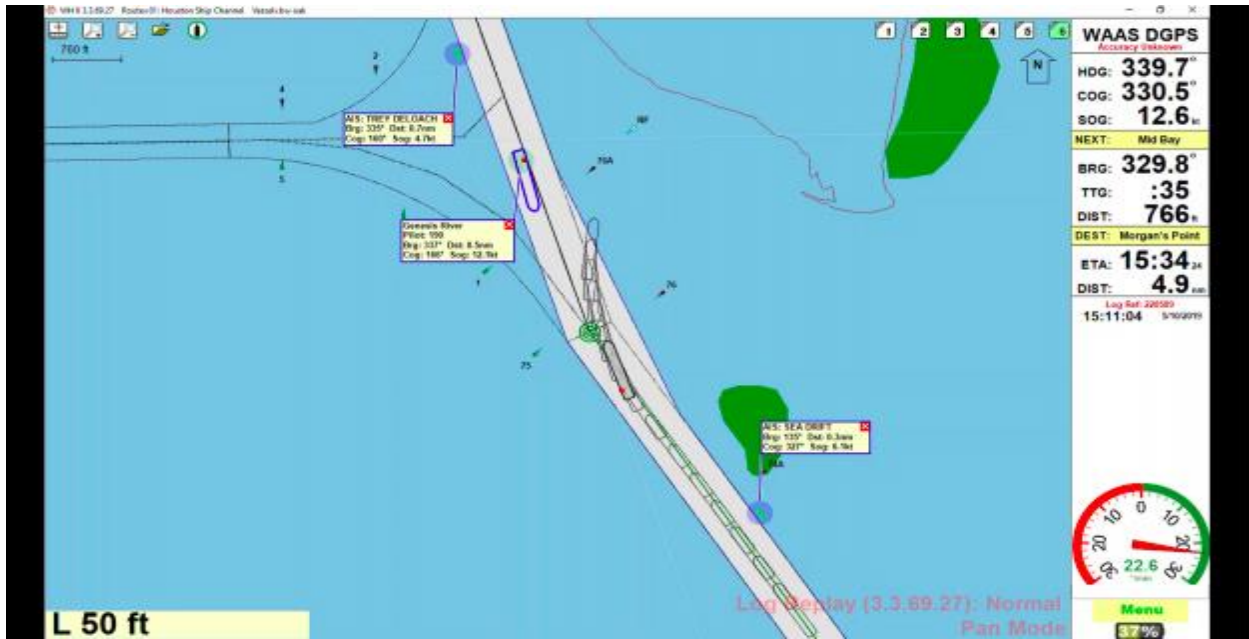
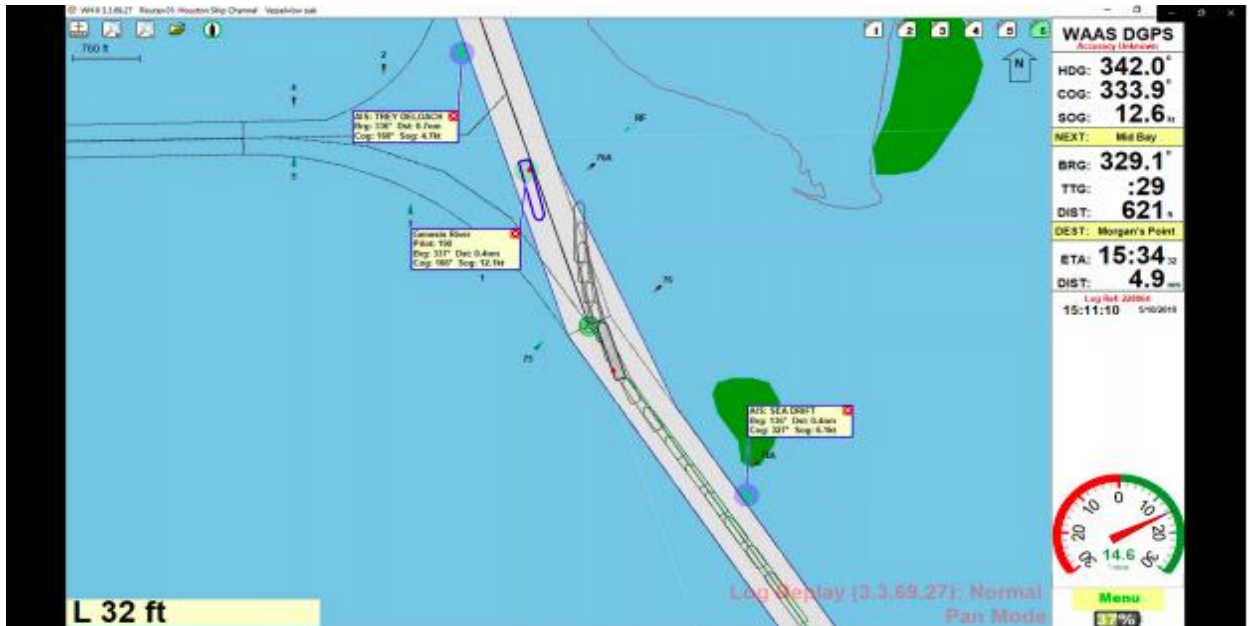
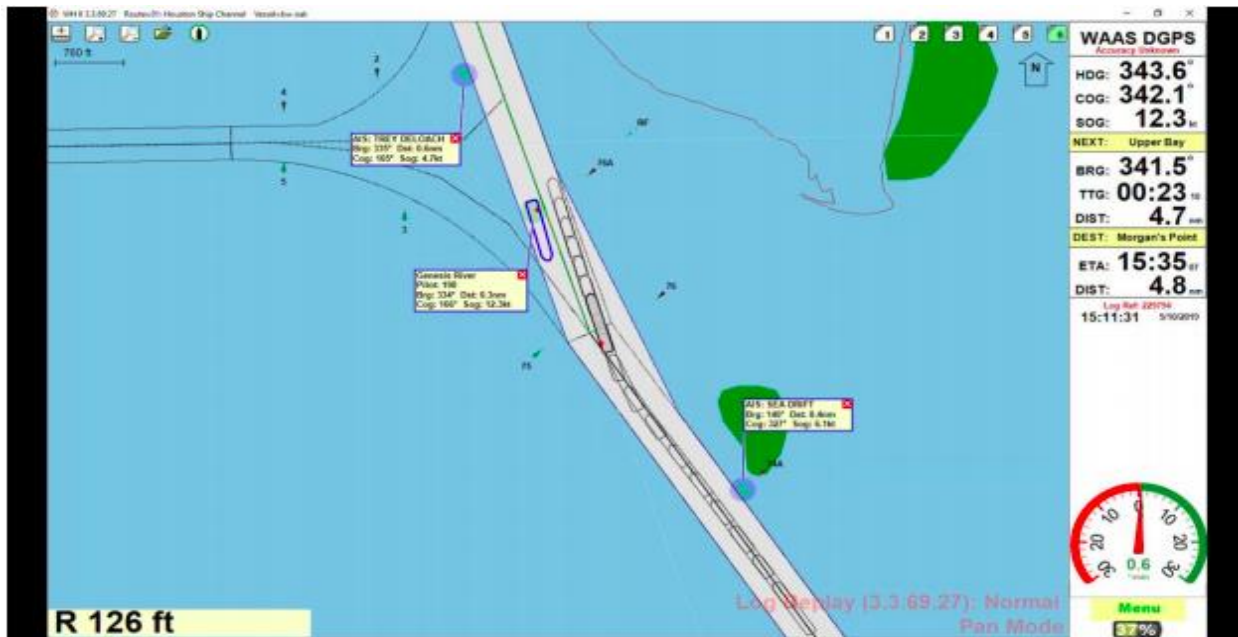
Around the time the two vessels agreed to this passing, the *BW Oak* was preparing to make a starboard turn at the flare. As she did, her stern swung out slightly to the port side, crossing the centerline by 49 feet.

³ Figures 6–12 illustrate the passing of the *Genesis River* and the *BW Oak*. The ship descending from the top of each illustration is the *Genesis River*; the one moving up from the bottom is the *BW Oak*.

By the time the *Genesis River* and the *BW Oak* closed to within a half mile, the *BW Oak* had completed her turn at the flare. She had then moved 134 feet to the right of the centerline, comfortably on the red side.

As the vessels passed each other, Captain Charpentier expressed no concern that the *BW Oak* was squeezing the *Genesis River* against the channel bank on her starboard side, did not ask the *BW Oak* for more room, nor ever suggested that the *BW Oak*'s position in the channel otherwise impeded the *Genesis River*'s navigation. In fact, Captain Charpentier has never criticized the *BW Oak*'s handling of the

vessels' meeting. Captain Charpentier, the Houston Pilots, and both vessels' bridge teams all agree: there was nothing unusual about the passing.

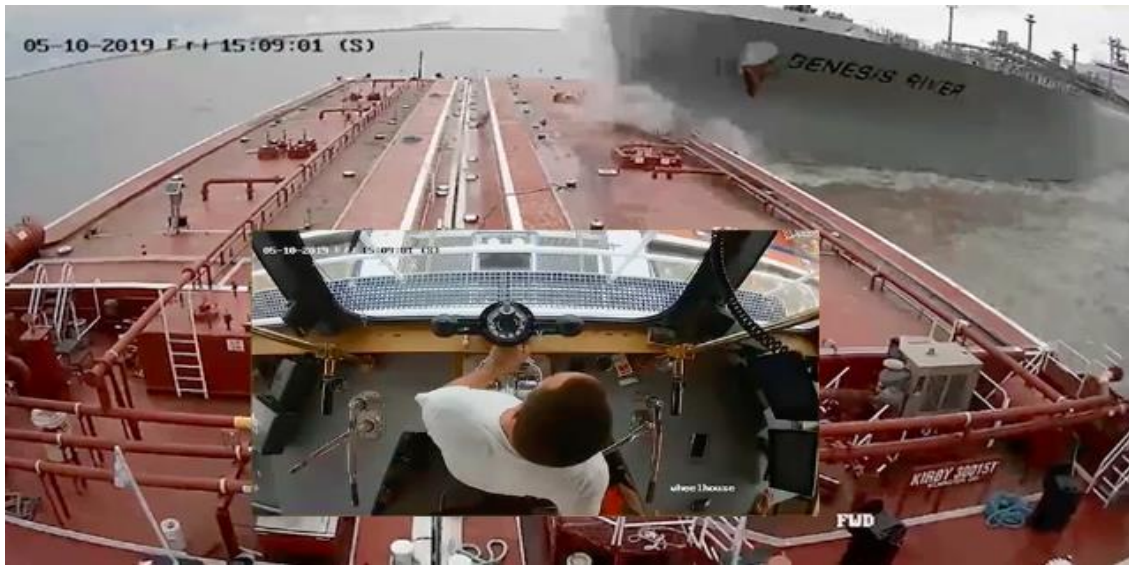
While Captain Marie tried to move the *Voyager* to the green side, the *Genesis River* crossed the channel's centerline and entered the barge lane where the *Voyager* had been. Had the *Genesis River* maintained this new position on the red side of the channel, she would have complied with the new starboard-to-starboard agreement. But, as Captain Charpentier predicted, she did not. Shortly after she darted to the red side of the channel, the *Genesis River* took yet another sheer, which sent her back toward the green side where the *Voyager* had fled.

Both Captain Marie and Captain Charpentier now realized that a collision was certain. Seconds after the vessels' crews braced for impact, the *Genesis River's* bow sliced into one of the barges (the *Kirby 30015T*), nearly cutting her in half, and reformat gushed into the channel. The force of the impact also caused the other barge (the *MMI 3041*) to capsize. Fortunately, though the damage to the vessels was great and the spill catastrophic, there was no loss of life.
