UNITED STATES
DEPARTMENT OF LABOR
MINE SAFETY AND HEALTH ADMINISTRATION

REPORT OF INVESTIGATION

Fatal Underground Coal Burst Accidents
August 6 and 16, 2007

Crandall Canyon Mine
Genwal Resources Inc
Huntington, Emery County, Utah
ID No. 42-01715

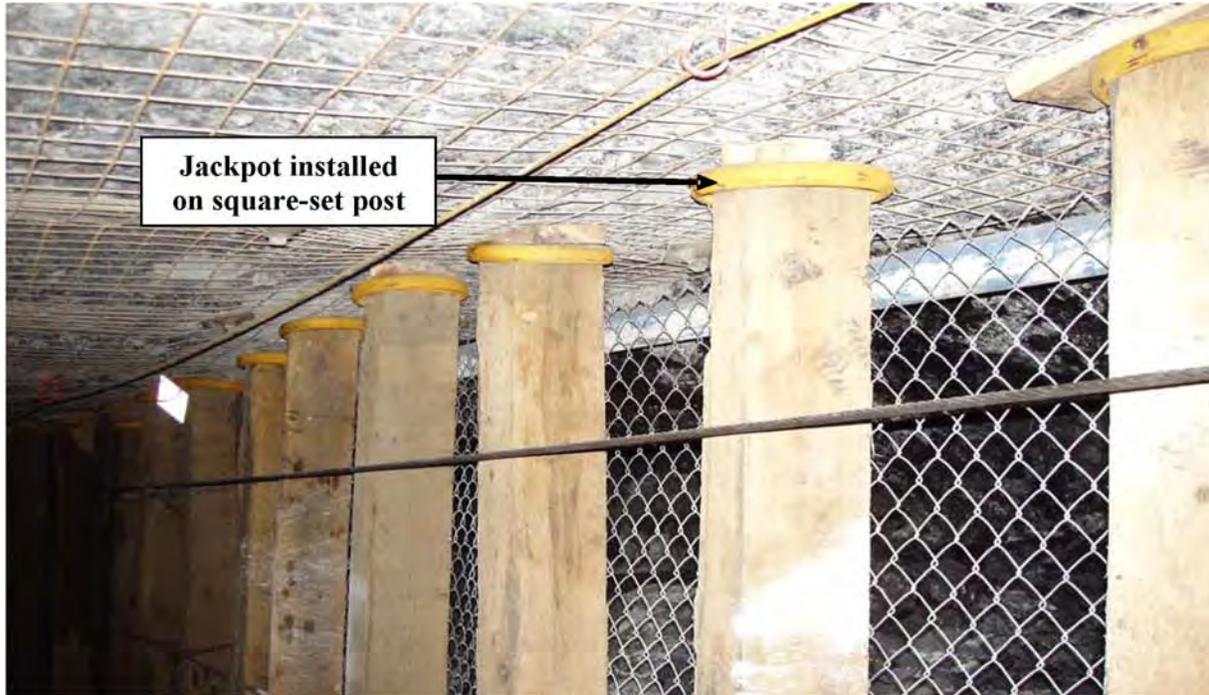
Figure 5 - Hardwood Posts Installed with Jackpots in No. 1 Entry

As specified in the plan, pressurized roof-to-floor standing supports were installed along pillar ribs for protection from pillar bursts. On August 8, 6 x 8-inch hardwood wood posts were installed on both sides of the No. 1 entry beginning at crosscut 118, narrowing the roadway to 14 feet. These posts were capped with Jackpots to actively preload each support between the roof and floor (see Figure 5). The wood posts were installed in the No. 1 entry to midway

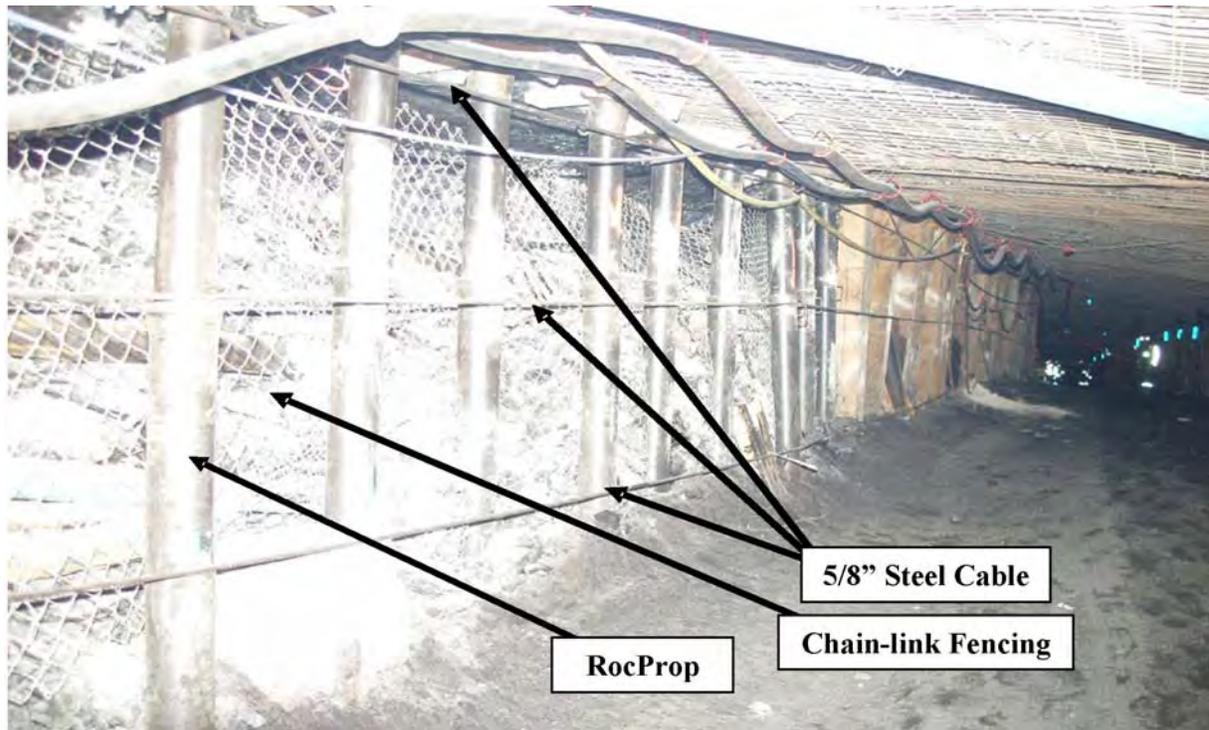
Figure 6 - RocProps, Cables, and Chain-link Fencing Installed in the No. 1 Entry

between crosscut 119 and 120 until RocProps (telescoping steel supports expanded with high pressure water) were available. Thereafter, RocProps were used exclusively as roof-to-floor support (see Figure 6). After the supports were installed, chain-link fence was installed between the rib and the row of supports to confine dislodged coal and to protect miners and the roadway. Additionally, 5/8-inch steel cables were wrapped around the RocProps to secure them from being dislodged.

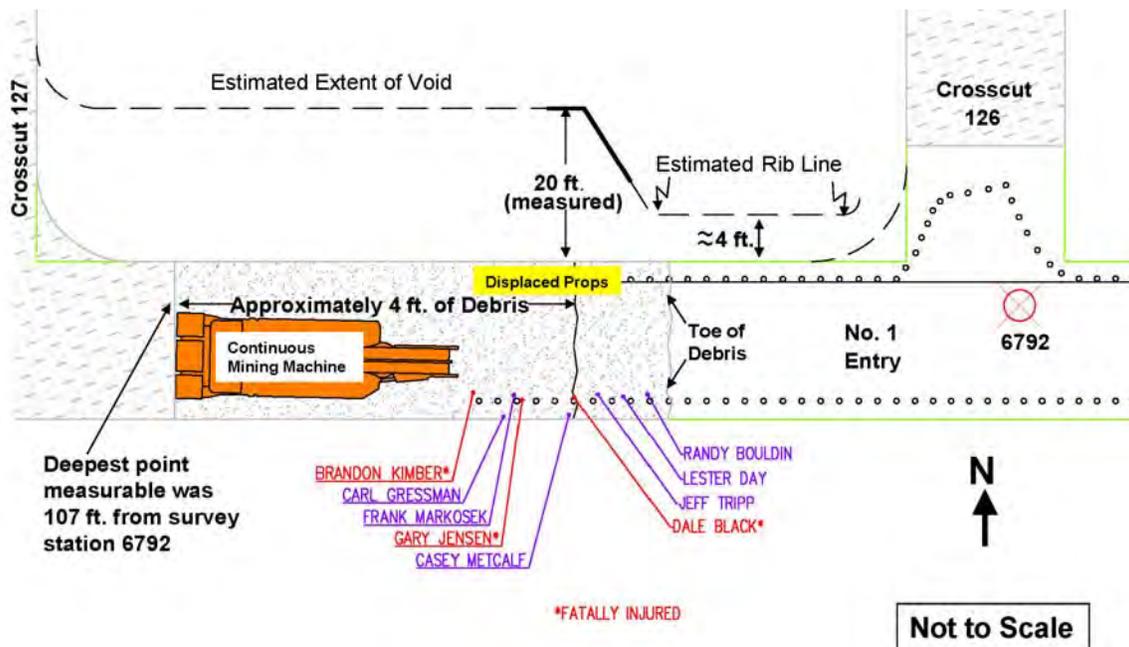
Figure 14 - August 16, 2007, Coal Burst Effects and Location of Injured Miners

At 6:38 p.m., as the crew completed installing ground support in the clean-up area, the coal pillar between the No. 1 and No. 2 entries burst. Coal was thrown violently across the No. 1 entry during the magnitude 1.9 seismic event. The burst created a void up to 20 feet deep into the pillar at the roof line (see Figure 12 and Figure 13, view indicated by arrow). The dislodged coal threw eight RocProps, steel cables, chain-link fence, and a steel channel toward the left side of the entry, striking the rescue workers and filling the entry with approximately four feet of debris (see Figure 14). Heavy dust filled the clean-up area, reduced visibility, and impaired breathing. Oxygen deficient air from the inby area migrated over the miners. The dust and oxygen deficiency were slow to clear due to damaged ventilation controls.

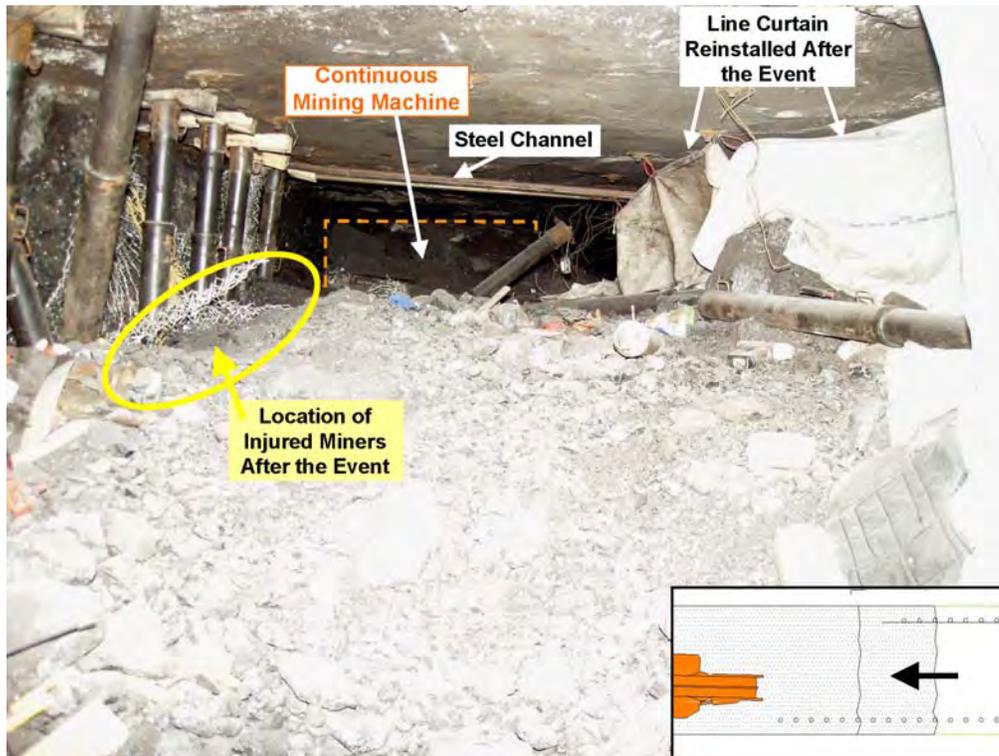
Figure 15 – Clean-up Area Following the Fatal August 16, 2007, Accident
The direction and location of camera view is denoted by black arrow in the insert.

Harper rejoined Mann and Ward. Harper helped Day get a ride outside while Mann and Ward continued inby to assist other victims. As the miners were working to free the injured miners, several factors were slowing their efforts. Not only were rescuers dealing with the quantity of burst material, the roof and rib support that had been installed to protect the workers was now part of the rubble. The electrical cable and water line used to operate the continuous mining machine, along with the line curtain used for ventilation of the clean-up area, were also hindering the recovery of the injured miners (refer to Figure 15).

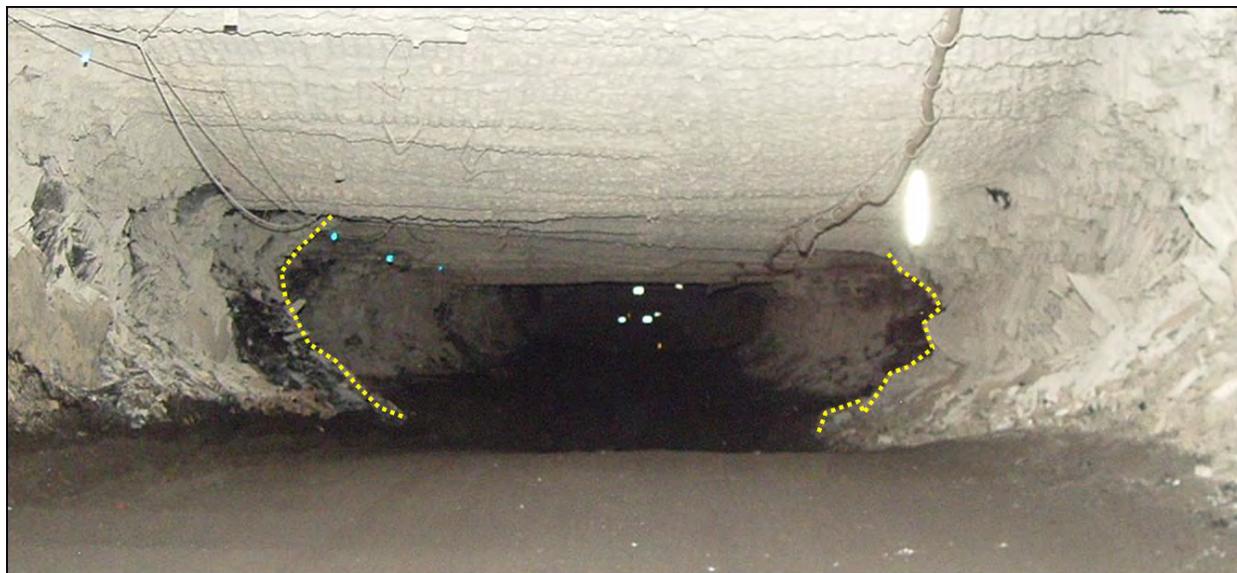
Figure 24 - Hour Glass Shape of Stressed Pillars

Areas of Main West developed with continuous haulage were mined an average of approximately 20 to 21 feet wide (based on measurements from 1991 era mining east of crosscut 107). In the newer development, entries and crosscuts were mined 18 feet wide, although the approved roof control plan permitted a maximum mining width of 20 feet. Throughout the mine, pillars showed an hour glass rib profile (see Figure 24). Consequently, mining widths measured at mid pillar often were wider than the original excavated width. The hour glass rib profile was evident when overburden exceeded approximately 1,100 feet and was more pronounced as the depth increased. For example, measurements made during the accident investigation beneath 1,500 feet of cover indicated that older entries, which averaged 20.6 feet on development, had hour glassed to 24.7 feet. Similarly, recently mined 18.5-foot wide openings had hour glassed to an average of 22.4 feet.

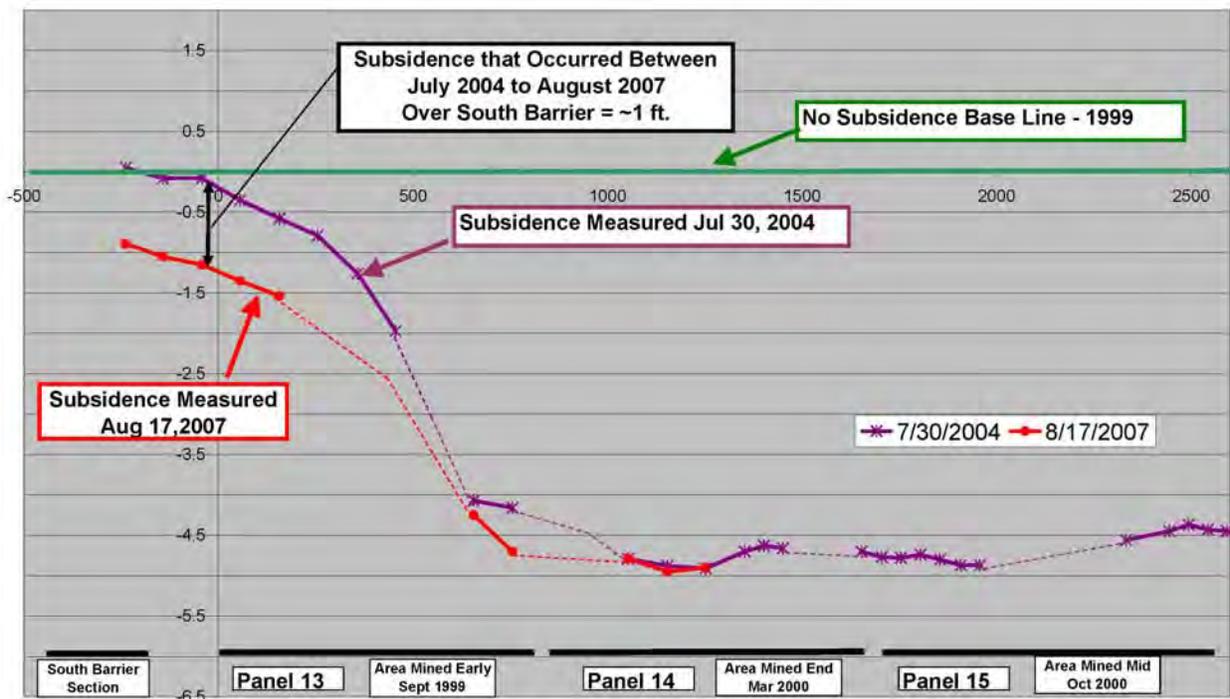
Figure 30 - Subsidence Profiles over Panels 13 to 15
Measurements from 2004 and 2007, vertical scale exaggerated

The longwall subsidence behavior observed in Figure 30 is somewhat typical of the Wasatch Plateau. In this region, strong, thick strata in the overburden control caving characteristics and are responsible for the high abutment stresses and long abutment stress transfer distances discussed in the ground control analysis portion of this report. Subsidence data collected elsewhere in the region indicates that the amount or extent of cantilevered strata at panel boundaries varies. Data presented in Figure 30 indicate that subsidence adjacent to the South Barrier section was incomplete over more than half the width of Panel 13. The figure also demonstrates that additional subsidence over the panel and the adjacent barrier was observed between 2004 and 2007. To determine how much of the recorded movement during the 3-year period was associated with the August accidents, Interferometric Synthetic Aperture Radar (InSAR) analyses were conducted.

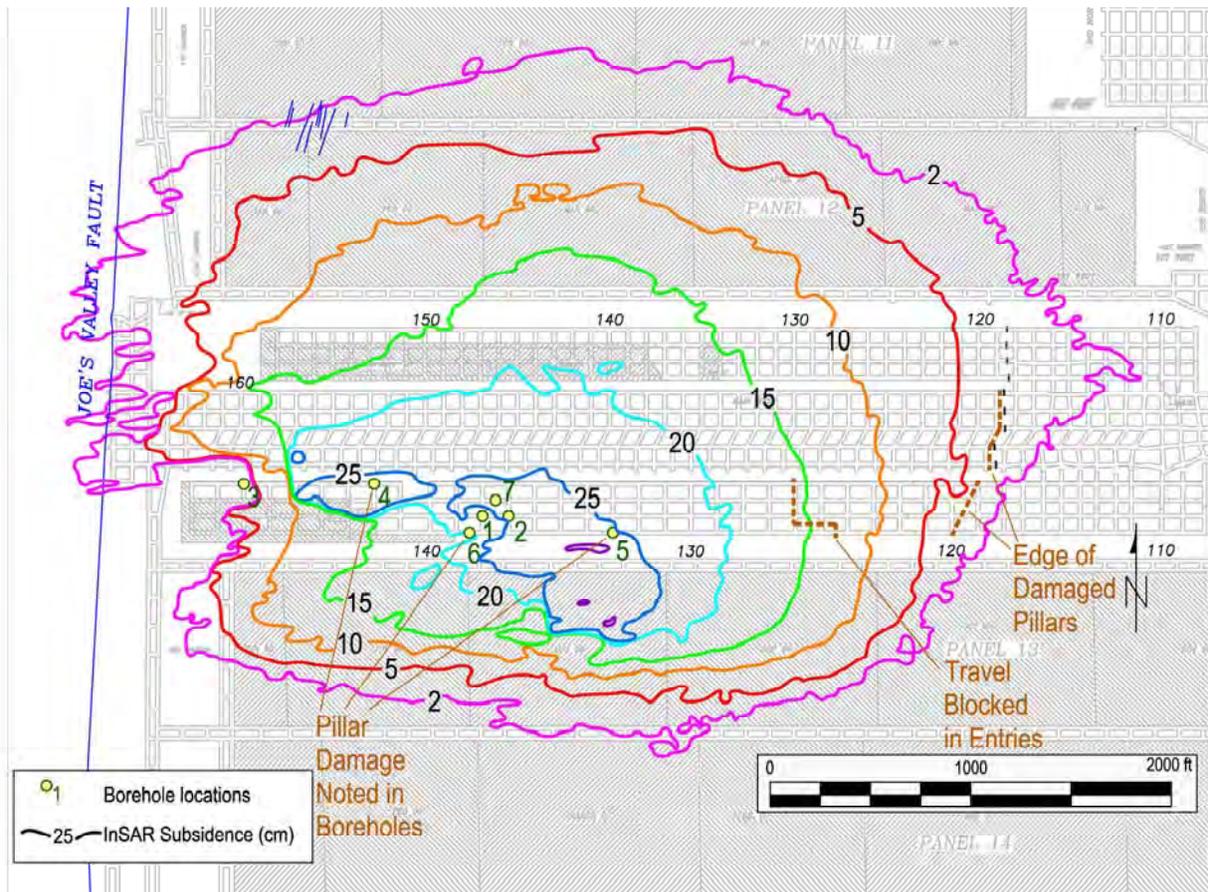
Figure 31 - Surface Deformation from Neva Ridge InSAR Analyses (June to Sept. 2007)

Neva Ridge Technologies (Neva Ridge) in Boulder, Colorado, subsequently was contracted to provide an independent InSAR analysis. The Neva Ridge report (see Appendix M) confirmed the lateral extent and vertical displacements determined by USGS. Maximum vertical displacement at the center of the depression was 12 inches (30 centimeters). Vertical subsidence from the Neva Ridge study is shown on Figure 31. Calculations, based on coal density (in situ and post mining) and mining geometry (pillar and entry volumes) demonstrate that surface subsidence of this magnitude is consistent with extensive coal pillar bursts and substantial filling of entries. A discussion of the two studies is included in Appendix L.

The InSAR analysis generally confirms the magnitude of subsidence determined in the GPS survey and further constrains the time in which the subsidence occurred. The analysis also provides insight to the lateral extent of the collapse zone. As illustrated in Figure 31, the surface area affected by the collapse extends approximately 1 mile east-to-west and $\frac{3}{4}$ miles north-to-south. At seam level, subsidence principles suggest that the extent of the collapse would be less laterally but greater vertically than the surface expression implies.

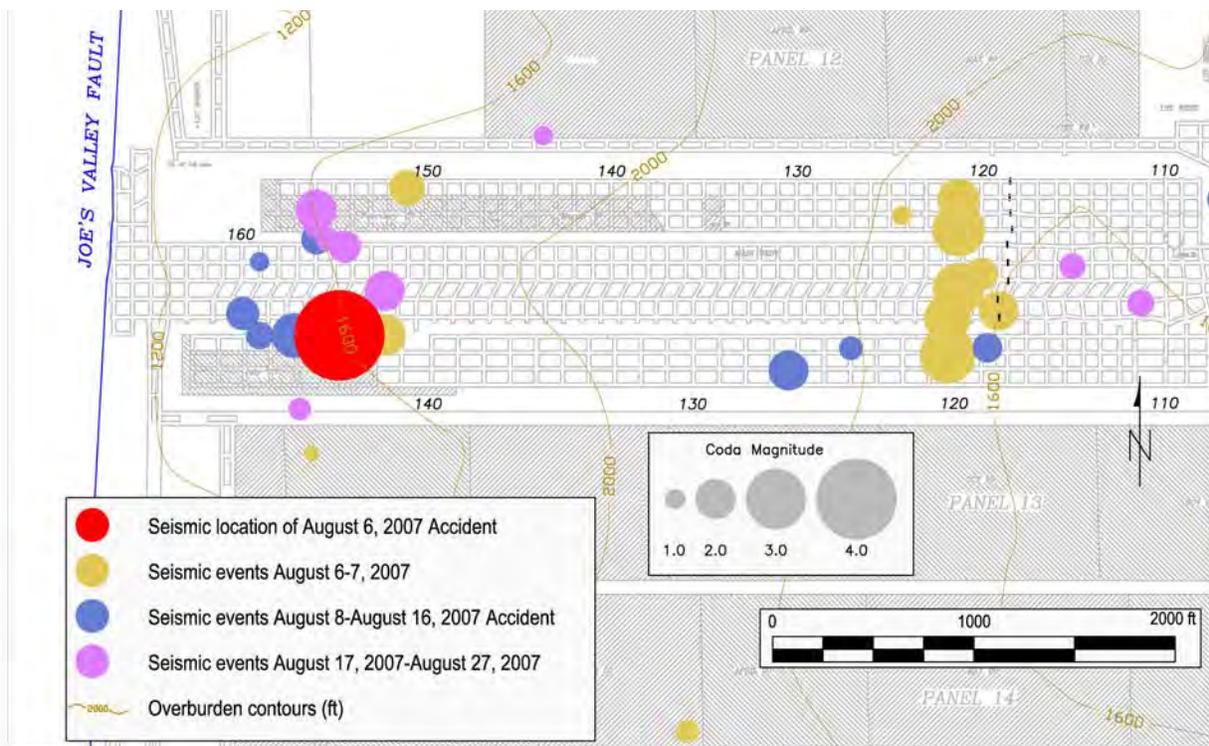
Figure 32 – Double Difference Locations of Seismic Events, August 6-27, 2007

Refined double difference locations of seismic events for the period of August 6 to August 27, 2007, are shown in Figure 32. These refined locations were unavailable until three months after all rescue efforts had been suspended. The August 6 event is indicated by the red circle and the twelve events that occurred within 37 hours afterward are represented as tan circles; the radius of each circle corresponds to the relative magnitude of the events. Activity during the first 37 hours after the accident was predominantly located on the outby side of the collapse area. Conversely, seismic activity for the time period August 8-27 (shown as blue and magenta circles) was concentrated on the inby side of the collapse area. Very few events were located near the north and south boundaries of the collapse area.

After the August 6 accident, seismic activity continued regularly for approximately 37 hours (see Figure 32). During this period, miners reported a substantial amount of rock noise emanating from the area north and west of the accessible portion of the South Barrier workings. One of these events recorded by UUSS was related to the August 7 coal burst that ended the rescue operation in the No. 4 entry. No further seismic events were recorded until August 13, 2007, when seismic activity was recorded at the inby edge of the collapse area (over 2,000 feet west of the clean-up area). In a presentation before the Utah Mine Safety Commission on November 11, 2007, Dr. Walter Arabasz noted a “5.8 day gap between August 7 and 13 for events above the threshold for complete detection of magnitude (MC) 1.6.” A general reduction in activity was observed underground during this time period as well.

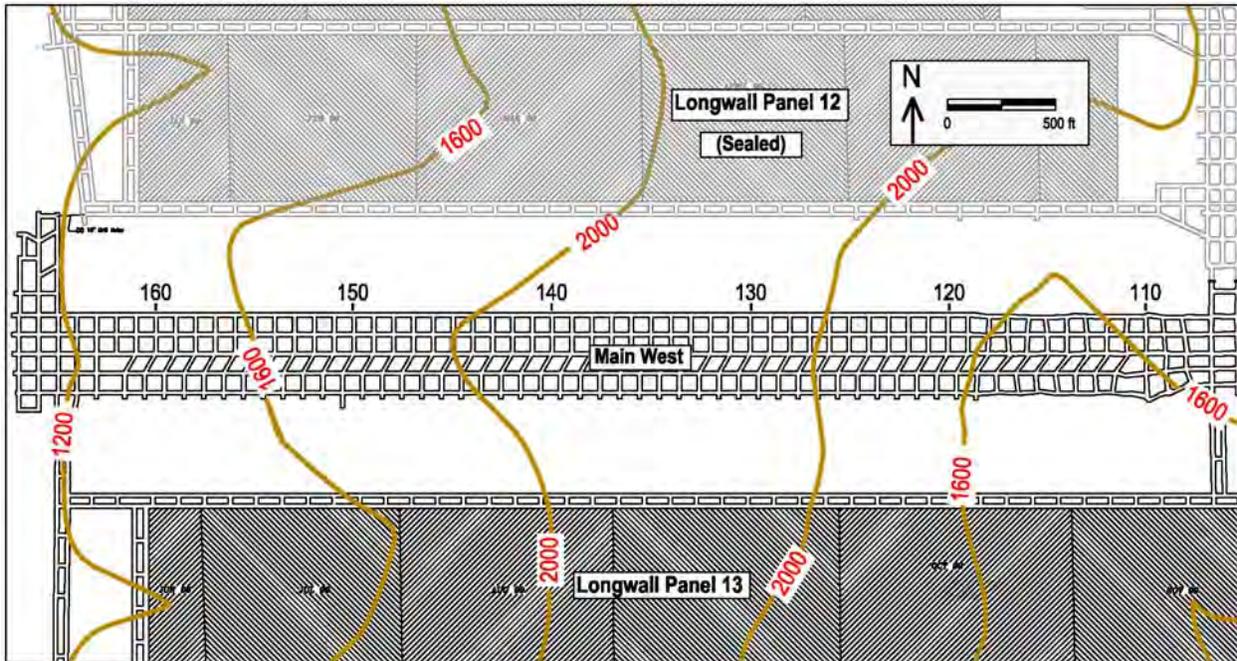
Figure 34 – Initial Main West Barrier Pillars after Panel 13 Mining showing Overburden

Longwall panels were mined parallel to the Main West entries between 1997 and 2003. Six panels were mined north of Main West (Panels 7 to 12) and six were mined to the south (Panels 13 to 18). Barrier pillars measuring approximately 450 feet wide were established between Main West and the adjacent longwall Panels 12 and 13 (see Figure 34).

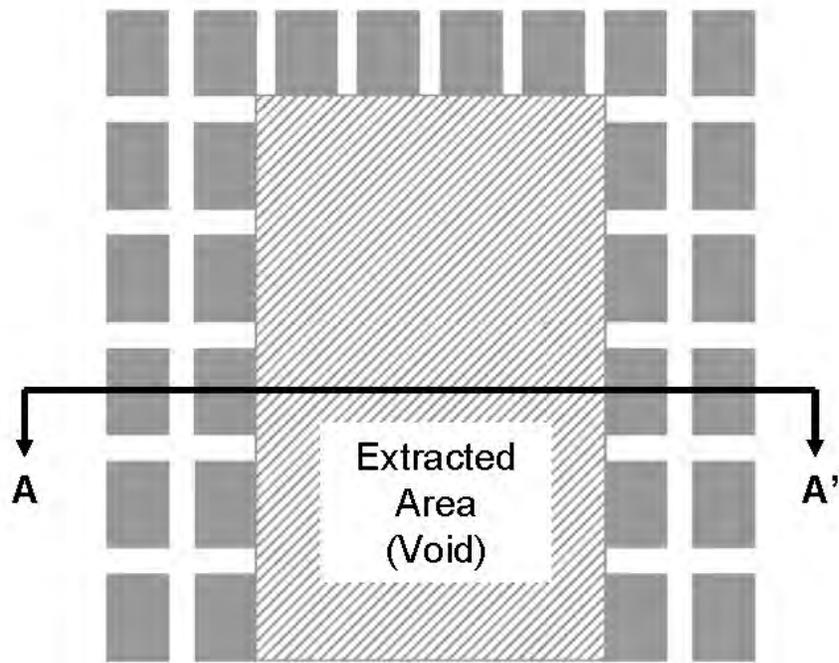
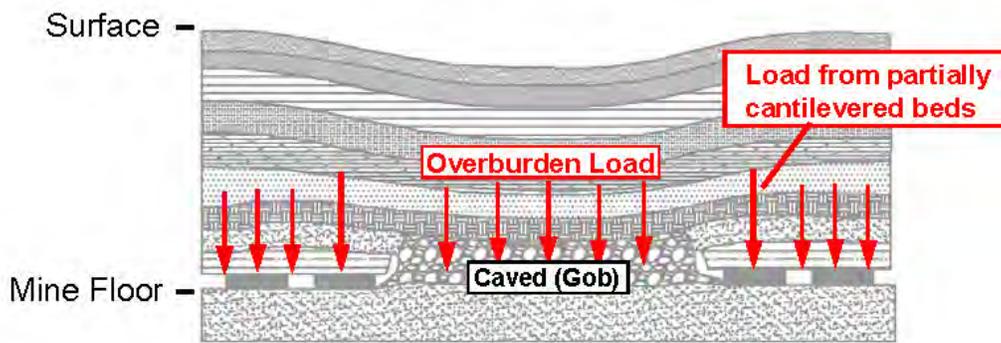
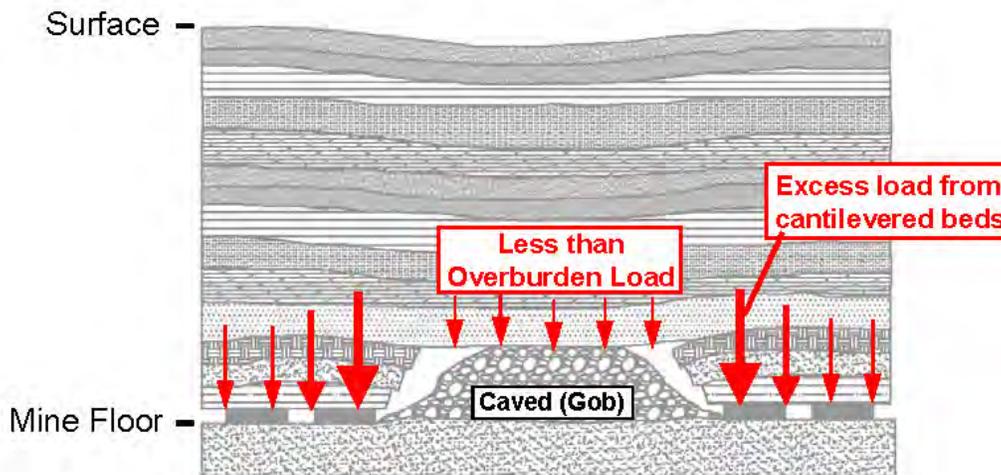
Figure 35 - Abutment Stress due to Cantilevered Strata from Mining

In deep overburden and/or in narrow extraction areas, failure may not propagate to the surface. Instead, strata near the excavation can fail and fall into the void while higher strata may simply sag onto the fallen lower layers. The strength and stiffness of rock layers in the mine roof generally dictate the degree to which the uncaved layers sag and transfer load into the broken material (gob). If the rock layers are strong and thick, load can be transferred across the void created by mining in much the same way that an arch bridge rests on abutments at either of its ends. This abutment stress is usually highest near the excavation and lessens with distance away from the caved area.

Abutment stresses are transferred from extracted areas to adjacent workings (see Figure 35). The stresses are highest near pillared areas (referred to as "gob") and diminish with distance. Rules of thumb used to estimate abutment stress transfer distance are discussed in Appendix T. However, longer transfer distances have been observed in some mines in the Wasatch Plateau. In a paper titled *"Long load transfer distances at the Deer Creek Mine,"* Goodrich et al.⁹ wrote:

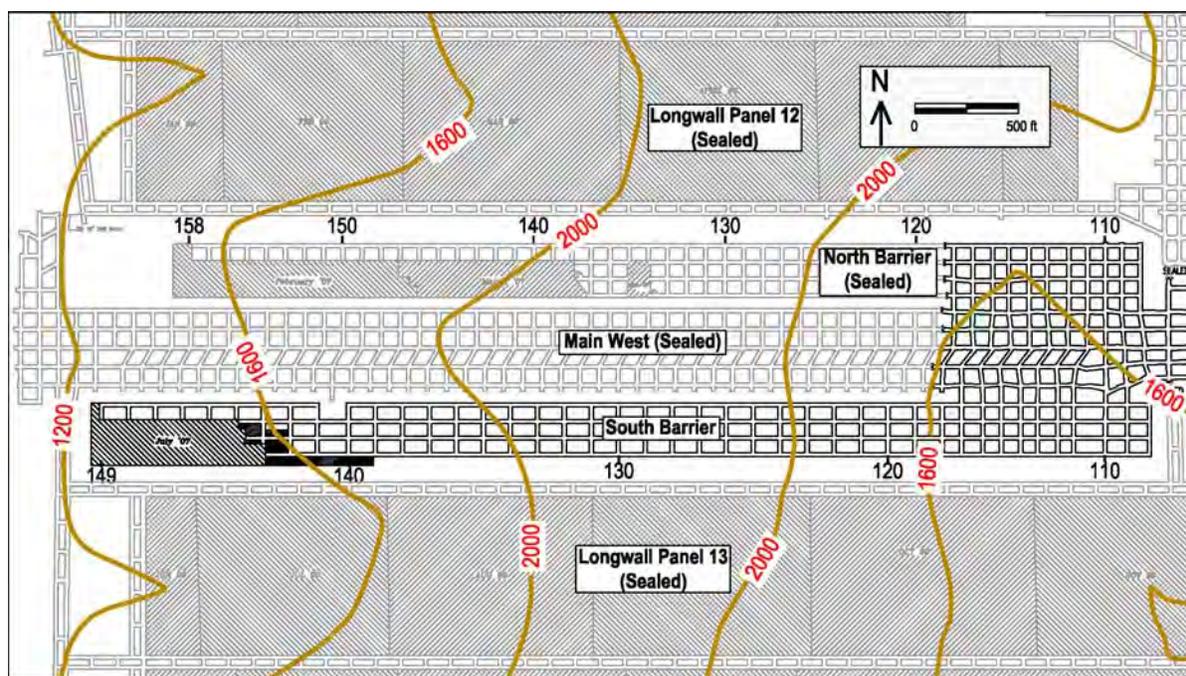
Figure 37 - North Barrier Section Mining showing Overburden

In contrast to the sequential development and recovery plan used in the South Mains, four entries were driven on 80 x 92-foot centers through the Main West North Barrier prior to retreat. The original 448-foot barrier width was reduced during development to 135 feet between the section and Panel 12 to the north and to 53 feet between the section and the sealed Main West to the south (see Figure 37). One implication of this approach was that the load bearing capacity of these barriers (i.e., their ability to support front and side abutment loading during pillar recovery) was reduced. Another was that entries used to access the working faces were subjected to abutment loading during development.

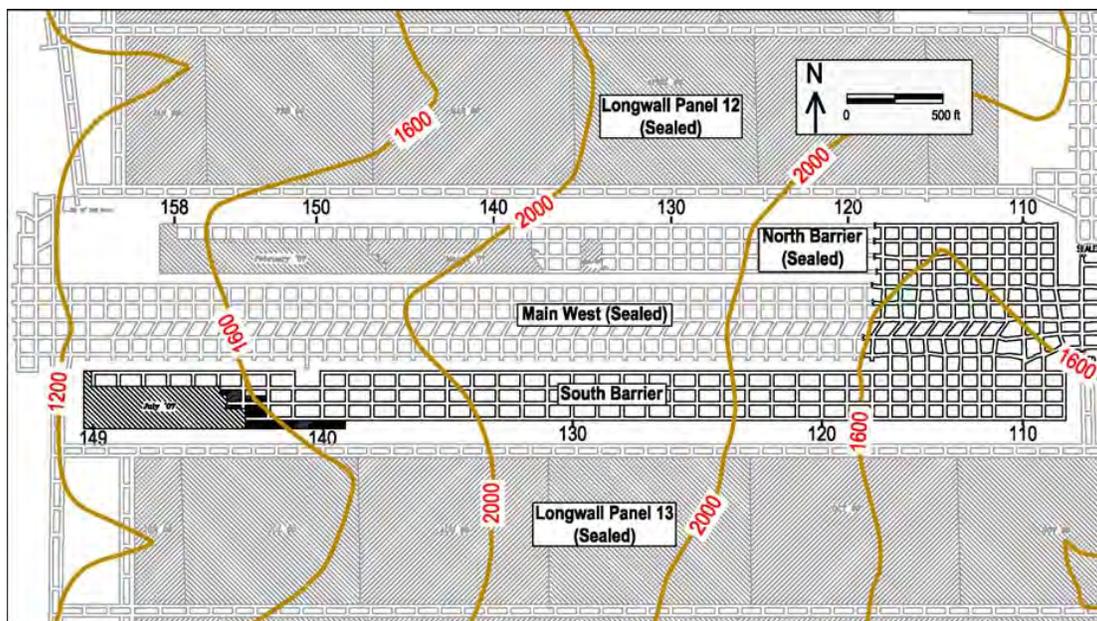
Figure 40 - South Barrier Section Mining showing Overburden

In the South Barrier section, pillar length was increased by 38 feet (from 92 to 130-foot center-to-center – see Figure 40). AAI indicated that this change *“increases the size and strength of the pillars’ confined cores, which helps to isolate bumps to the face and reduce the risk of larger bumps overrunning crews in outby locations.”*

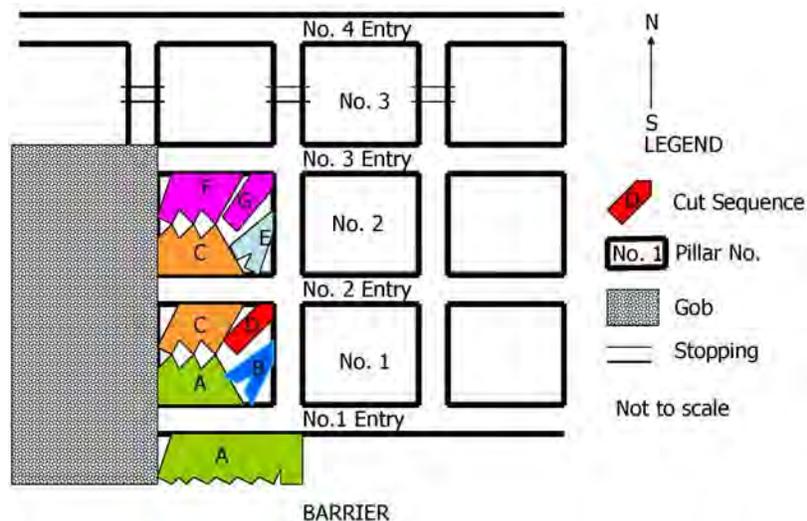
Figure 41 - South Barrier Section Pillar Recovery Cut Sequence

The cut sequence when mining a row of pillars is shown in Figure 41. Half of the No. 1 pillar and the barrier to the south were mined simultaneously, right and left, from the No. 1 entry (Sequence A). The remainder of the No. 1 pillar and the No. 2 pillar were then mined as they had been in the North Barrier section (Sequences B, C, D, E, F, and G).

Coal production resumed at 10:35 a.m., as the day shift crew mined the remaining cuts from either side of the No. 2 entry inby crosscut 142. Adverse ground conditions in the No. 3 entry prevented mining the north half of the damaged pillar (cut F and G as shown on Figure 41). Crew members (including the section foreman) discussed the possibility that management would decide to pull out of the South Barrier section due to similarities between the outburst accident that morning and the events in the North Barrier. The section was visited by mine management, who discussed the conditions with the section foreman. After this discussion, the section foreman informed the crew that they were to begin mining the barrier and skip some pillar rows. The crew moved the continuous mining machine outby crosscut 142 in the No. 1 entry and mined a lift from the barrier pillar. Six cuts were mined from the barrier during the night shift, retreating to near crosscut 141. Mining in the barrier between crosscuts 139 and 142 was prohibited by the approved roof control plan.

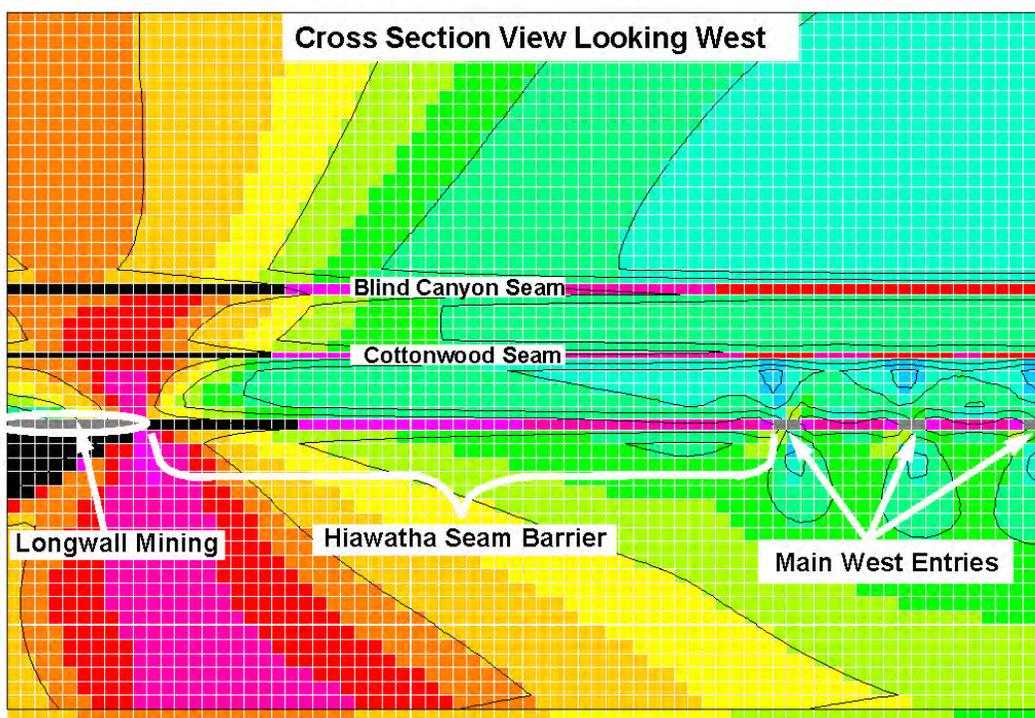
Longwall Mining. Model results in the second mining stage, longwall panel extraction, indicate that some areas have reached the elastic limit while others are well below (see Figure 49). For example, 25% of the barrier pillar separating the Main West from the longwall panels has yielded in this stage of mining. Although the remainder of the barrier adjacent to the Main West has not yielded, it is highly stressed. The gray elements in Figure 49 indicate mine openings in the Hiawatha seam and the black elements represent element safety factors less than 1.0.

Although yielding is isolated to the longwall side of the barrier opposite Main West, longwall mining has had a significant effect on stress levels in the Main West pillars. The highest SF in the Main West pillars is 1.34 which is substantially less than the values on development. Roof and floor SF’s are in the 4 to 5 range suggesting that they continue to be stable.

Figure 49 - Element Safety Factors about a Barrier Pillar after Longwall Mining

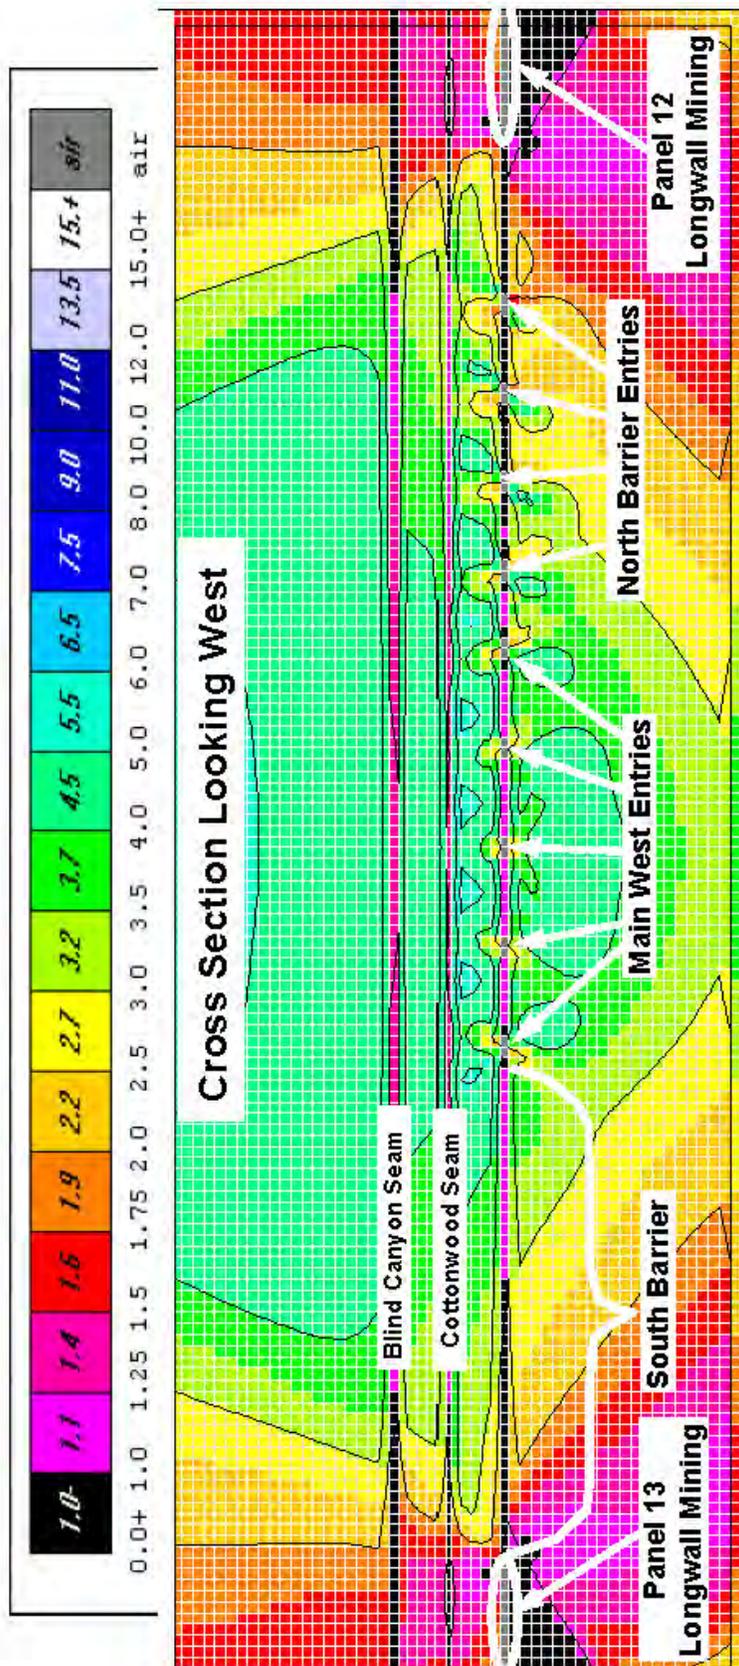
North Barrier Section Development. Model results from the third stage of excavation, development in the North Barrier, indicate that most elements in the north side barrier pillar are now at yield (note the black elements on the right side of Figure 50 at seam level). Rib elements in pillars adjacent to the Main West entries are also at yield. The outside entry of Main West shows ribs yielding in the pillar between it and the new north side barrier pillar entry. The south outside entry ribs show yielding extending 10 feet into the ribs and the highest safety factor in any pillar element in Figure 50 is 1.2.

Figure 50 - Element Safety Factor Distribution after North Barrier Section Development

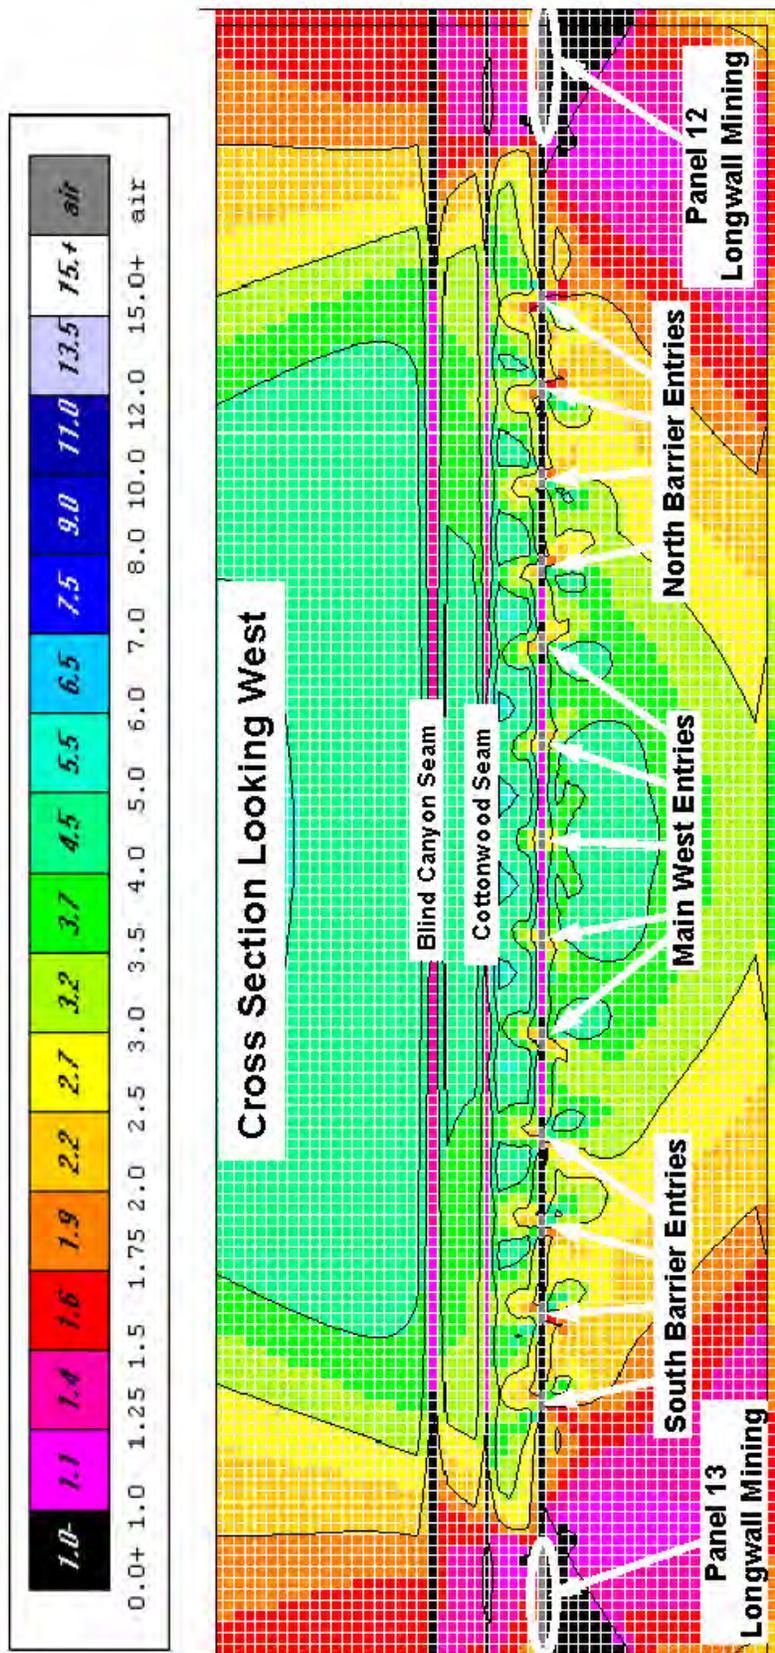
South Barrier Section Development. The fourth and last stage of analysis is entry development in the South Barrier. The distribution of element safety factors at this stage is shown in Figure 51. Almost all elements in the south side barrier pillar are now at yield and all pillar elements across the mining horizon are close to yield. Again, since purely elastic behavior leads to an underestimate of the extent of yielding, it is likely that yielding would spread further and affect portions of the pillars that have not yielded in the elastic model.

Peak vertical stress in the barrier pillars exceeds 38,400 psi, over 9 times the unconfined compressive strength of the coal. Horizontal stress exceeds 7,300 psi. Even so, this high confining pressure is insufficient to prevent yielding. The lowest vertical pillar stress is about 6,000 psi, almost half again greater than the unconfined compressive strength of the coal; the lowest horizontal pillar stress is about 1,500 psi. Any release of horizontal confinement would likely result in rapid destruction of pillars. Additionally, entries nearest to the mined panels are showing reduced roof and floor safety factors. Overlying coal seams are also yielding or are very close to yielding over portions of the barrier pillars, as seen in Figure 51. These model results are indicative of unstable conditions.

Figure 51 - Element Safety Factor Distribution after South Barrier Section Development

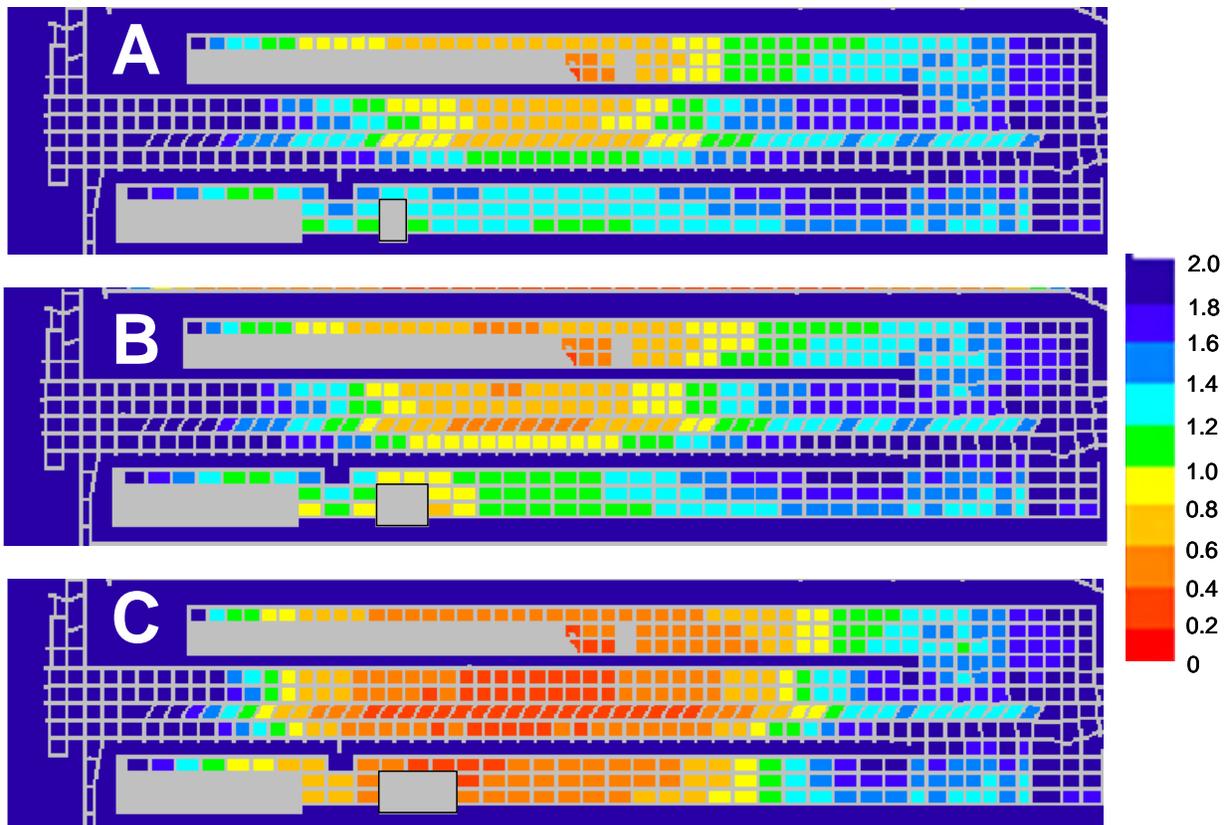
Steps were added to Dr. Heasley’s model to simulate the planned pillar recovery outby crosscut 139 (with the barrier intact between crosscuts 139 and 142). Pillar safety factors associated with pillar extraction in the rows between crosscuts 139 and 136 are shown in Figure 59. These results indicate that even if the barrier had not been mined between crosscuts 139 and 142, pillars in the South Barrier section likely would have failed if pillar mining continued in the next several pillar rows. After one row of pillars is recovered, pillar SF’s are still above 1.0 as indicated by the blue and green colors in Figure 59A. When the next row of pillars is recovered (Figure 59B), failure occurs near the pillar line (yellow and orange) and with recovery of the third row, failure propagates outby over a broad area as indicated by the red and orange colors in Figure 59C.

Figure 59 - Pillar Safety Factors for Pillar Recovery Outby Crosscut 139

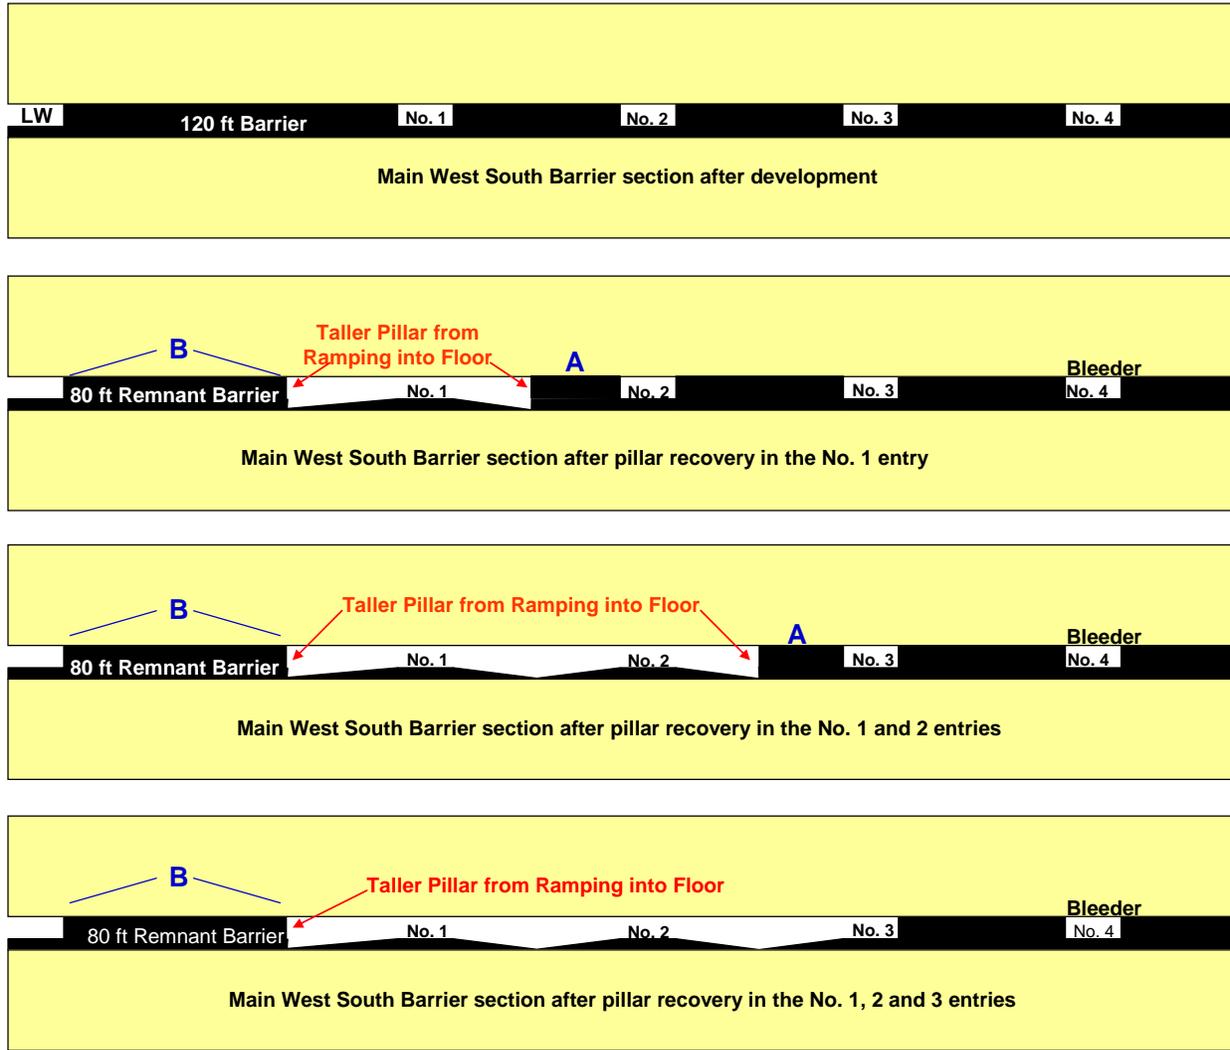
Bottom mining creates taller pillars, which are generally weaker than shorter pillars of the same length and width. In the South Barrier section, the affected areas were the remnant pillars and the 80-foot wide remnant barrier labeled A and B, respectively, in Figure 60. Bottom mining in the pillars affected pillar stability as mining proceeded within each row. However, once a row

Figure 60 - Cross-Section through South Barrier Section during Pillar Recovery

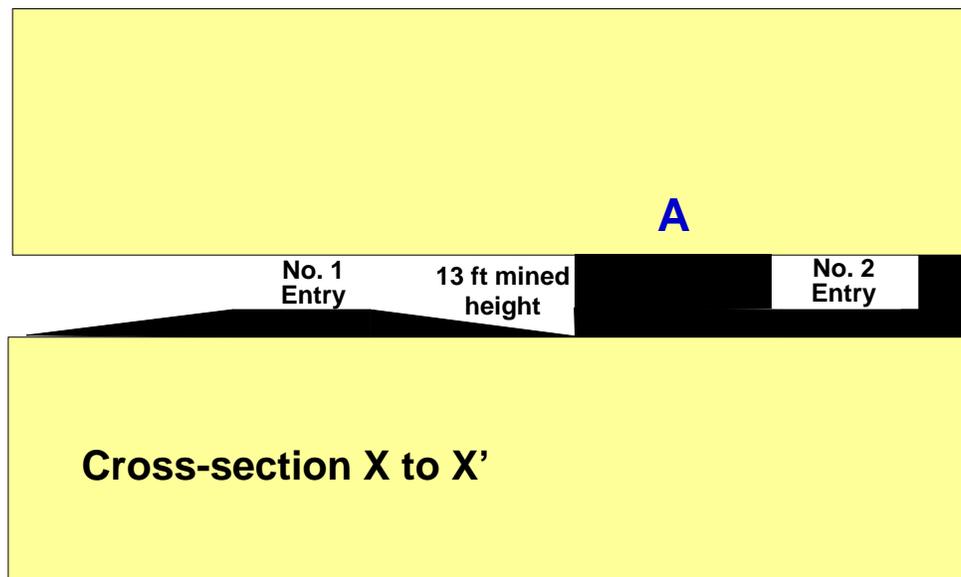
As illustrated in Figure 61, the partial pillar between No. 1 and No. 2 entry separates the mining crew from the caved area. The stability of the work area relies largely on the stability of the partial pillar, particularly as mining progresses outby to the intersection. Bottom mining on the gob side of this pillar increases the pillar height and effectively reduces its strength. A similar situation occurs when mining moves to the No. 3 entry. Thus, bottom mining can impact local stability even though the pillars are intentionally being reduced in size and the roof is expected to collapse. Also, bottom mining adjacent to the remnant barrier weakened the remnant barrier in the pillar line and contributed to overall instability of the section as it retreated.

Figure 61 - Effect of Bottom Mining on Pillar Geometry
(e.g. inby crosscut 142)
