UNITED STATES
DEPARTMENT OF LABOR
MINE SAFETY AND HEALTH ADMINISTRATION

REPORT OF INVESTIGATION

Fatal Underground Coal Burst Accidents
August 6 and 16, 2007

Crandall Canyon Mine
Genwal Resources Inc
Huntington, Emery County, Utah
ID No. 42-01715

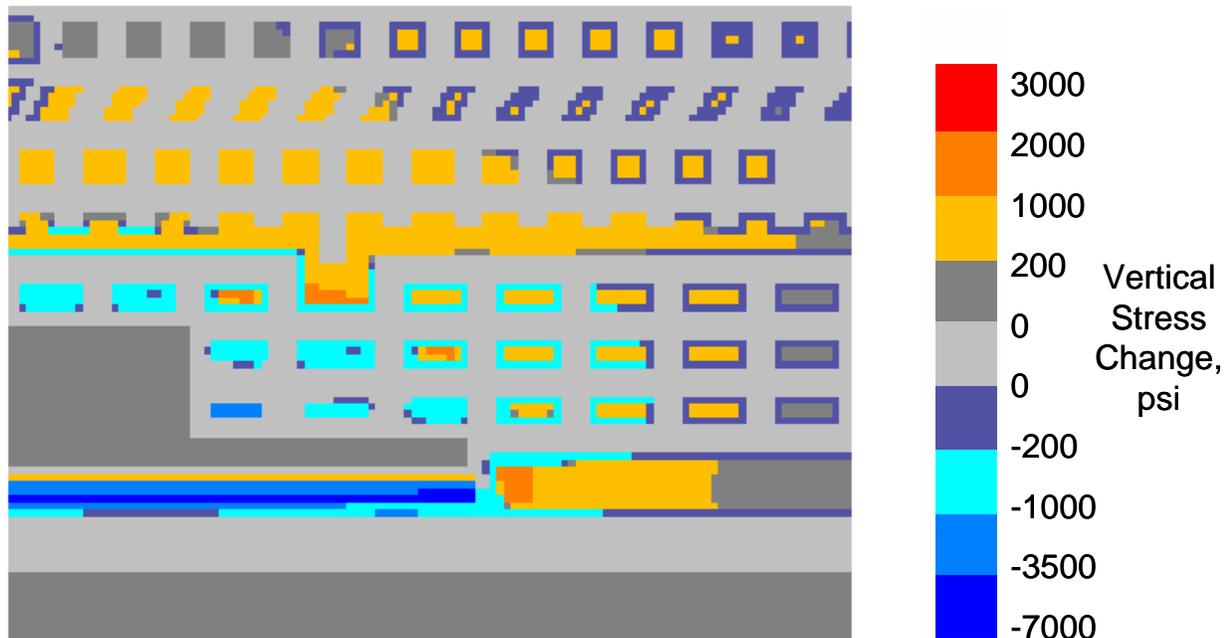
Although there are subtle differences over a broad area, the primary impact of bottom mining is seen in the remnant barrier. The core of the 80-foot wide remnant barrier has a higher peak and residual strength (Figure 63 top) when bottom mining is not conducted. With bottom mining, load that otherwise may have been supported by the barrier is redistributed to other elements. Stress redistribution was examined by subtracting model results in the two model grids shown in Figure 63. Negative values reflect stress decreases that result from lower element strength and/or yielding. Positive values represent stress increases. Since no additional mining was simulated, decreases between the models demonstrate the stress redistribution between elements. In effect, Figure 64 shows where stress increased and decreased as a result of bottom mining.

Figure 64 - Differences in Vertical Stress due to Bottom Mining

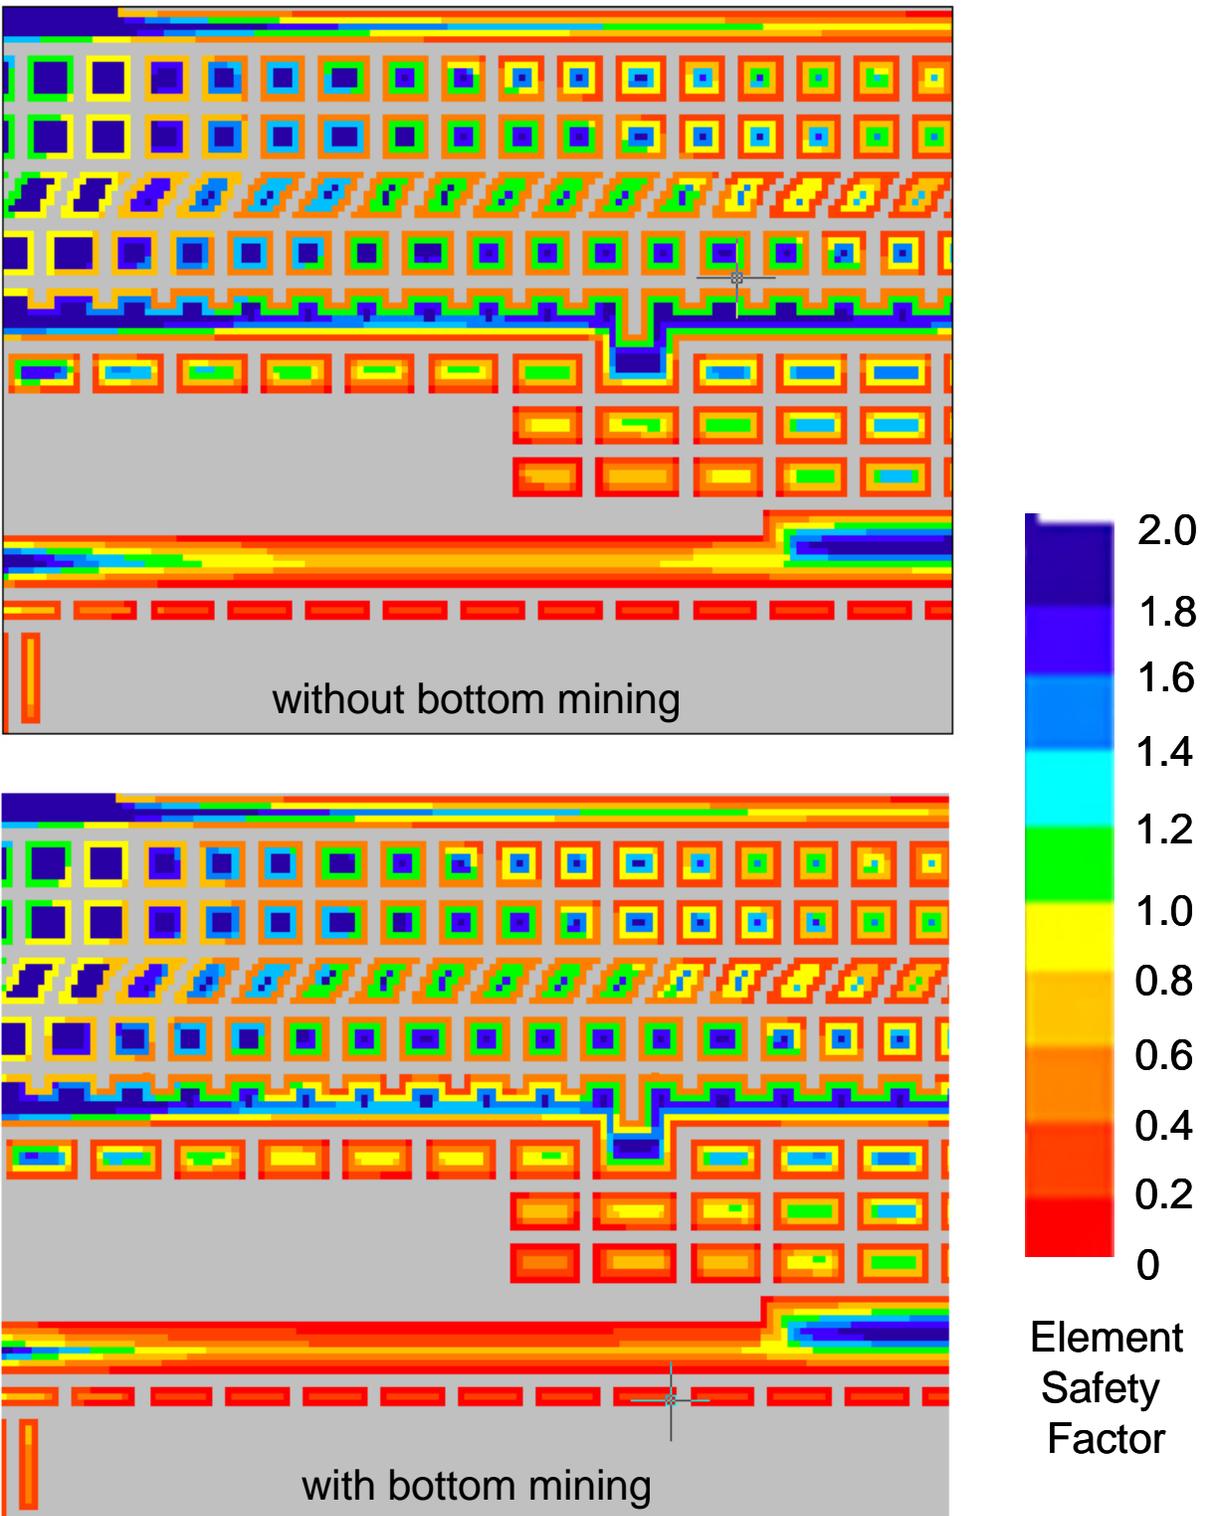
The element safety factors from the model results indicate that the remnant barrier would have failed even if the bottom coal had not been mined (Figure 65). Element stability factors below 1.0 in Figure 65 indicate that the peak strength of elements was exceeded across the entire width of the barrier even though the modeled mining height was 8 feet. The primary effect of bottom mining in by the pillar line was to weaken an already undersized remnant barrier. Bottom mining in the barrier cuts between crosscuts 139 and 142 weakened the barrier near the last known location of the miners and, consequently, contributed to increased stress levels.

Figure 65 - Element Safety Factors

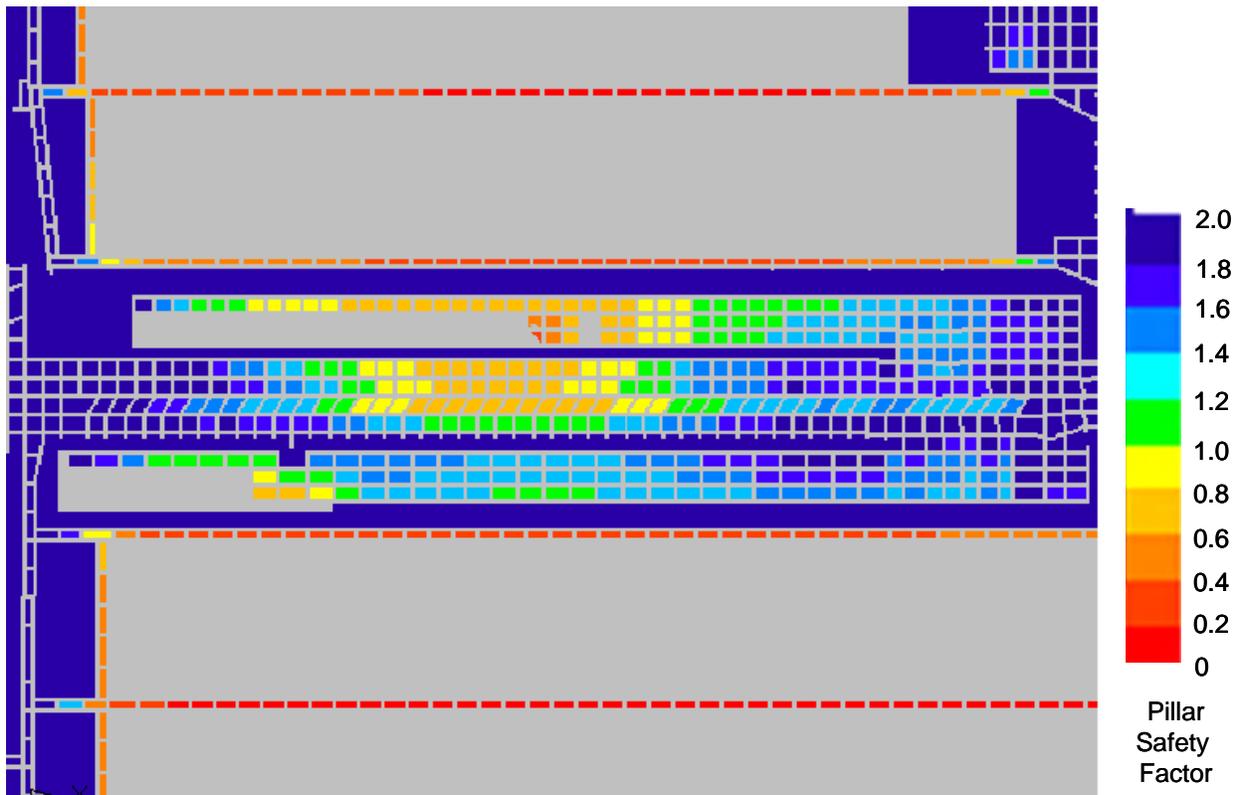
Figure 66 illustrates pillar safety factors calculated for the Main West region as it was actually developed and recovered prior to the August 6 accident. These model results are consistent with Dr. Heasley's results that show some pillar failure in the sealed portion of Main West but stable pillars in the section after development and after the pillar recovery prior to the August 6 accident. Although broad pillar failure can be triggered by one of several mechanisms, the model demonstrates a general reluctance for the Main West failure to propagate south past the

75-foot wide barrier pillar (modeled as 80 feet wide) and into the South Barrier Section. In contrast, when the north side barrier width is reduced to 55 feet (modeled as 60 feet), Main West pillar failure propagates southward into the section during development mining.

Figure 66 – Pillar Safety Factors Modeled with a 120-foot Southern Barrier

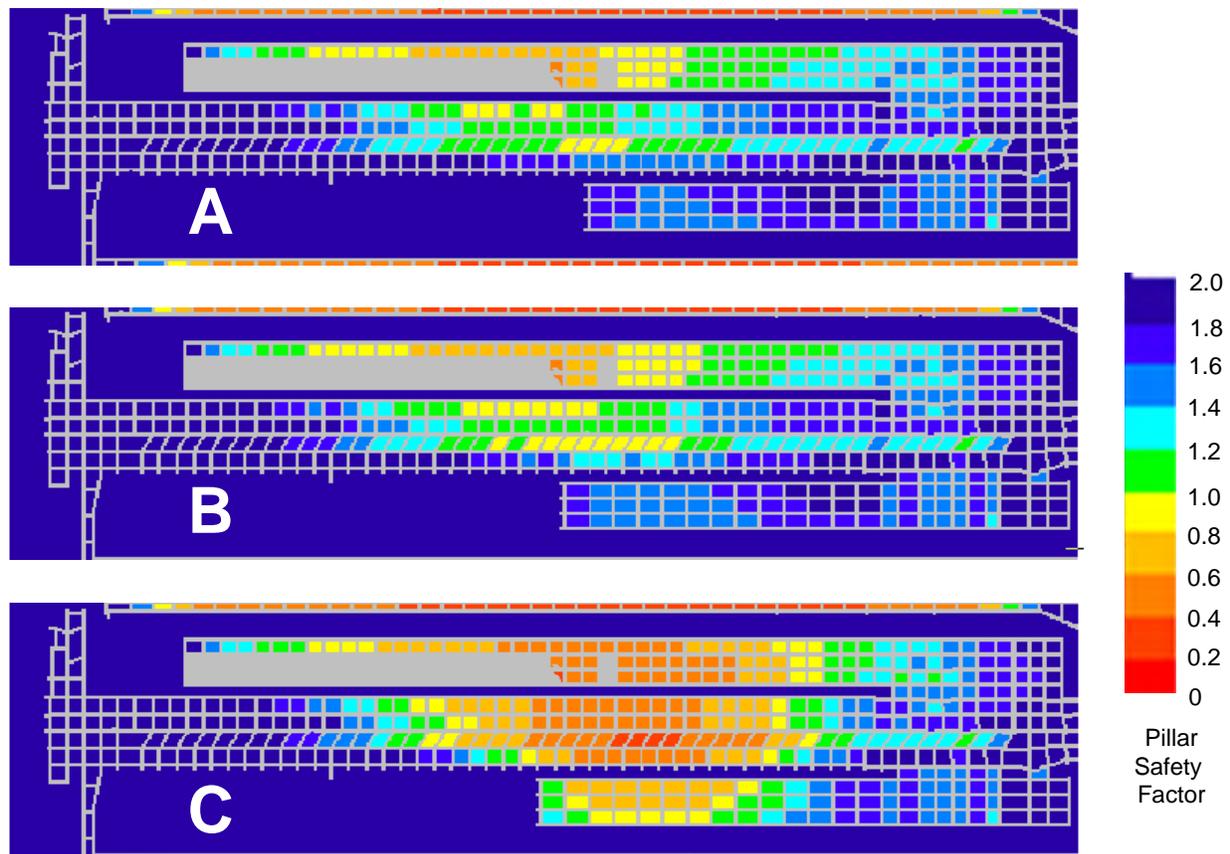
Figure 67 illustrates pillar safety factors for three model steps that represent development mining in the South Barrier section modeled with a 60-foot north side and a 140-foot south side barrier. In Figure 67A, pillars in the South Barrier section are stable as indicated by the blue colors. In Figure 67B, one additional crosscut has been developed. The South Barrier section remains stable but several additional pillar failures are noted in the Main West. In Figure 67C, another crosscut has been developed and failure is widespread throughout the South Barrier section as noted by the yellow and orange colors. A wider barrier south of the section (137-foot versus the 121-foot actually mined) may have decreased the likelihood of failure from Panel 13 longwall extraction abutment stress. However, model results suggest that pillar failure may have occurred in the section during development as a result of the corresponding reduction of barrier width to the north (55 feet initially planned versus 75 feet as mined measured outside the Main West notches).

Figure 67 – Pillar Safety Factors Modeled with a 140-foot Southern Barrier for Development Mining

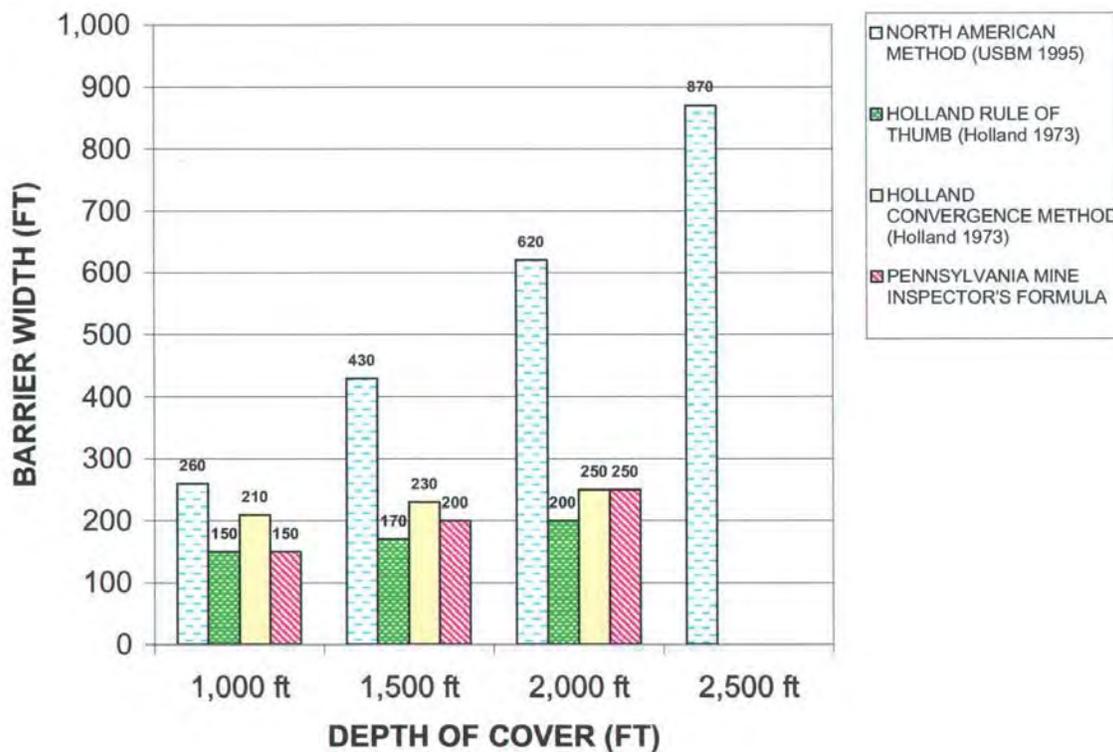
Figure 68 - Barrier Pillar Sizes from Empirical Methods
Figure 4 in AAI's May 5, 2000, Report

As indicated in Figure 68, AAI had previously used the North American method to determine barrier width in overburden depths up to 2,500 feet. This method is the only one of the four that accounts for the width of the adjacent panel in determining the barrier width. AAI's results in Figure 68 were based on using two longwall panel widths (~1,560 feet) and, even at lower depths of cover, this method recommends wider barrier widths than the other three methods. This is a reasonable assumption, given the caving characteristics of strata in the Wasatch Plateau (i.e., maximum subsidence may not be achieved with the extraction of a single panel – see Appendix L). However, if one panel width is used (~800 feet), the calculated barrier widths are much more consistent with the other methods (i.e., 130 feet wide at 1,000 feet of overburden, 210 feet wide at 1,500 feet of overburden, 310 feet wide at 2,000 feet of overburden, and 430 feet wide at 2,500 feet of overburden). As indicated in Table 9, the recommended barrier width using this approach is 357 feet for 2,160 feet of overburden (the depth at which pillar recovery was abandoned in the North Barrier section). Although this approach generates a narrower barrier width than what AAI had calculated in 2000, the recommended width is still nearly three times larger than the 130-foot width determined through numerical modeling in AAI's 2006 studies.

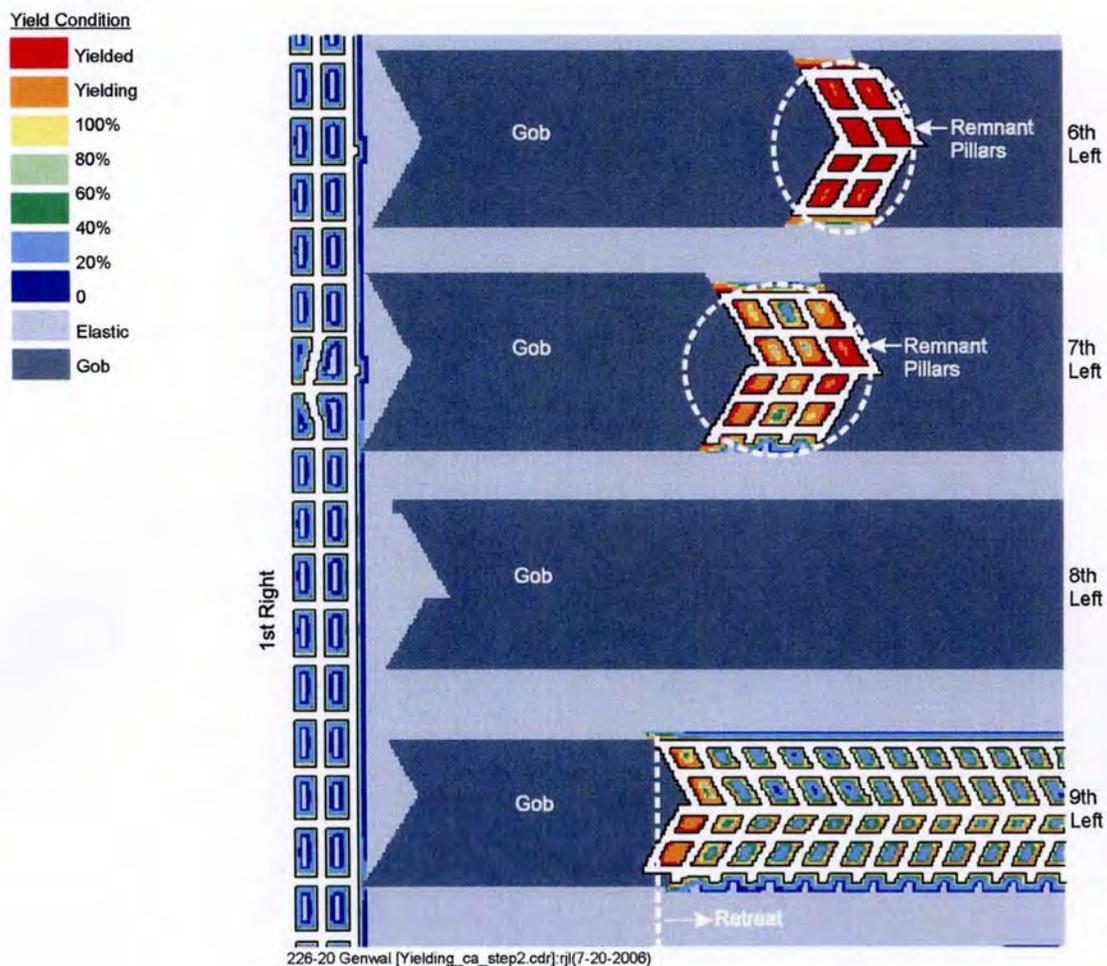
Figure 71 - Modeled Yield Condition - Partial Retreat in 9th Left Panel

AAI claimed that they calibrated the LaModel program using three criteria: vertical stress, convergence, and yielding condition. Lamination thicknesses and coal strength were varied to gauge the sensitivity of model results, reportedly to calibrate to all three input criteria. In their written response to the accident investigation team, AAI indicated that this activity resulted in a calibrated model that simultaneously fit all three criteria. However, interview statements of the AAI engineer that did the modeling reveal that the calibration process relied exclusively on an evaluation of pillar yield condition. Coal strength was adjusted until pillars in the first pillar row of the 1st North, 9th Left Panel (immediately north of Main West crosscut 99) yielded during panel retreat while the outby rows did not (Figure 71).

While mining the 9th Left panel, difficult roof conditions were encountered (i.e., “peeling top coal”) on the pillar line. AAI noted that 2.0 inches or more of convergence was associated with the yielded pillar row in their “calibrated” model. Thus, 2.0 inches of convergence was considered a site-specific indicator of potential roof and rib instability for subsequent predictive models.

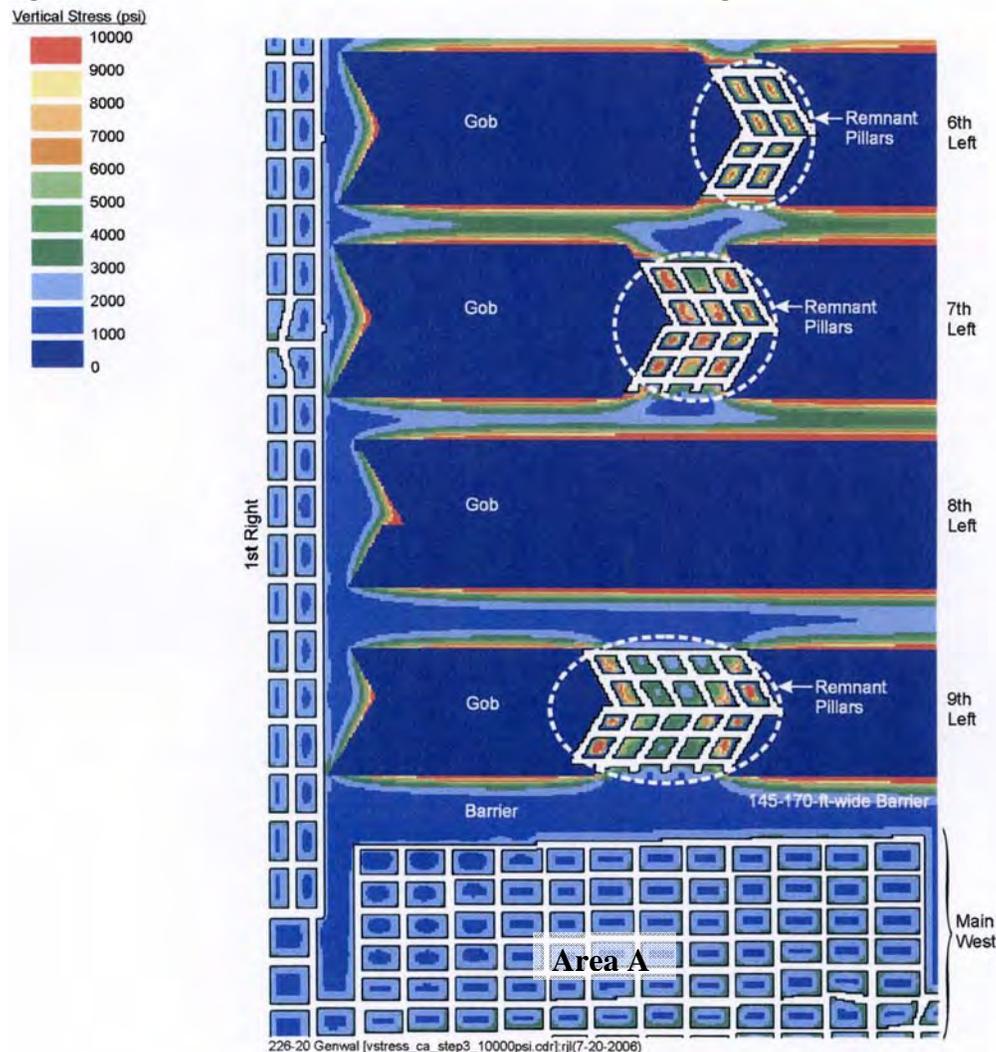
Figure 72 - Modeled Vertical Stress – Retreat Completed in 9th Left Panel

AAI also interpreted abutment stress transfer from their model of the completed 9th Left Panel. As illustrated in Figure 72, AAI's model included mining that was done north of the Main West entries. This northward extension of Main West (labeled "Area A" in Figure 72) was developed intermittently between 2003 and 2005 and approached to within about 145 feet of the 9th Left Panel. AAI interpreted model results to show "no significant side abutment stress override across the barrier on the main pillars, consistent with actual conditions." Since this interpretation appears in a report section titled "1st North Left Panels Back-Analysis," it appears to be intended to support the validity of AAI's model. However, the interpretation actually does little to verify that abutment stress transfer in AAI's model is reasonable.

Underground observations made by the accident investigation team (in Area A, Figure 72) confirmed that there were no significant effects of abutment stress transfer from the adjacent 9th Left Panel. However, this observation does not validate AAI's model results. Given the geometry, substantial abutment stress effects would not be anticipated to occur in Area A. The center of this area is bounded by unrecovered pillars in the 9th Left Panel. One end of the area is bounded by solid coal and the other by a barrier and unmined pillars of the 1st Right Mains. A more appropriate method of validating model behavior is to correlate model results with stress damage (e.g., roof or rib deterioration) rather than a lack of damage.

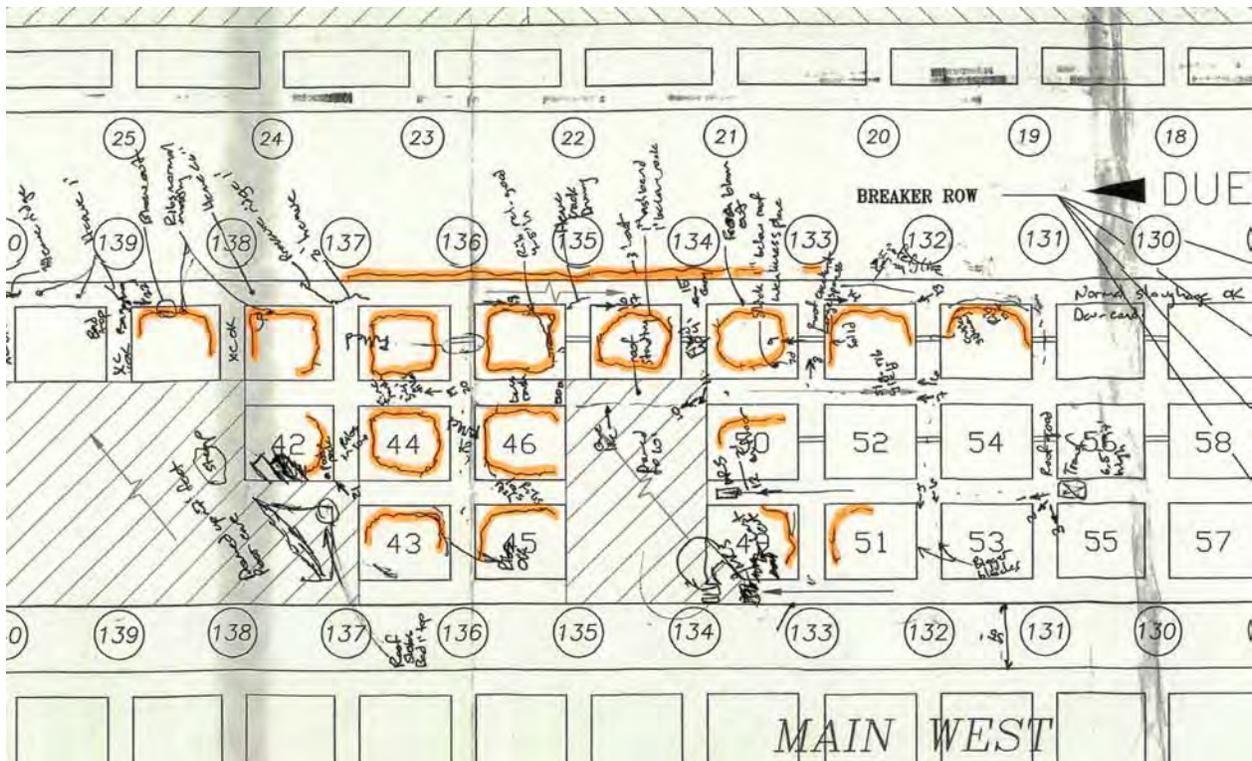
**Figure 73 - Notes Made by AAI on March 16, 2007
(orange lines added for emphasis)**

Photographs, sketches, and interview statements of others indicate that the area affected by the burst was not limited to six or seven pillars and did extend outby. BLM’s Falk noted, for example, that “*Entry ways outby two breaks from the face had extensive rib coal thrown into the entry way. Stress overrides outby the face were very concerning.*” AAI’s field notes also suggest that the damage was more widespread (see Figure 73). The remnants of damaged pillars are sketched inside the original pillar boundaries as indicated by the orange lines in the figure. Photographs taken in this area during AAI’s March 16 visit are included in Appendix O.

AAI attributed the March burst to a lagging cave inby crosscut 138 and the start-up cave between crosscuts 134 and 135 based on their onsite observations. The model grid was changed to reflect this condition. Open entries (as opposed to gob material) were used to represent the areas between crosscuts 134 to 135 and 138 to 139. However, this change had a negligible effect on the model results. Since the gob modulus used in both models was very low, the amount of load transmitted to the gob (rather than transferred to adjacent pillars) was small in either case. Models run by the accident investigation team indicated that peak stress in the gob only increased by approximately 7 psi when the lagging cave was replaced with AAI's low gob modulus.

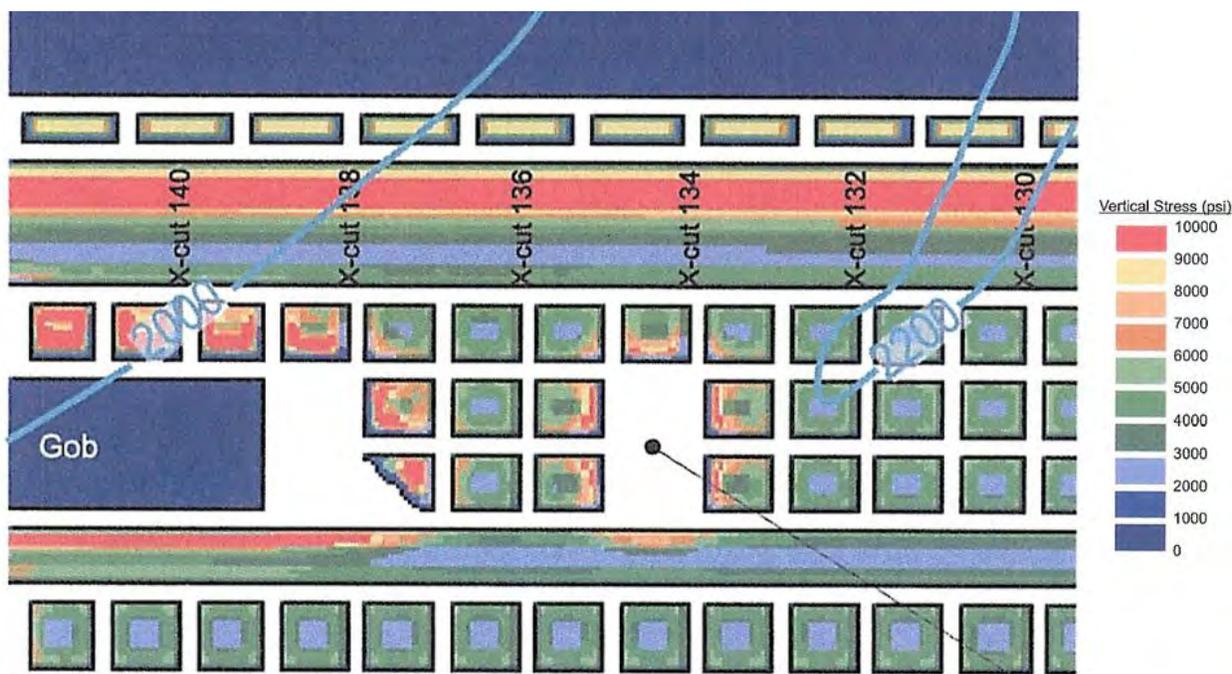
Figure 74 - AAI Model Results of Vertical Stress in March 2007 Burst Area

Models that AAI developed after the March bursts indicated that high stresses were concentrated in the area between these two partially caved or un-caved gobs (see Figure 74). A comparison of Figure 73 and Figure 74 indicates that, even with the lagging cave incorporated into the model, high vertical stresses do not coincide with the extent of damage observed in the mine. Modeled vertical stresses in pillars between crosscuts 136 and 137 appear to be quite similar to stress levels in pillars outby crosscut 133. Furthermore, the pillars outby 133 appear to be largely unaffected by stress transfer from either the longwall gob to the north or the un-caved pillared area between crosscuts 135 and 134. AAI postulated that a dynamic failure (a localized burst) of these pillars could have propagated to pillars over a much wider area.

The changes that AAI made to their numerical model after the March bursts did not constitute a recalibration of the model to the observed ground conditions. Had the disparity between field conditions and model results prompted a careful examination of model input and model recalibration, a properly constructed model would have shown that the South Barrier section mine design was destined to fail. The following section illustrates the output that can be derived by a properly constructed model using AAI's reported parameters.

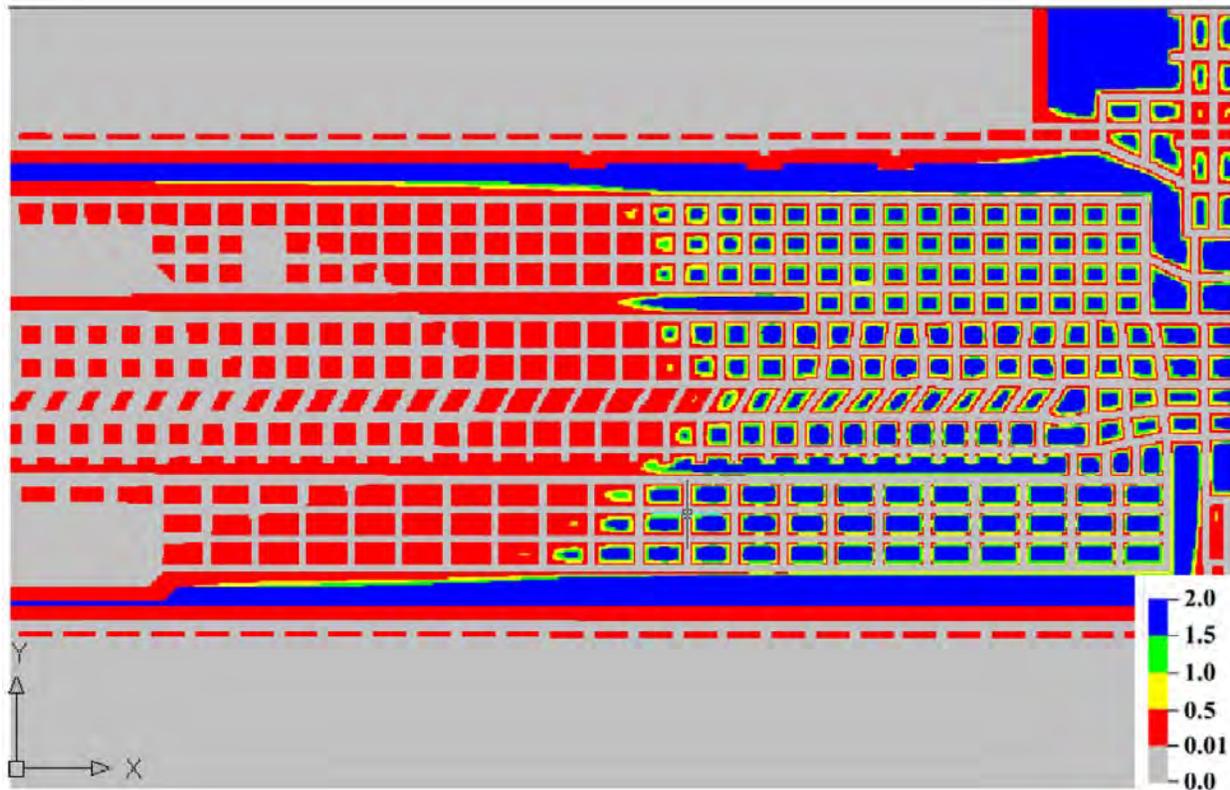
Figure 75 - Element Safety Factors with Coal Properties Distributed as Indicated in AAI Report

BEM Using AAI Model Constructed as Reported. LaModel analyses were conducted with coal properties distributed as outlined in the text of AAI's July 20 report (Appendix F). Results indicate that pillars in the North and South Barrier sections would have failed over a relatively

broad area (Figure 75). In this figure, red and yellow represent elements with a safety factor less than 1 (i.e., the element is considered to have failed).

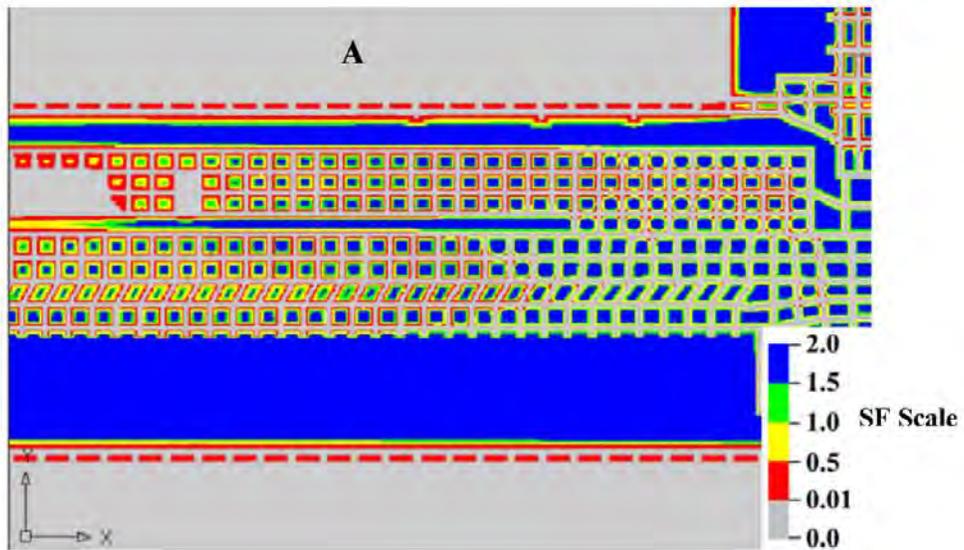
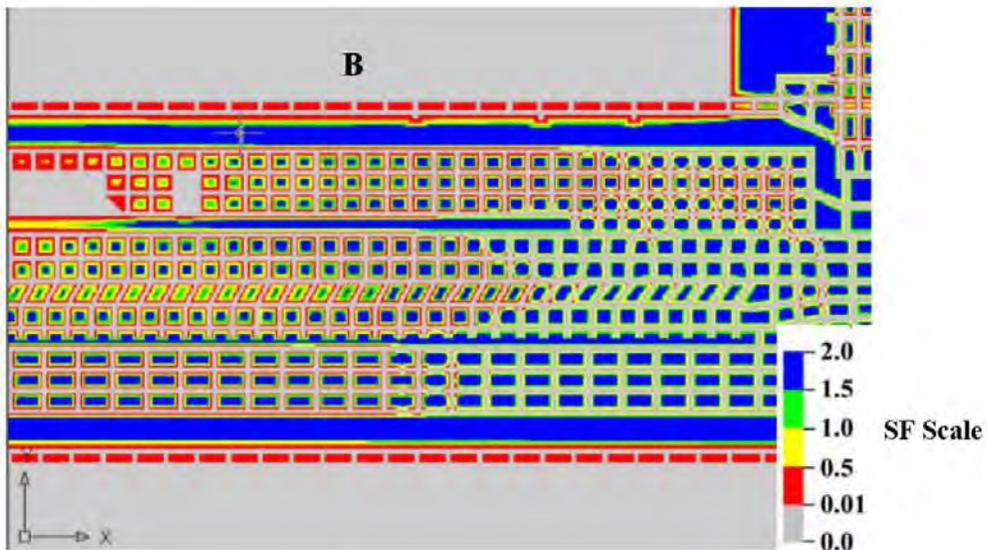
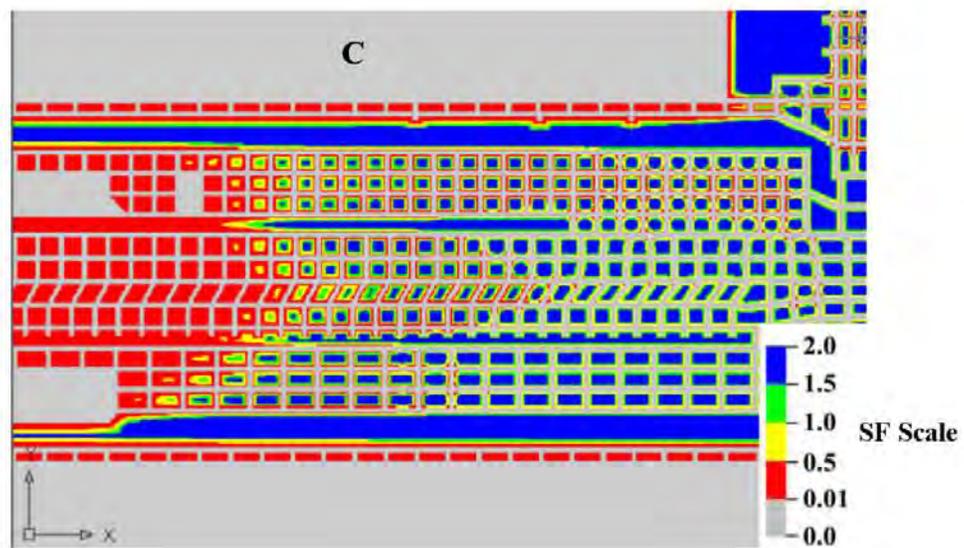
Figure 76 - Element Safety Factors using Modified Coal Strength Property Distribution, Gob Properties, and Lamination Thickness

Figure 76 illustrates element safety factors from a simulation in which AAI's model was further modified to reflect gob properties and lamination thicknesses more consistent with their calibrated EXPAREA model. In this case, a bilinear gob model was used rather than strain hardening and lamination thickness was increased to 115 feet rather than 25 feet. The greater thickness was established using an equation provided by Heasley⁵. Also, rather than modeling a single scenario as AAI had, mining in the North and South Barriers was modeled as three steps: (A) North Barrier pillar recovery to crosscut 133, (B) South Barrier development and (C) South Barrier pillar recovery to about crosscut 131. Results of these model steps are illustrated in Figure 76. Both models (Figure 75 and Figure 76) show widespread pillar failure.

Element safety factors based on the modified model show pillar failure near the site of the March 10 outburst accident (Figure 76 A). Pillar rib elements fail under the deepest cover but pillars remain stable as the South Barrier is developed (Figure 76 B). However, as pillars are recovered in the South Barrier, failure propagates outby the face and extends into the Main West and North Barrier section workings. Although the model does not match the observed damage as well as Dr. Heasley's model, it is generally consistent with the failures that occurred in March and August 2007 at Crandall Canyon Mine. The modeling results illustrate that a properly constructed and calibrated model will depict that the South Barrier section pillar design is unstable and destined to wide spread failure.

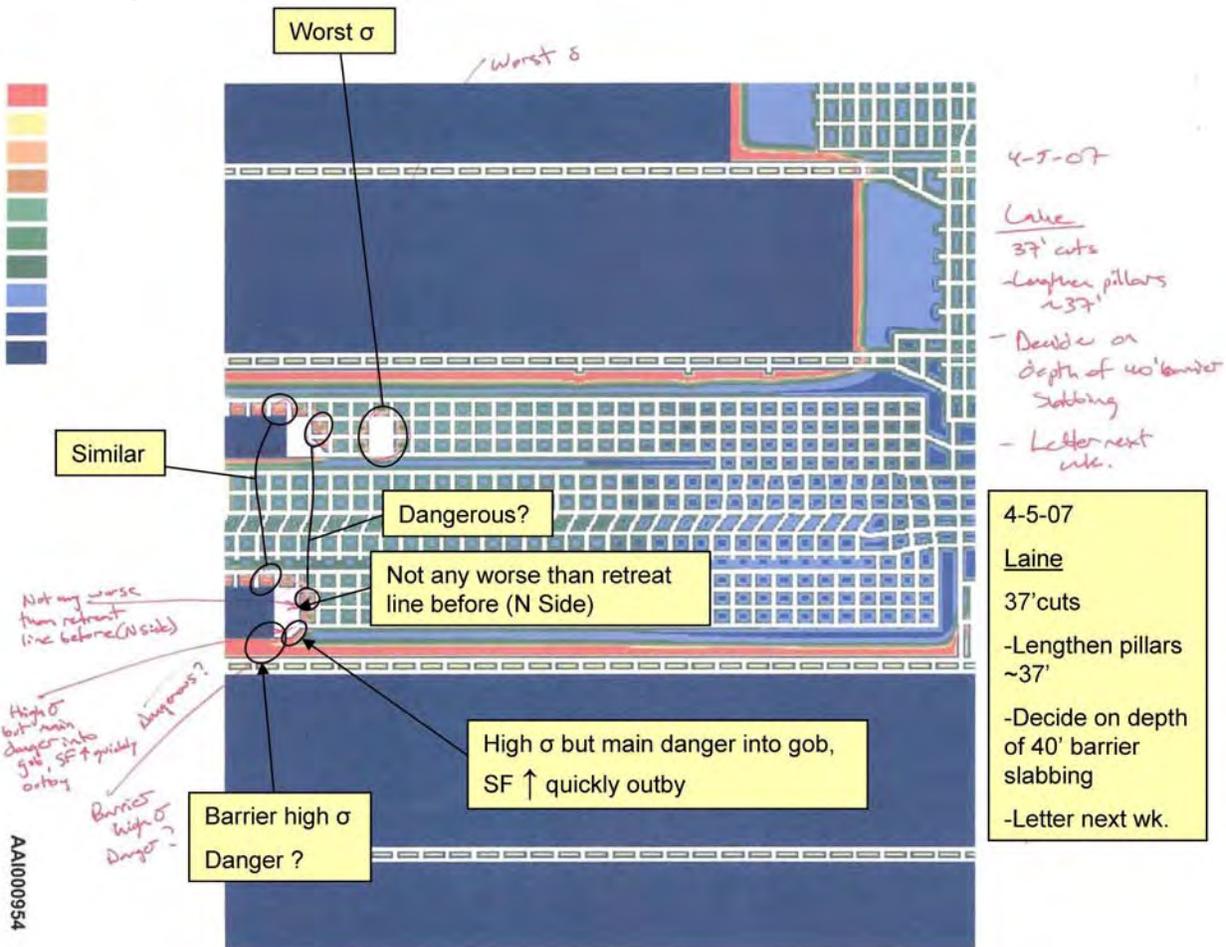
Figure 77 - AAI Notation on Plot of Model Results
Text boxes reflect handwritten notes and were added for clarity.

South Barrier Design. After the March burst, AAI changed their model to reflect a lagging cave but this change had very little impact on model results. The model used to evaluate designs for the South Barrier section was essentially the same as the model used to design the North Barrier section. Proposed design changes including longer crosscut spacing were evaluated. AAI had modeled the effects of longer crosscut spacing early in the Main West Barrier Mining project. Their earlier conclusion was that “increasing crosscut spacing does not significantly improve conditions.” Increased pillar length (reported as a 20-foot increase, but modeled as a 10-foot increase from 70 to 80 feet) “only incrementally reduces rib yielding, corresponding to a modest decrease in entry convergence.” In the South Barrier section models, however, pillar length was increased by 37 feet (72 to 109 feet). AAI noted that modeled stresses in the projected South Barrier workings were similar to those experienced at the March burst site when crosscuts of similar length were used (see handwritten notes, Figure 77). However, AAI concluded that the longer crosscut spacing “increases the size and strength of the pillars’ confined cores, which helps to isolate bumps to the face and reduce the risk of larger bumps overrunning crews in outby locations.”

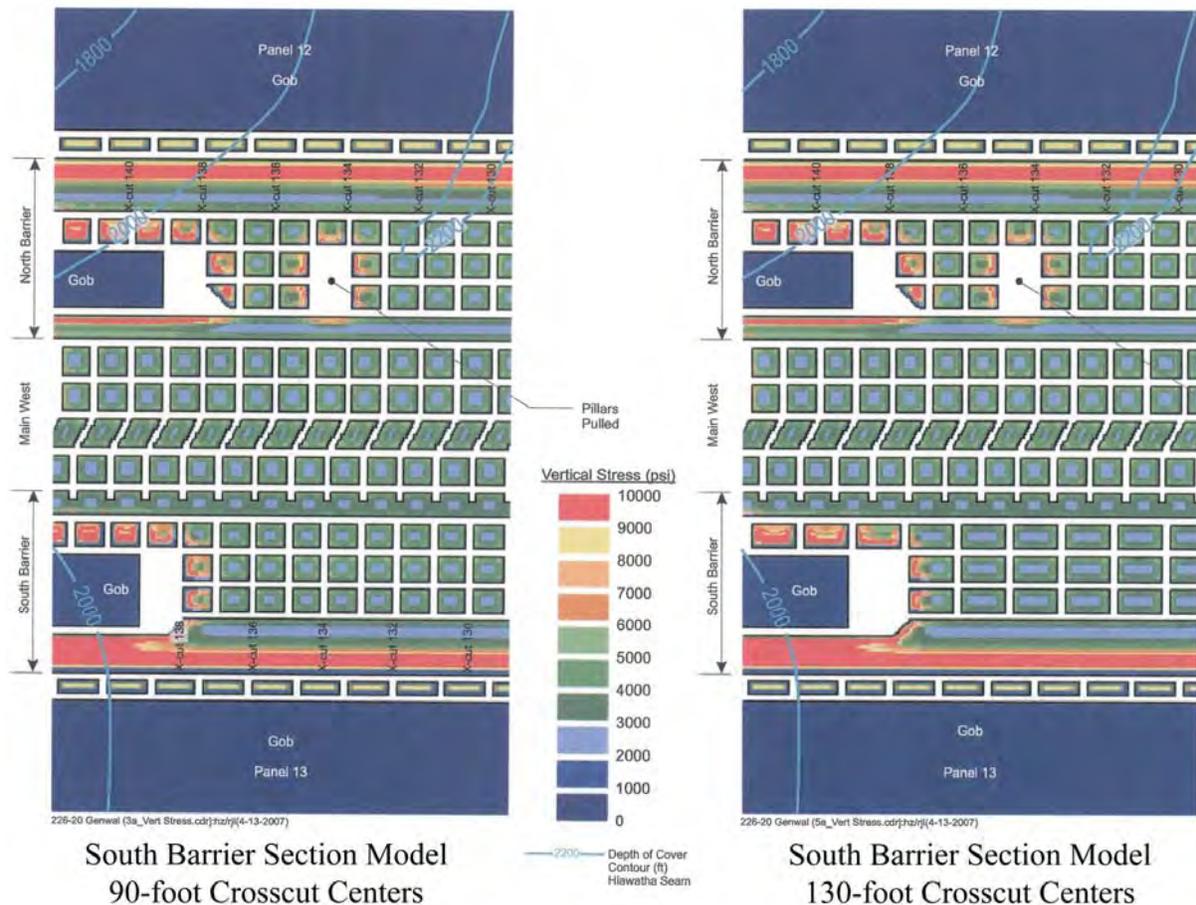
Figure 78 – AAI Modeled Vertical Stress Results Comparing Effects of Crosscut Spacing

AAI’s model results with two different crosscut spacing distances are shown in Figure 78. The images are similar in the sense that high stresses are concentrated in pillar ribs adjacent to the expanding gob area. With longer pillars, the concentration appears to be reduced in the vicinity of the outby intersection. It is important to note, however, that the models did not evaluate pillar recovery on a cut-by-cut basis. When pillar cuts remove coal from the inby ends, the pillars in

the active mining area are reduced in size. Consequently, some of the benefit of longer pillars in the active mining area is diminished as pillar recovery proceeds. The stress concentration will migrate towards the outby intersection as the pillar in the active mining area is reduced. Although the larger (i.e., longer) pillars used in the South Barrier were stronger than those used in the North Barrier, they were not sufficient to ensure the stability of these workings during pillar recovery. Given the aforementioned deficiencies, the models provided no insight into the “risk of larger bumps overrunning crews in outby locations.”

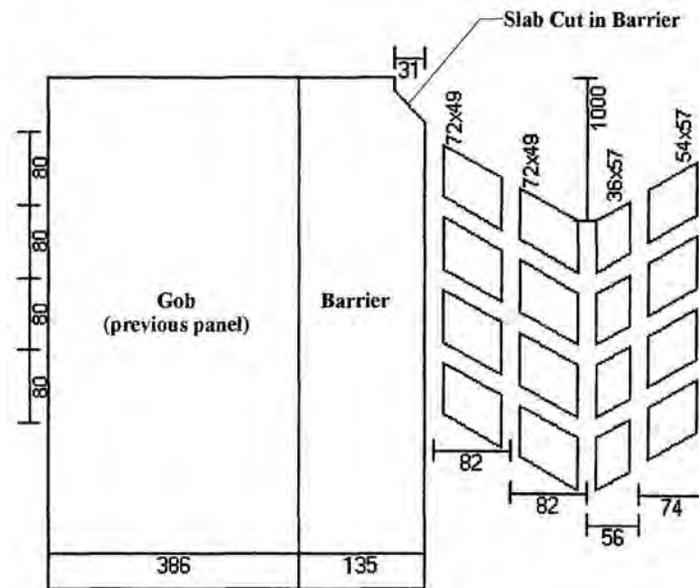
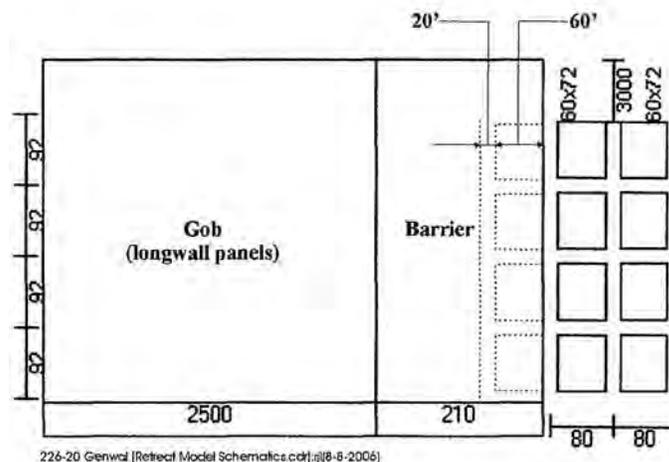
Figure 79 - ARMPS Analysis Geometries used by AAI

ARMPS Input. AAI calculated stability factors (StF²s) for the 1st North Panels and for the North Barrier section. The calculations were performed using default values available in ARMPS. For example, the analyses relied on default values for in situ coal strength (900 psi), unit weight of overburden (162 lb/ft³), abutment angle of gob (21°) and extent of the active mining zone (AMZ). Using these values and the geometries illustrated in Figure 79, AAI determined that the minimum pillar stability factor (PStF) in the 1st North Panels was 0.37.

Minimum PStF in the North Barrier section was 0.53 at 2,000 feet of overburden. These values (0.37 and 0.53) are generally consistent with the PStF values discussed earlier in Table 5 and Table 7 (Method 1 – 215-foot barrier). However, it is important to note that Method 1 overstates the benefit of leaving a row of bleeder pillars. More conservative estimates of PStF at 2,000 feet of overburden, obtained using Methods 2 and 3, are 0.29 and 0.27, respectively.

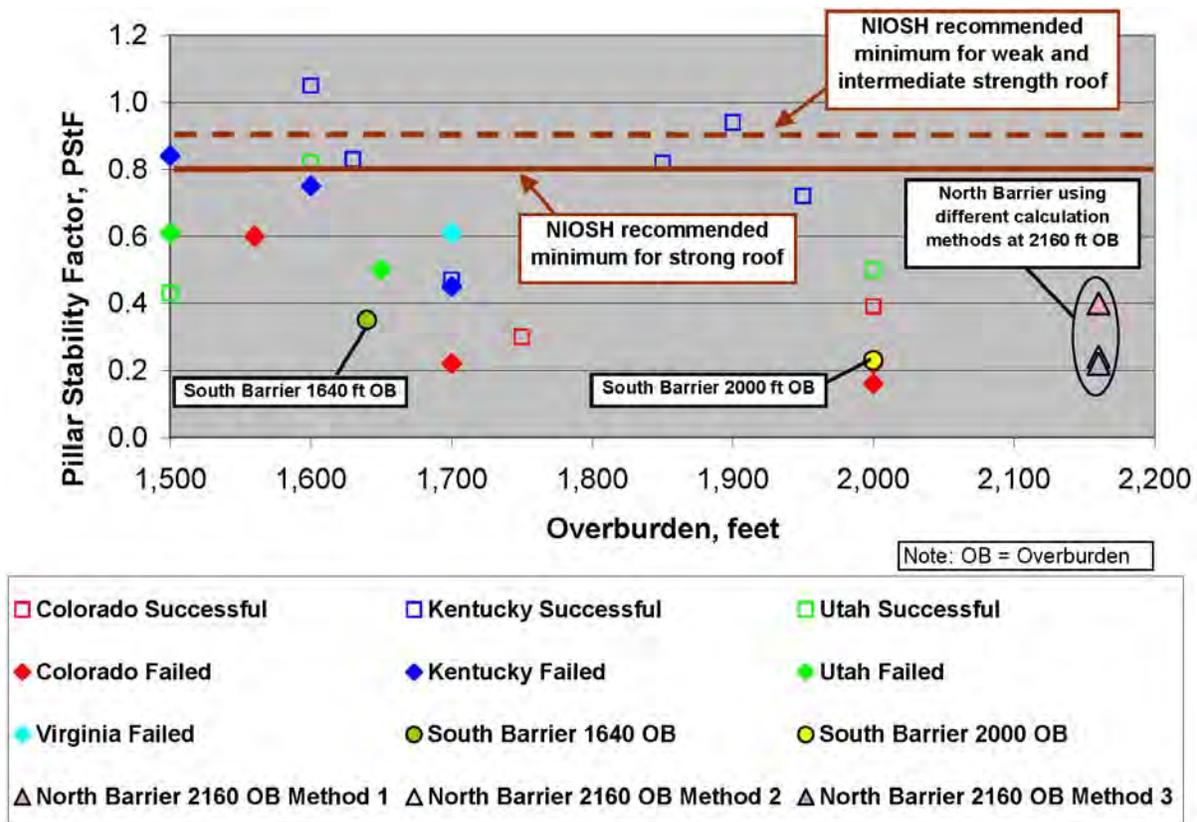
Figure 80 - Pillar Stability Factors from NIOSH ARMPS Database for Depths Over 1,500'
NOTE: NIOSH ARMPS Database only contains case histories at or below 2,000' overburden.

This observation is accurate. Eleven of 21 cases at depths greater than 1500 feet were deemed to be satisfactory designs. Difficult ground conditions were attributed to the remaining ten. Similarly, five of ten cases with PStF’s less than 0.53 (i.e., the PStF value they determined for the proposed North Barrier section) were satisfactory and the other five experienced difficulties (see Figure 80). It is noteworthy that in all of the “failed” cases, NIOSH indicated some degree of pillar “bumping” was involved.

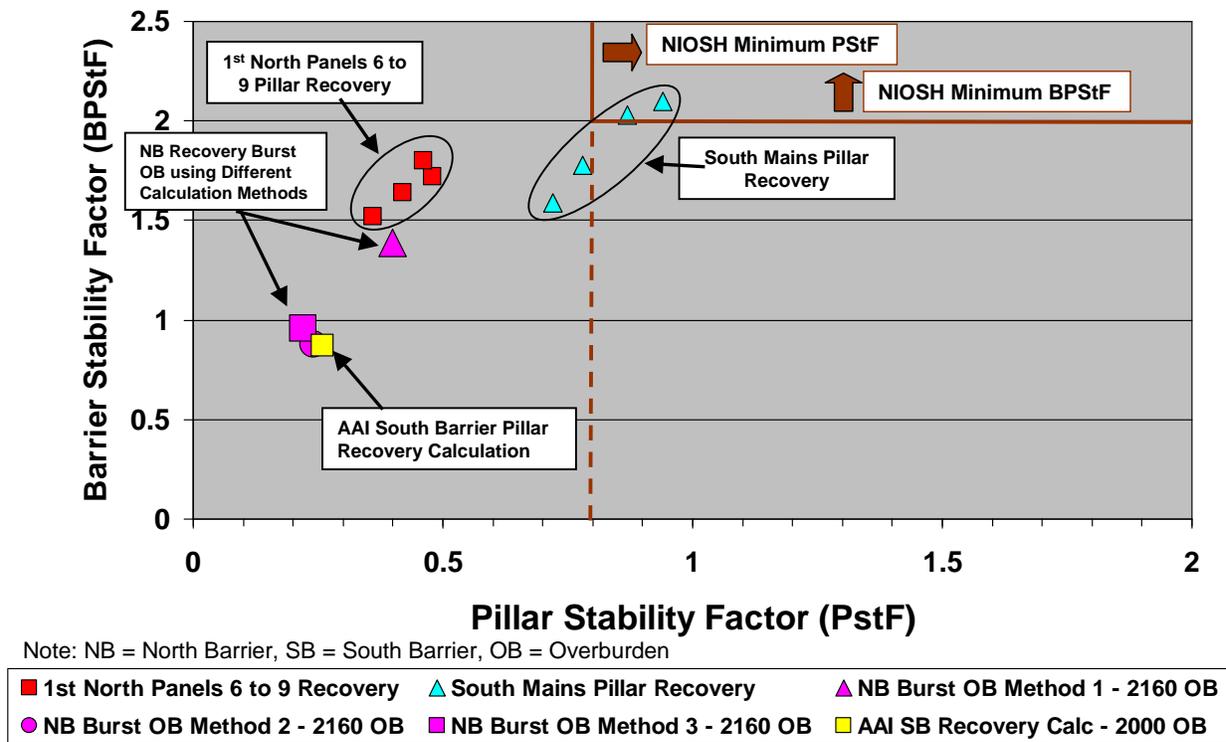
Figure 81 – Crandall Canyon Mine ARMPS Stability Factors showing AAI South Barrier Calculations

Finally, after the March 10 outburst accident, AAI again used ARMPS to evaluate several potential pillar designs for use in the South Barrier section. The analyses included a design similar to the one that was actually implemented. The ARMPS pillar stability factor for this design is 0.26 and the barrier pillar stability factor is 0.87 (yellow square in Figure 81). There are no indications that these values were included in any written report or email to GRI. AAI's StF's were based on a barrier width of 137 feet between the section and the worked out longwall Panel 13. When it was actually developed, the barrier width was reduced to 121 feet. For this scenario, the pillar and barrier pillar stability factors are 0.23 and 0.76, respectively. The South Barrier section PStF's are below AAI's mine-specific stability threshold of 0.4 and below the values associated with the March 10 outburst accident. Also, Figure 80 illustrates that the PStF values for the implemented South Barrier section pillar design at 2,000 feet of overburden are below all successful cases in the data base and equivalent to two failed cases. None of these ARMPS results were presented in the April 2007 AAI report for the South Barrier section design that MSHA considered in the plan approval process (see Appendix I).
