UNITED STATES
DEPARTMENT OF LABOR
MINE SAFETY AND HEALTH ADMINISTRATION

REPORT OF INVESTIGATION

Fatal Underground Coal Burst Accidents
August 6 and 16, 2007

Crandall Canyon Mine
Genwal Resources Inc
Huntington, Emery County, Utah
ID No. 42-01715

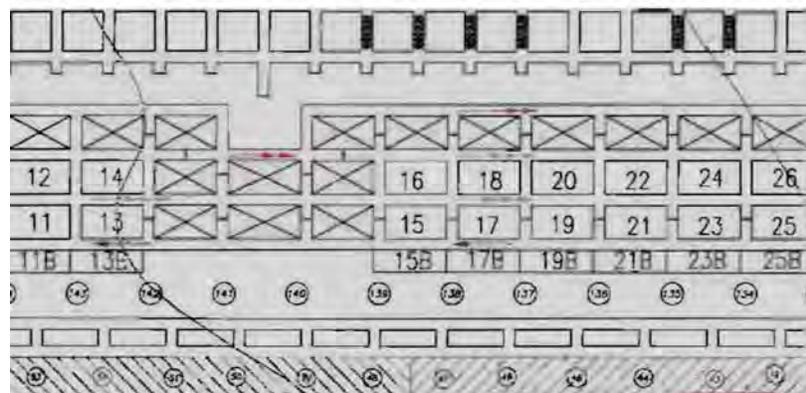
Figure 82 - Comparison of South Barrier Roof Control and Ventilation Plans

Portion of mine map from ventilation plan approved June 1, 2007 showing pillar and barrier mining from crosscuts 139 to 142 allowed.

Portion of mine map from roof control plan approved June 15, 2007 showing pillar and barrier mining from crosscuts 139 to 142 not permitted.

Roof control plans as required by 30 CFR 220(a) (1) must be developed and followed by the mine operator and be suitable for the prevailing geologic conditions and the mining system to be used at the mine. MSHA approved site specific roof control plans for pillar recovery in the North and South Barrier sections by considering observed mining conditions and AAI’s analyses of mine stability provided to MSHA by GRI. Although no adverse conditions were observed when MSHA roof control specialists visited the sections during development mining, adverse conditions were encountered during pillar recovery on both sections, including coal burst accidents on at least three occasions: March 7, March 10, and August 3. Prior to the March 10 and August 6 accidents, miners were struck by coal, ventilation was impaired, regular mining was disrupted, and equipment was damaged, indicating that the roof control plan was not suitable for controlling the roof, face, ribs, or coal bursts. While recovering pillars in the South Barrier

section, miners recognized that ground conditions were similar to those that forced abandonment of the North Barrier section. Although these similar conditions indicated that the roof control plan was inadequate, revisions to the plan were not proposed by GRI and mining was allowed to continue until the August 6 accident.

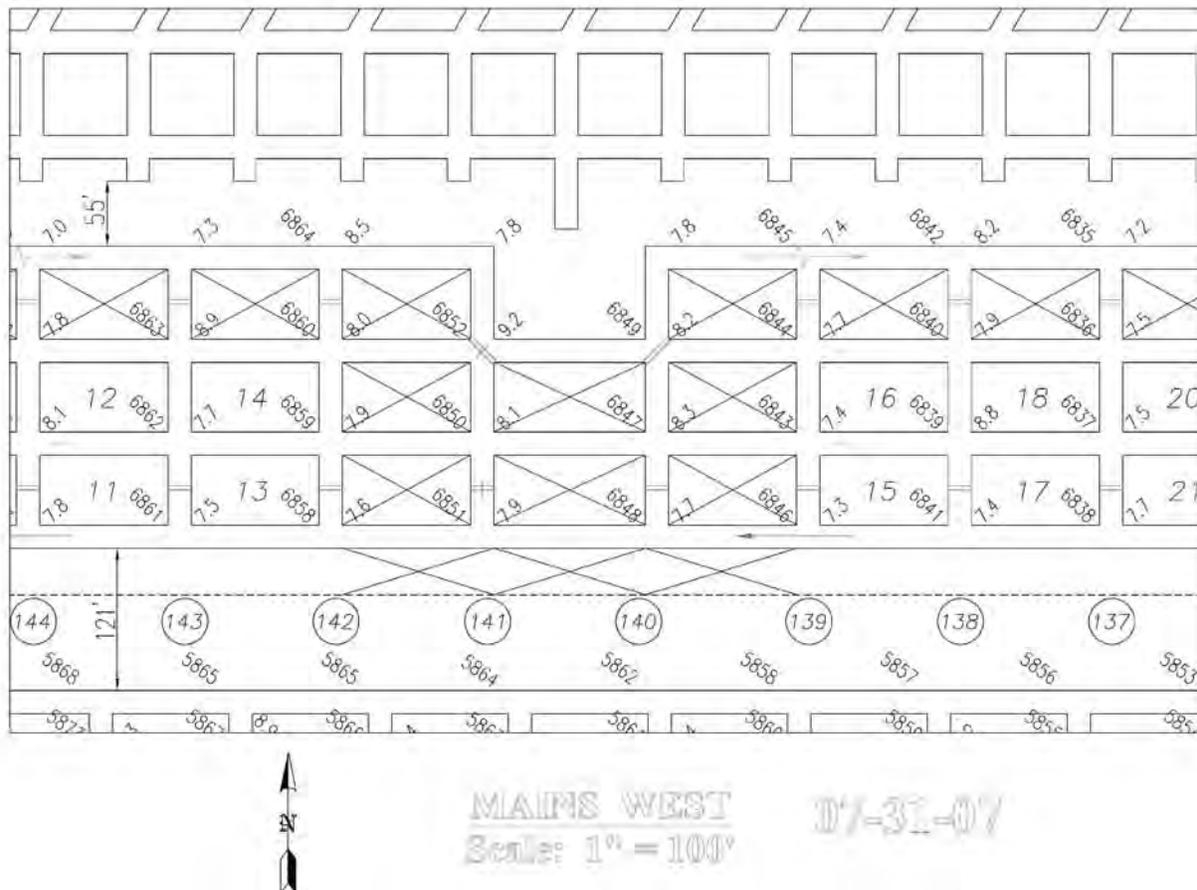
Figure 83 - Mark Up Map Provided to Mine Management on July 31, 2007

The initial South Barrier section mark up map showed the pillar recovery sequence from crosscut 149 to crosscut 142. On July 31, 2007, as pillar recovery approached crosscut 143, Gary Peacock emailed David Hibbs (manager of engineering), "We need an updated mark up map at Crandall showing the pillars that will be left in the area were there is only 3 entries." Hibbs replied, "Gary, I feel we need to leave all rows in the area of 3 entries and also delete the barrier. Do you have any thoughts?" Peacock answered, "I think we should take the barrier." Hibbs responded to Peacock: "Gary, This is the drawing in approved Roof Control Plan for that

area.” Hibbs attached a copy of the pillar extraction map from the approved roof control plan and included Shane Vasten (surveyor) in his email response to Peacock. Later that evening, Vasten emailed Peacock and Hibbs: “Gary, Here is a mark up map for you to look at based on the latest approvals forwarded to me from Dave. If you have any questions/concerns, get with Mr. Hibbs. Ace and I will be there tomorrow doing month end. I will check with you then to see if any changes need to be made. I will also plot more maps for you then. I just wanted to send you this one so you can be looking it over.” Between crosscuts 142 and 139, the attached mark up map (see Figure 83) correctly showed that no pillars were to be recovered and the barrier was to remain unmined south of the No. 1 entry (as indicated by the standard symbol X in the pillars) in accordance with the approved roof control plan. Interview statements, belt scale records, shift foremen’s reports, and production records revealed that the barrier south of the No. 1 entry between crosscuts 139 and 142 was, nonetheless, mined.

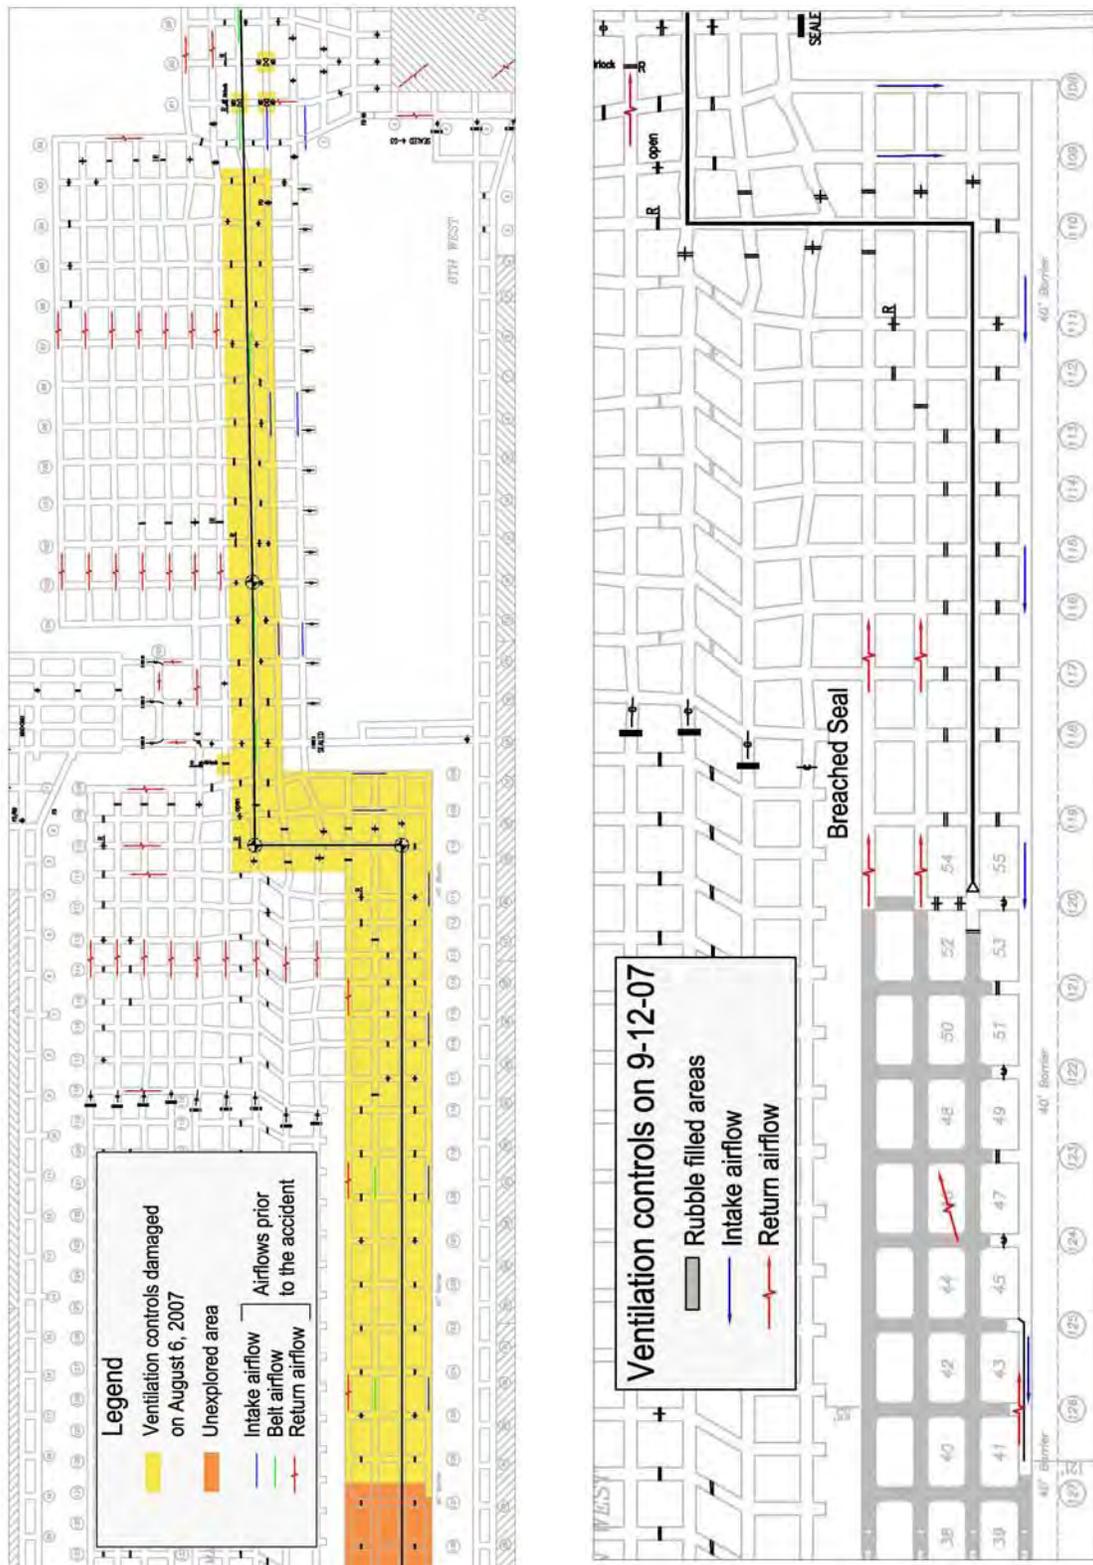
Figure 86 - Ventilation Controls after Accidents

Curtains were installed in place of the damaged permanent ventilation controls up to the rescue work site in the hours following the August 6 accident. The subsequent burst at 1:13 a.m. on

August 7 damaged many of these temporary ventilation controls. The temporary controls were then replaced with permanent stoppings. These permanent stoppings were completed prior to resuming rescue efforts. Figure 86 shows the locations of stoppings damaged in the August 6 accident and the stopping configuration after the August 16 accident.

Originally, the South Barrier section No. 3 entry was in common with the belt entry. As ventilation controls were reestablished, the No. 3 entry was utilized as a return air course. Stoppings were erected between the No. 2 and 3 entries. A feeder was set in the No. 2 entry between crosscuts 119 and 120. The stoppings between the intake and belt entries (No. 1 and No. 2) were reestablished up to crosscut 120. Crosscut 120 was left open to serve as the haul road to the feeder. A stopping was built across the No. 2 entry inby crosscut 120. Inby that point, the No. 1 entry served as the intake and the Nos. 2, 3, and 4 entries served as returns.

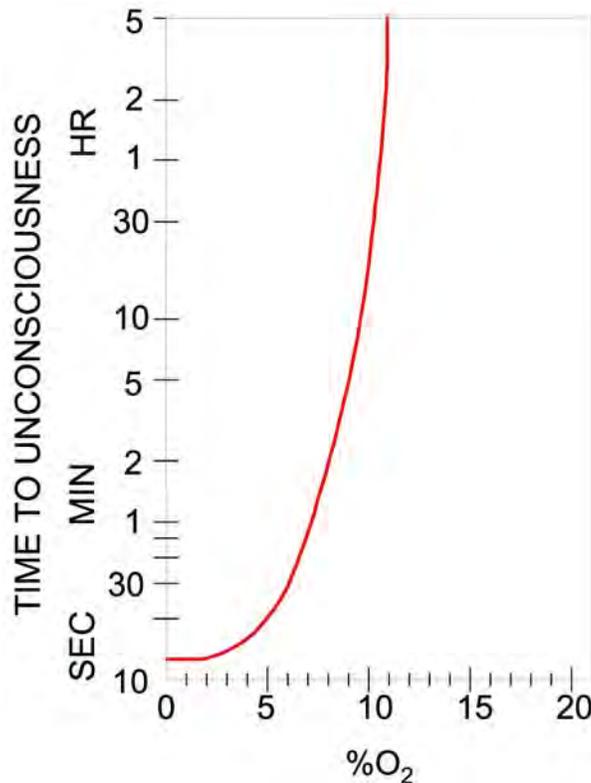
Before the accident, preshift examination records for the South Barrier section indicated air quality of 20.9% oxygen (O₂), 0% methane (CH₄), and 0 ppm carbon monoxide (CO). After the accident, oxygen deficiency as low as 16% was encountered. Samples from Borehole No. 1 taken at 9:57 p.m. on August 10, 2007, indicated 7.46% O₂, no detectable amount of CH₄, 141 ppm CO, and 0.58% CO₂. Exposure to this atmosphere will result in vomiting, unconsciousness, and death. Higher oxygen concentrations were detected in Borehole Nos. 3 and 4. However, no evidence of the miners was observed in these boreholes. It is likely the entrapped miners were exposed to an atmosphere similar to that observed in Borehole No. 1.

Had the miners survived the initial catastrophic ground failure, oxygen deficiency would have contributed to their deaths. Table 11¹⁶ lists effects of exposure to reduced oxygen. These effects would occur at increased oxygen concentrations at higher altitudes. Figure 87¹⁶ shows the time of useful consciousness versus oxygen concentration. At 7.5% O₂, the time of useful consciousness is just over one minute. The time of useful consciousness is the time after exposure to oxygen deficiency during which a person can effectively take corrective action such as donning an SCSR before impairment or unconsciousness occurs.

Figure 87 – Approx. Time of Useful Consciousness vs. Oxygen Concentration For Seated Subjects at Sea Level. Adapted from Miller and Mazur¹⁶

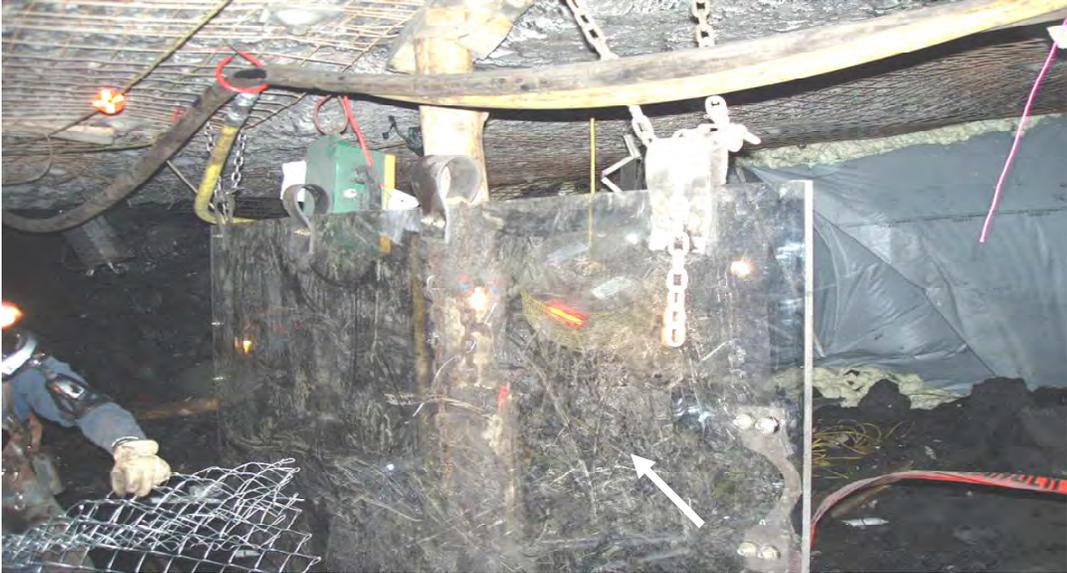
Figure 90 - Sheet of Lexan Suspended from Mine Roof

As clean-up advanced in the No. 1 entry, a number of changes were implemented to enhance the support system and/or to reduce worker exposure. For example, a 4 x 8-foot sheet of ½-inch thick Lexan¹⁸ was provided near the face to offer protection to rescue workers in the clean-up area. The sheet was secured to the mine roof by chains attached along one edge. The chain was connected to roof bolt plates (Figure 90). The Lexan sheet served as a shield between personnel and the coal pillar rib.

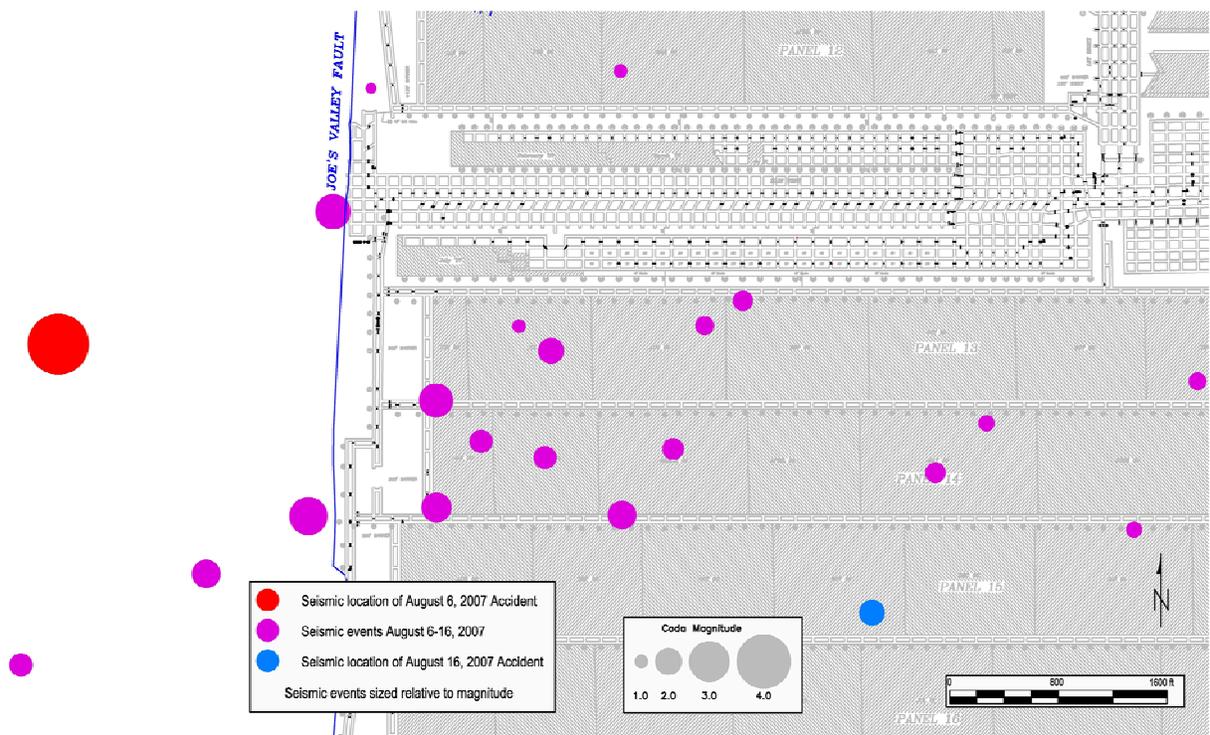
Figure 91 - Initial Location of Seismic Events August 6-16, 2007

Initial locations of seismic events lacked sufficient accuracy to be used for decisions affecting rescue efforts. Figure 91 shows the initial locations generated by the UUSS automated system. The red circle depicts the August 6 accident. The blue circle depicts the August 16 accident. The remaining magenta circles depict those events recorded between these accidents. All events plot in regions away from the underground rescue work. The more accurate locations of events shown in Figure 92 were not available until well after the rescue efforts had been suspended. Underground observations were much more representative of actual ground activity.

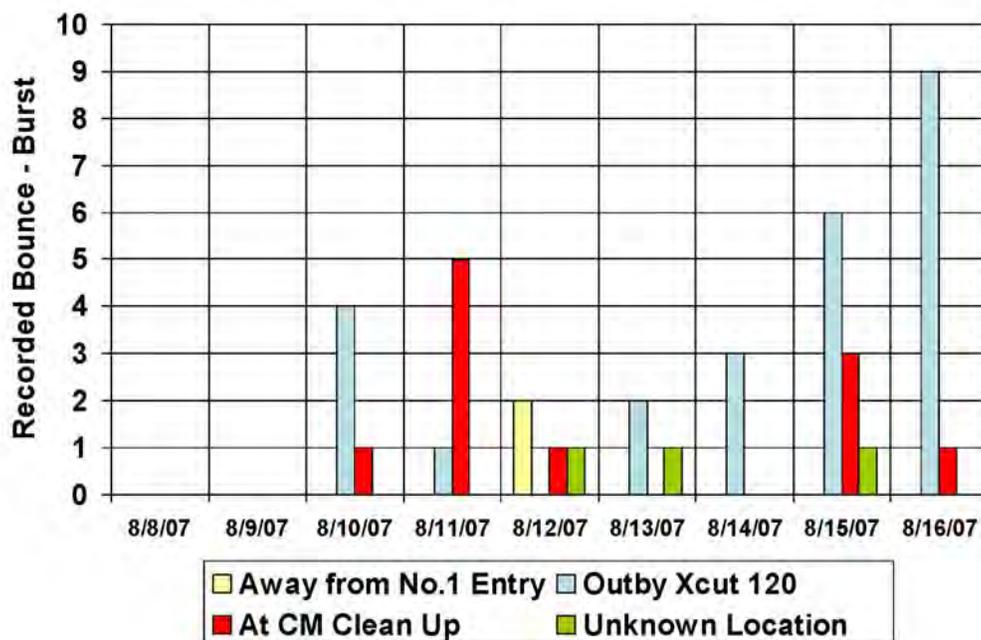
Figure 93 – Bounce or Burst Activity Recorded in Command Center Log Book August 8 to August 16, Prior to August 16 Accident

Forty-one events were reported by underground personnel during rescue work in the No. 1 entry prior to the August 16 accident. All bounce activity, which included bursts, originated from the section pillars to the north of the No. 1 entry. None was associated with the barrier to the south. The majority of these bounces or bursts were outby crosscut 120 (see Figure 93). This area was outby the crosscut leading to the feeder, away from the clean-up operation in the No. 1 entry (see Figure 3). The rescue work area was protected with RocProps or wood posts with Jackpots. Rib deterioration and bursts that occurred outby the clean-up area were contained by the support system.

Prior to the August 16 accident, eleven burst/bounce events were reported to have originated from the north side (right side) section pillars inby crosscut 120 (see Figure 93). These events occurred at the remote-controlled continuous mining machine where the material was being loaded, inby the area of the advancing RocProp system. The approved clean-up plan included procedures that minimized exposure of rescue workers in this area. It was thought that if a significant pillar burst were to occur, it most likely would be in the area where material was being removed. The command center log book noted that events in the clean-up area varied in size with two large pillar bursts in this area recorded prior to the August 16 accident. Prior to August 16, no significant bounces or bursts were recorded within the RocProp support system inby crosscut 120. One burst event was noted outby crosscut 120. Material piled behind the chain-link fencing inby crosscut 120 resulted from unreported bounces or bursts, or from rib sloughage.

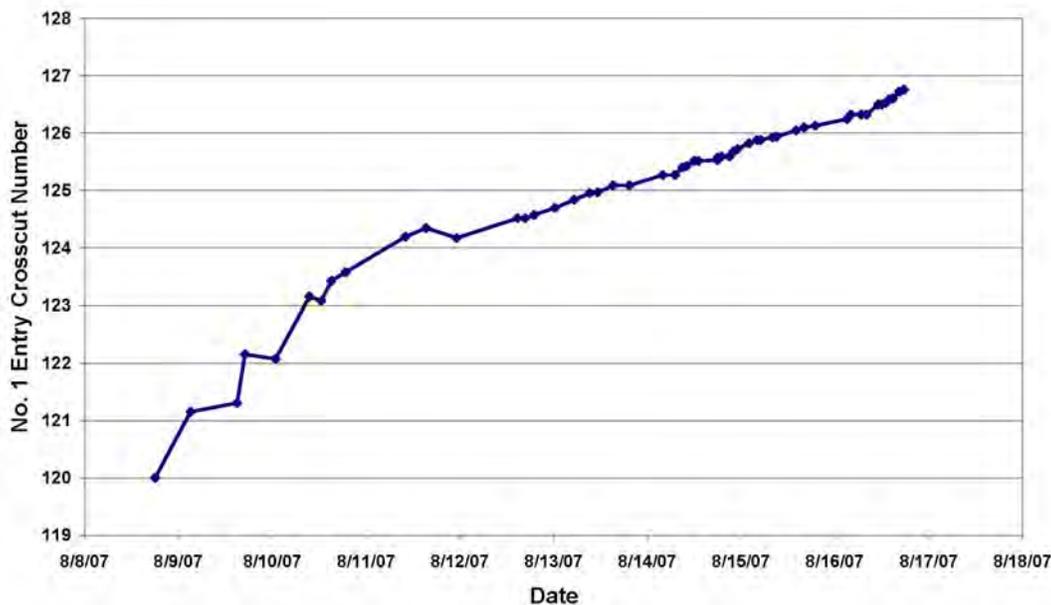
Figure 94 - No. 1 Entry Rescue Clean-up Progress Plotted by Day

The rescue advance in the No. 1 entry achieved a somewhat steady rate of approximately ½ crosscut (65 feet) per day after August 12 as illustrated in Figure 94. No correlation to rescue advance rate in the No. 1 entry and the burst or bounce frequency could be identified.

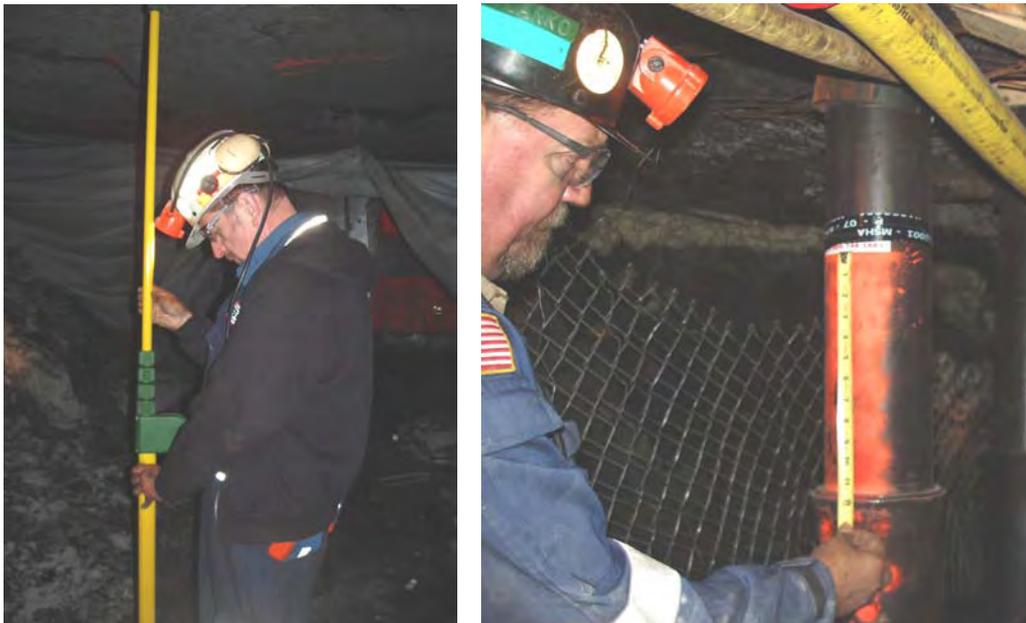
Each convergence station was established between two points on the mine roof and floor. Roof bolt heads were identified at specific locations to serve as measurement points on the roof. Directly beneath each roof bolt, a ⅜-inch diameter hole was drilled to accept a plastic anchor and a ¼-inch diameter screw that served as the measurement point on the floor. Spray paint and survey ribbon were used to identify the monitored locations. Convergence measurements were taken using a telescoping rod, shown in the photograph on the left side of Figure 95. This instrument, manufactured by Sokkia, can extend up to 26 feet and is capable of determining the distance between roof and floor points to within one millimeter.

Figure 95 - Convergence Measurements
Left: Roof-to-floor convergence station. Right: RocProp convergence station.

The convergence stations were monitored to determine the magnitude, rate, and distribution of roof-to-floor closure. Historically, measurements of this type have been useful in monitoring changing and potentially hazardous ground conditions. Initial (baseline) measurements were taken on August 15 and the stations were measured twice on August 16 prior to the accident. Measurements in this time frame indicated that ground conditions were stable; three of ten stations showed closures of 0.04 inches but this amount of displacement is within the precision of the measuring instrument.

Sixteen monitoring locations were established using RocProps in the No. 1 entry. As shown in the photograph on the right side of Figure 95, these monitoring locations were established by painting a line on installed RocProps, 12 inches above the locking ring. Entry convergence could be monitored at these locations simply by measuring the distance between the lock ring and paint line using a tape measure. Although not as exact as a convergence rod, these measurements were intended to provide a convenient method for determining convergence between the mine roof and floor that anyone with a tape measure could perform.

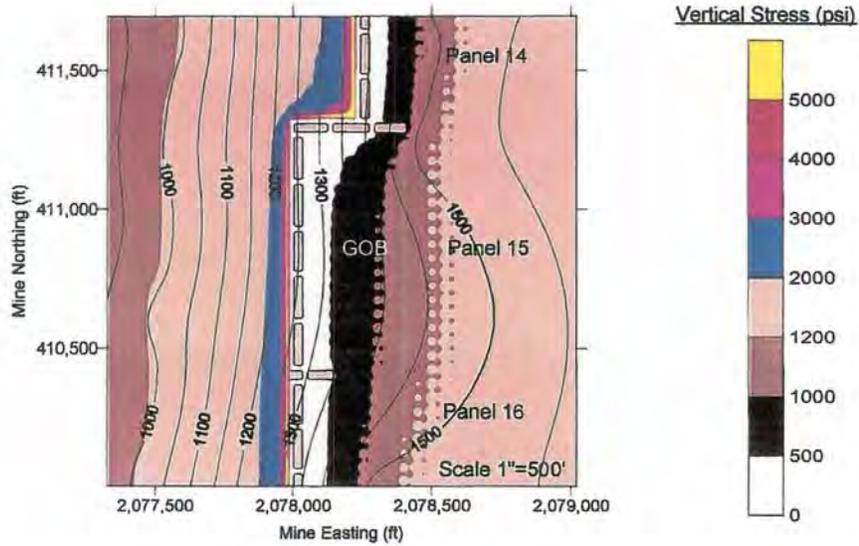
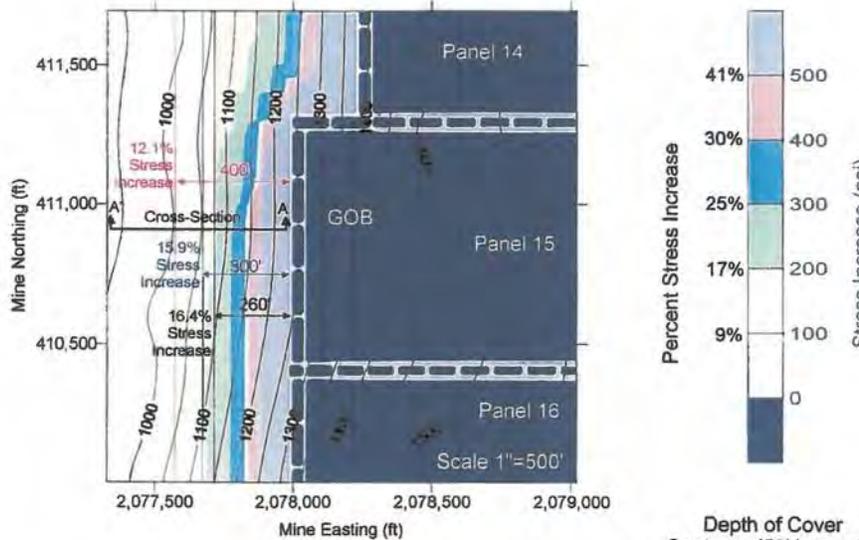
Figure 1 depicts a scenario in which Panels 14, 15, and 16 are fully extracted and no bleeder entries exist. Plots of vertical stresses and the change in vertical stresses due to LW mining are shown. The vertical stress at 260 ft, 300 ft, and 400 ft from the outer startup entry of Panel 15 are estimated to increase by 16.4%, 15.9%, and 12.1%, respectively, as a result of the longwall mining of Panels 14, 15, and 16. This increase in stress is the average increase along the face length of Panel 15. A cross section plot (A-A') of the vertical stress increase was created to show the rate of decrease in mining-induced

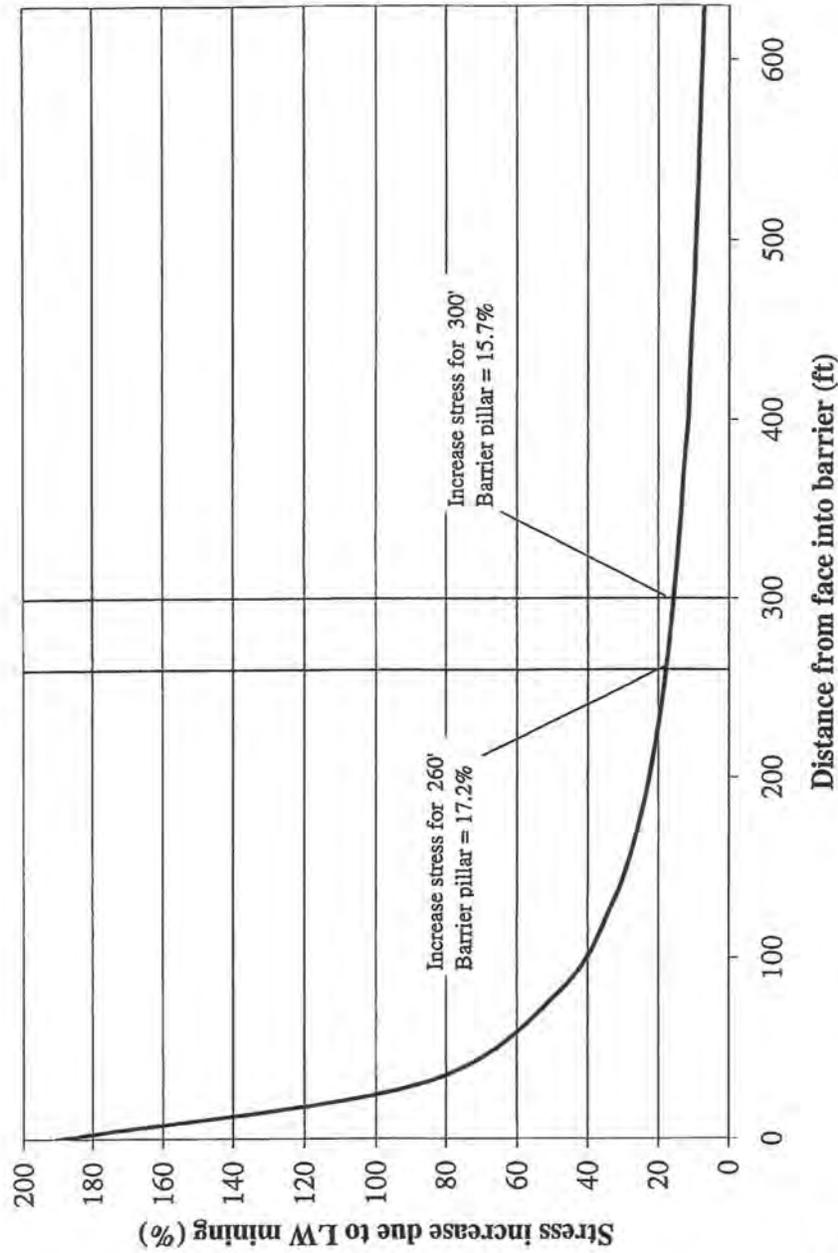
stresses with distance from the startup entries (Figure 2). If the bleeders were located 260 ft from the starter rooms, at the specific location of section A-A', they would experience a 1.3% increase in stress as compared to if the bleeders were at 300 ft. If the bleeders were at 400 ft from the starter room, the stress change would be 4.9% less than if located at 260 ft from the starter room.

Figure 2. Vertical Stress Change from Starter Room Access Drift as Percent of Pre-existing Vertical Stress

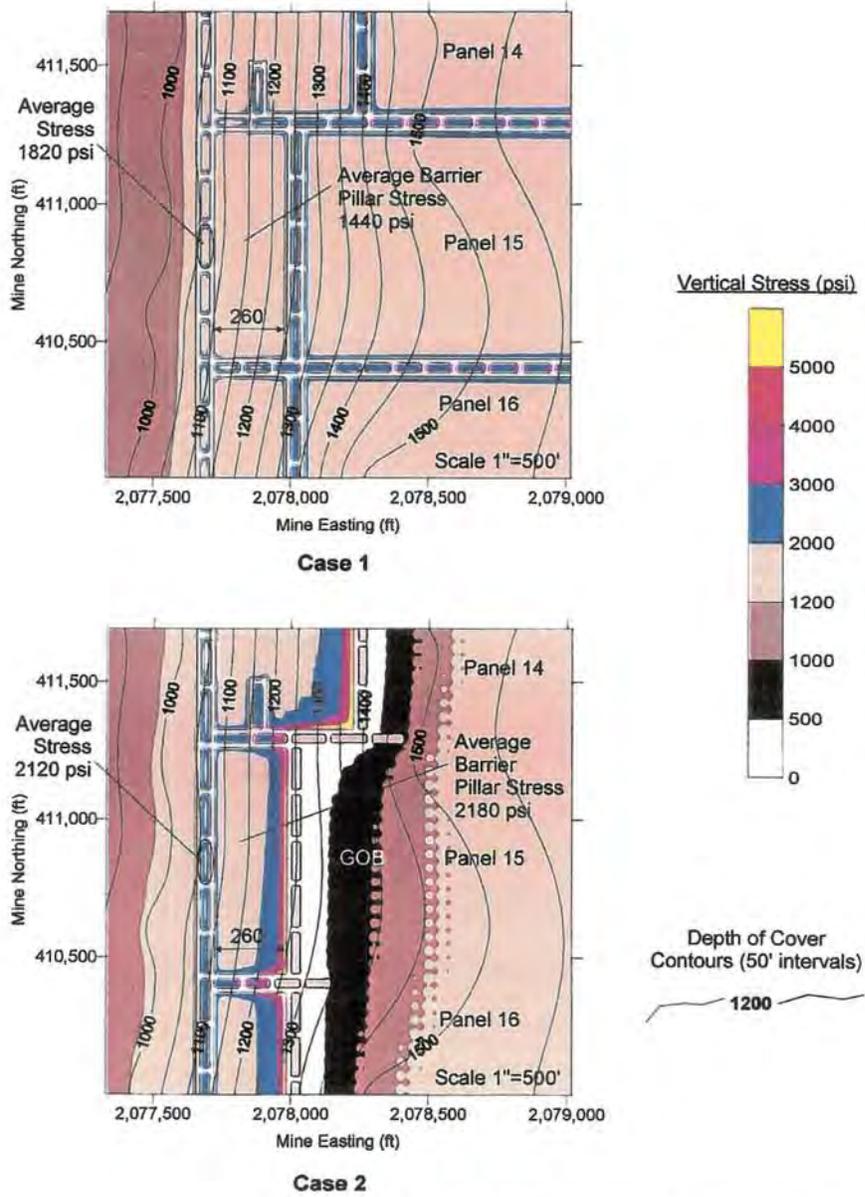
Figure 3 provides modeling results for two cases of a scenario in which bleeder entries have been developed forming a 260-ft barrier pillar to the east of Panel 15. In Case 1 only the development of the LW panels is complete, and in Case 2 the panels have been fully extracted. The average pillar stress of the yield pillar annotated in Figure 3 was estimated to be 1820 psi for Case 1 and 2120 psi for Case 2. This represents a 16.5% stress increase caused by LW mining. (This is very close to the expected stress increase indicated in Figures 1 and 2.)

Figure 3. Vertical Stress in Barrier and Bleeder Pillars for 260-ft Barrier Pillar

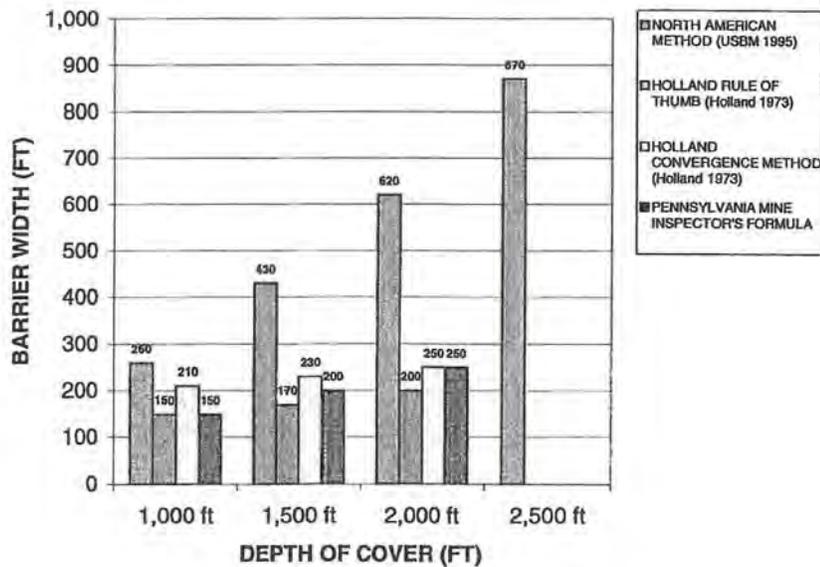
Figure 4. Barrier Pillar Sizes from Empirical Methods

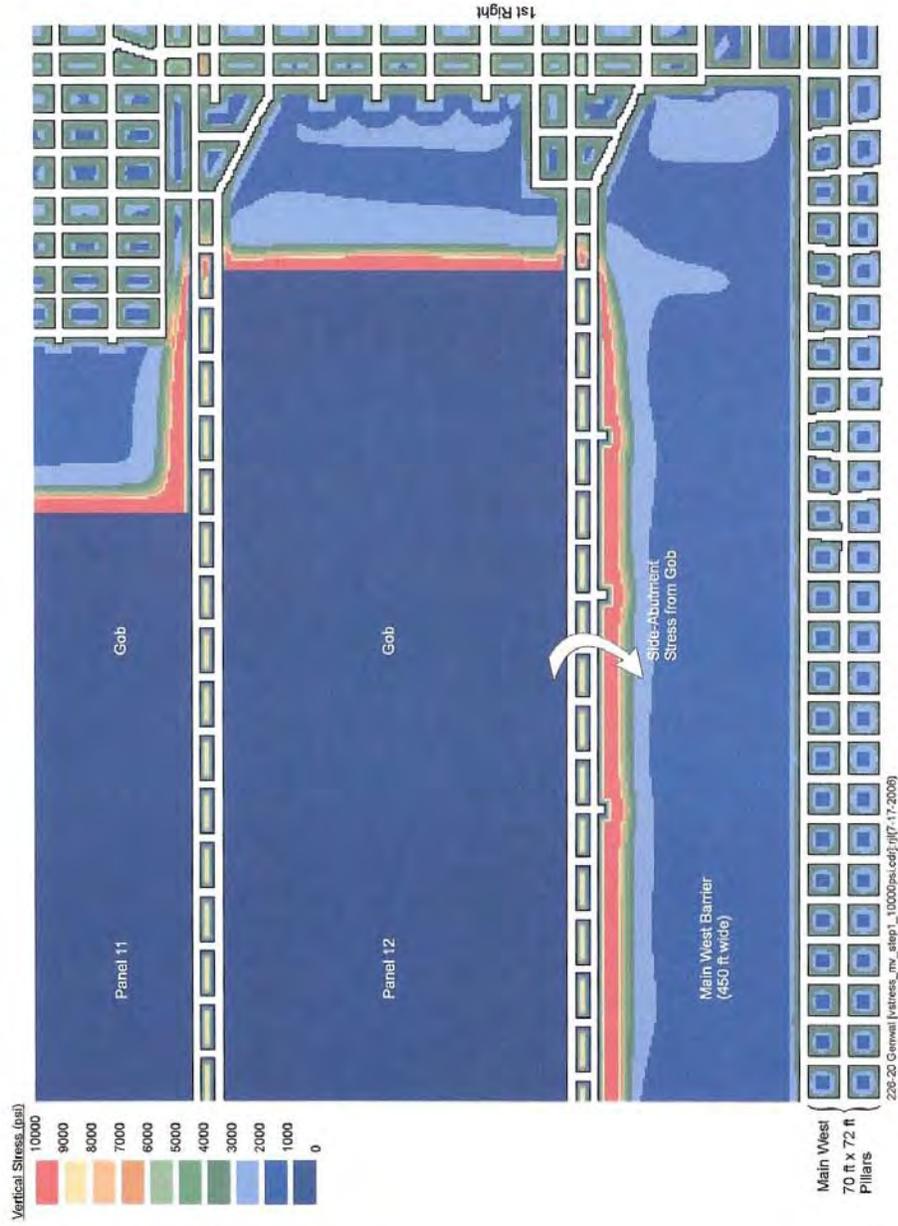
For the current geometry, the model shows side-abutment stresses reaching as high as 30,000 psi in the northern interior of the existing 450-ft-wide barrier. Figure 20 shows two stress profiles (A-A') through the barrier, one for the current geometry (magenta) and a second with planned mining in the barrier (blue). The location of Profile A-A' is shown in Figure 14. For the current geometry, stress levels taper to near pre-mining (in situ) stress levels approximately 100 ft into the barrier, indicating that the proposed 130-ft-wide barrier will limit exposure of the

Figure 11. Modeled Vertical Stress—Current Conditions in Main West Barrier

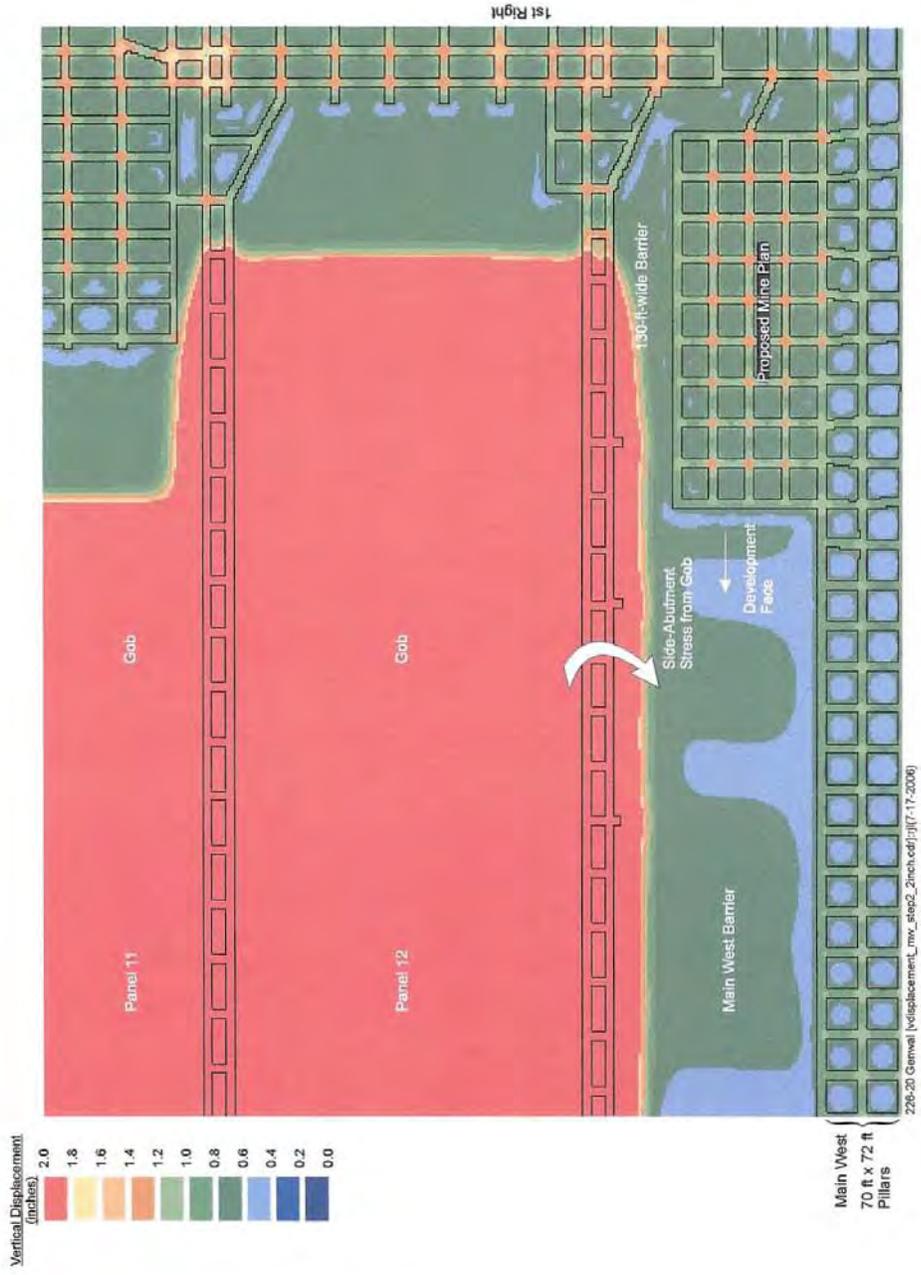
Results of the model are shown in Figures 11 through 19. Mining was simulated in three stages: (1) current conditions before any new mining (Figures 11 through 13), (2) early during planned mining with development part way into the barrier (Figures 14 through 16), and (3) after the barrier is fully mined (Figures 17 through 19). Planned mining includes 18-ft-wide rooms with 60 ft by 72 ft (rib-to-rib) pillars. These dimensions were rounded to 20 ft and 60 ft by 70 ft, respectively, in the model because of the 5-ft element size. Notably, the models show mining into the existing Main West entries. This may or may not be the final design. This is a conservative assumption useful for analyzing the highest pillar loading.

Figure 16. Modeled Roof-to-Floor Convergence—Partial Mining in Main West Barrier

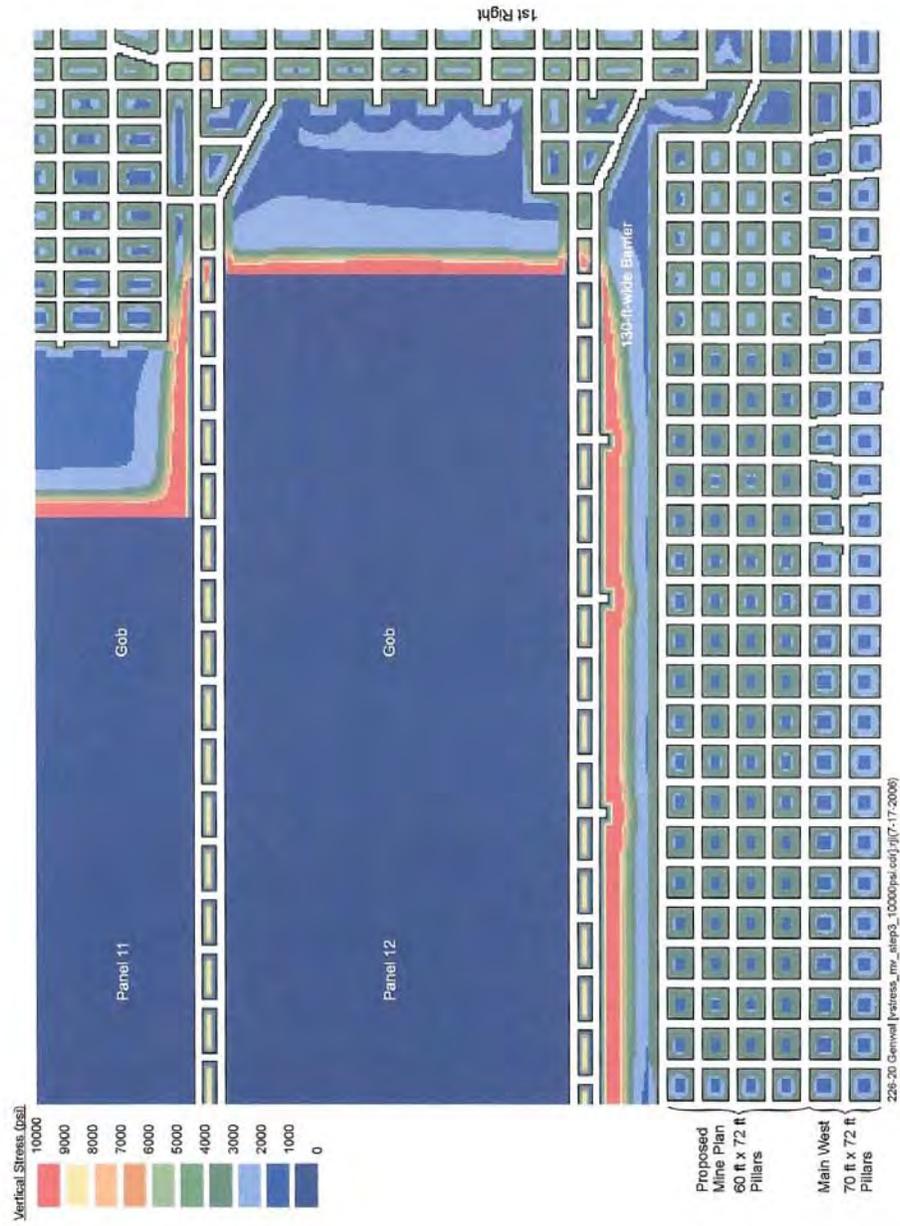
Figure 17. Modeled Vertical Stress—Mining Completed in Main West Barrier

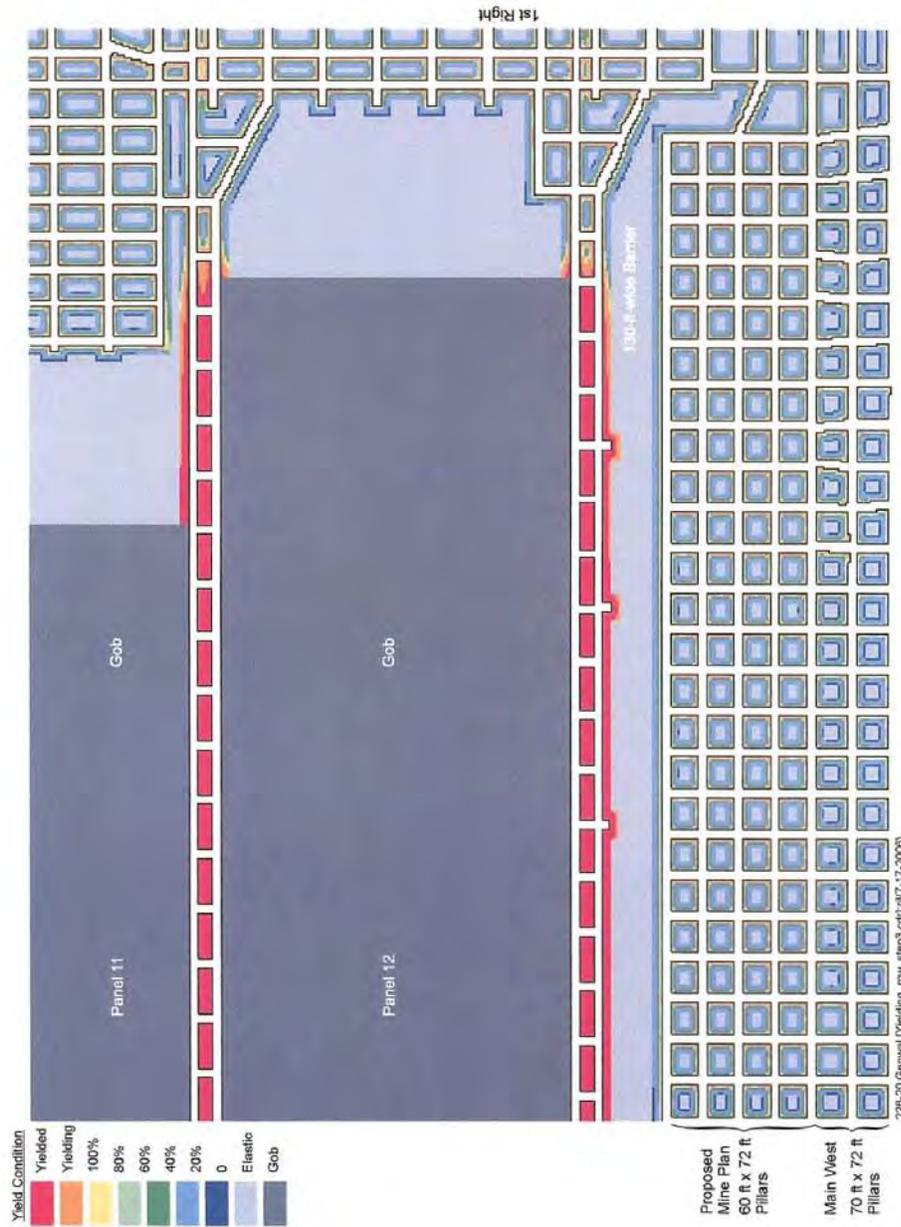
This reduced strength translates to slightly increased rib yielding (sloughage) and increased roof convergence. Figure 18 shows rib yielding predicted by the model. In the figure, rib yielding is limited to the corners of the existing 70-ft by 72-ft pillars (bottom two rows of pillars). In the proposed smaller pillars (top four rows of pillars), yielding occurs in the skin all the way around the pillar. However, the pillar cores are shown to remain competent in all locations, indicating acceptable pillar performance.

Figure 18. Modeled Coal Yielding—Mining Completed in Main West Barrier

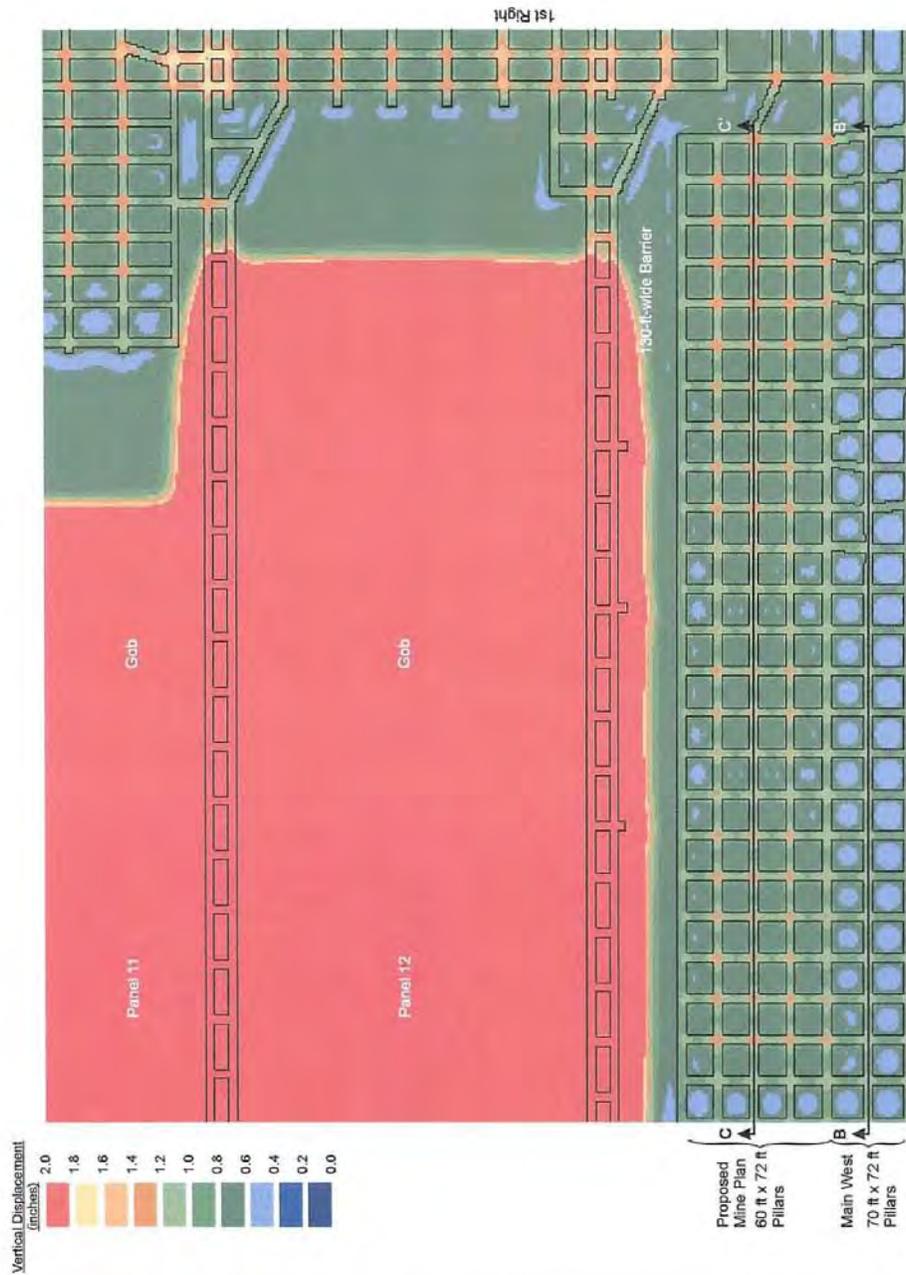
Figure 19 shows predicted roof convergence. Figure 21 compares centerline convergence along an entry in the existing mains (Profile B-B') with an entry central to the new mining (Profile C-C'). Profile locations are shown in Figure 19. The figures show that the proposed smaller pillars result in up to a 0.15 inch increase in roof convergence in the intersections, or about a 15% increase, compared to historical conditions in Main West. This reflects the increased rib yielding around the smaller pillars.

Figure 19. Modeled Roof-to-Floor Convergence—Mining Completed in Main West Barrier

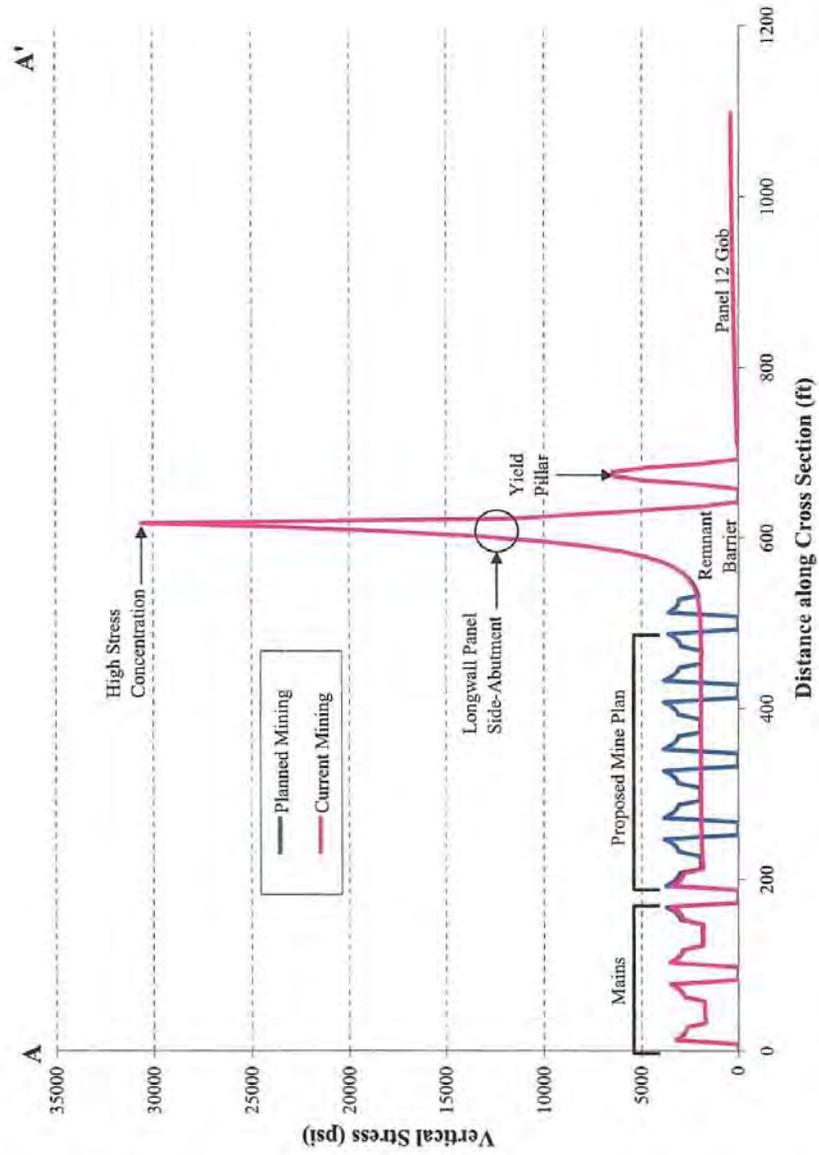
Figure 20. Modeled Vertical Stress Profiles Across Main West Barrier—Profile A-A' (profile location shown in Figure 14)

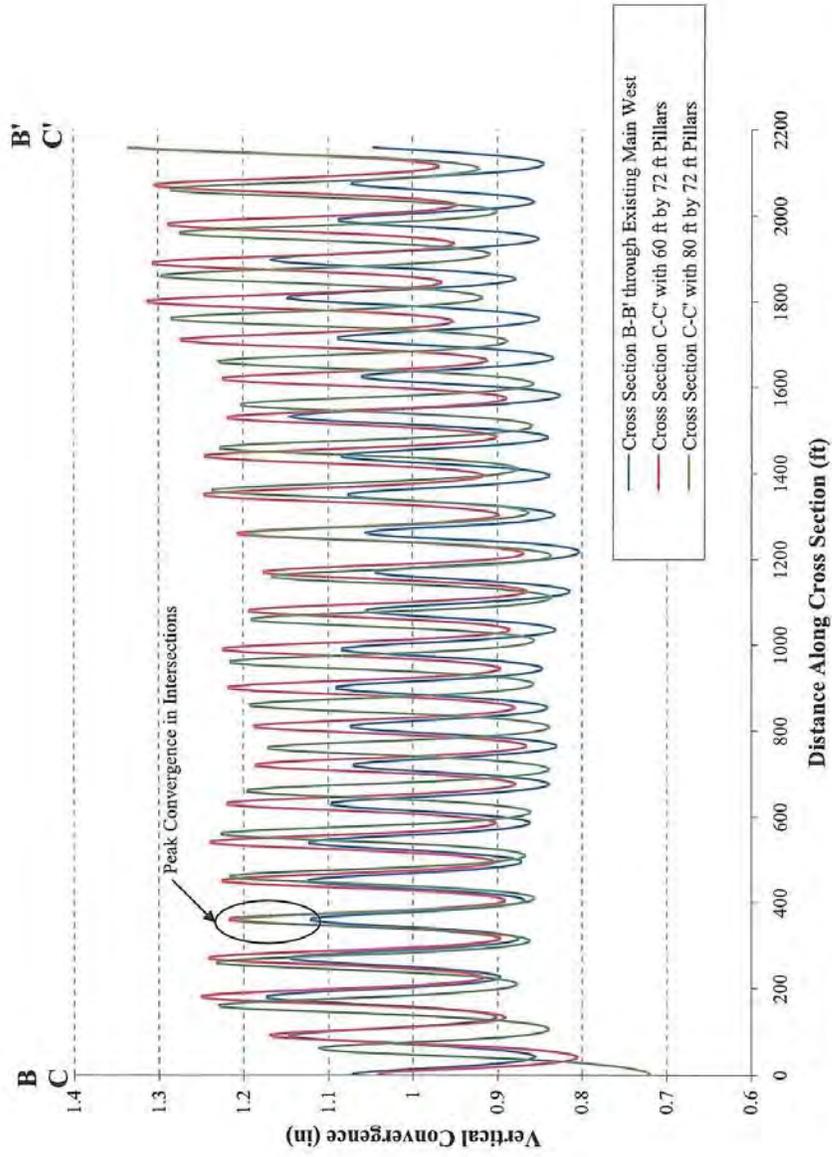
Figure 21. Modeled Roof-to-Floor Convergence Profiles Along Main West Entries—Profiles B-B' and C-C' (profile locations shown in Figure 19)
