UNITED STATES
DEPARTMENT OF LABOR
MINE SAFETY AND HEALTH ADMINISTRATION

REPORT OF INVESTIGATION

Fatal Underground Coal Burst Accidents
August 6 and 16, 2007

Crandall Canyon Mine
Genwal Resources Inc
Huntington, Emery County, Utah
ID No. 42-01715

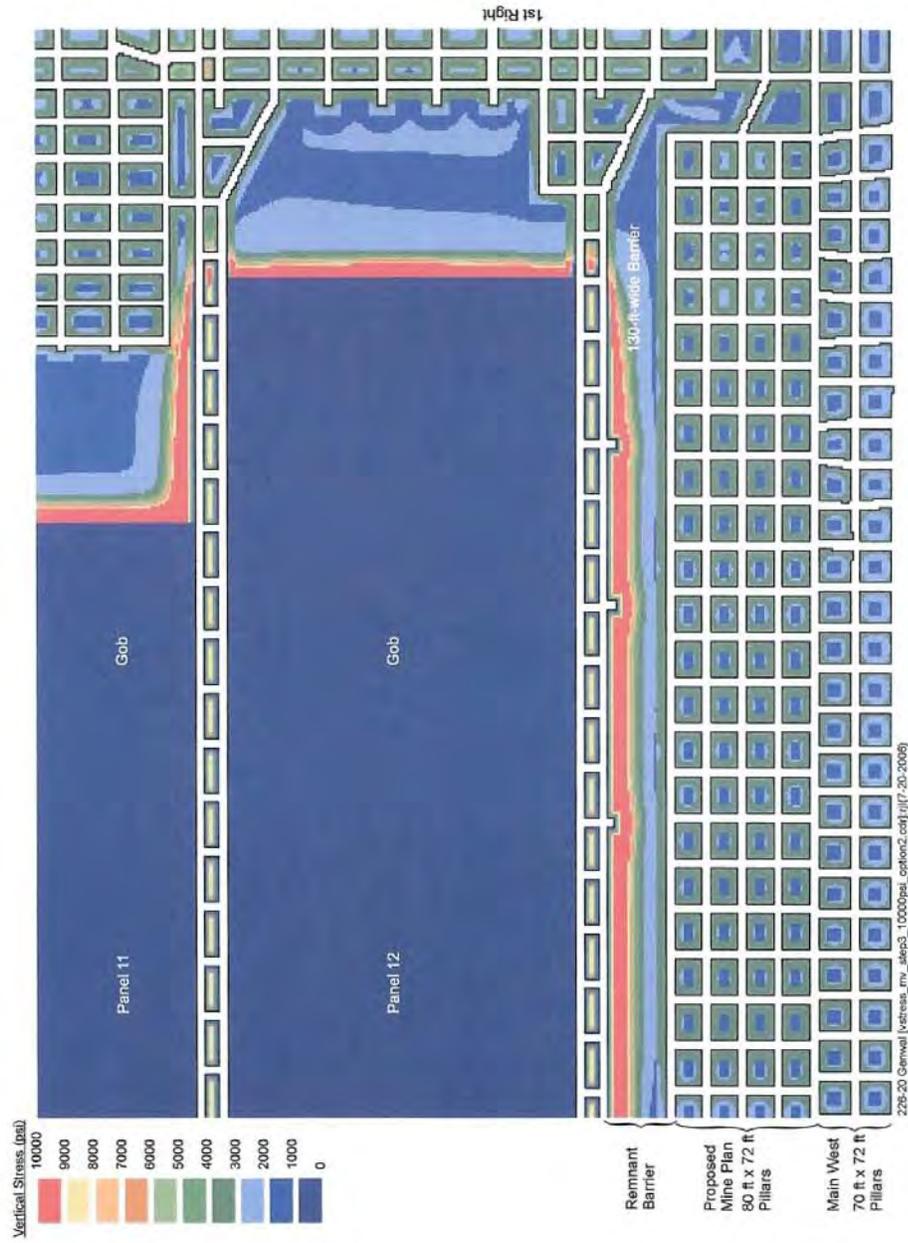
Model results indicate that increasing crosscut spacing does not significantly improve conditions. Figures 22 through 24 show stress, yielding, and convergence for a 60-ft by 80-ft pillar, representing about a 20-ft increase in pillar length (between crosscuts) over the proposed design. The increased length only incrementally reduces rib yielding, corresponding to a modest decrease in entry convergence of about 2% to 4%, as shown by comparison of convergence profiles in Figure 21.

Figure 22. Modeled Vertical Stress—Main West Barrier Mining with 60-ft by 80-ft Pillars

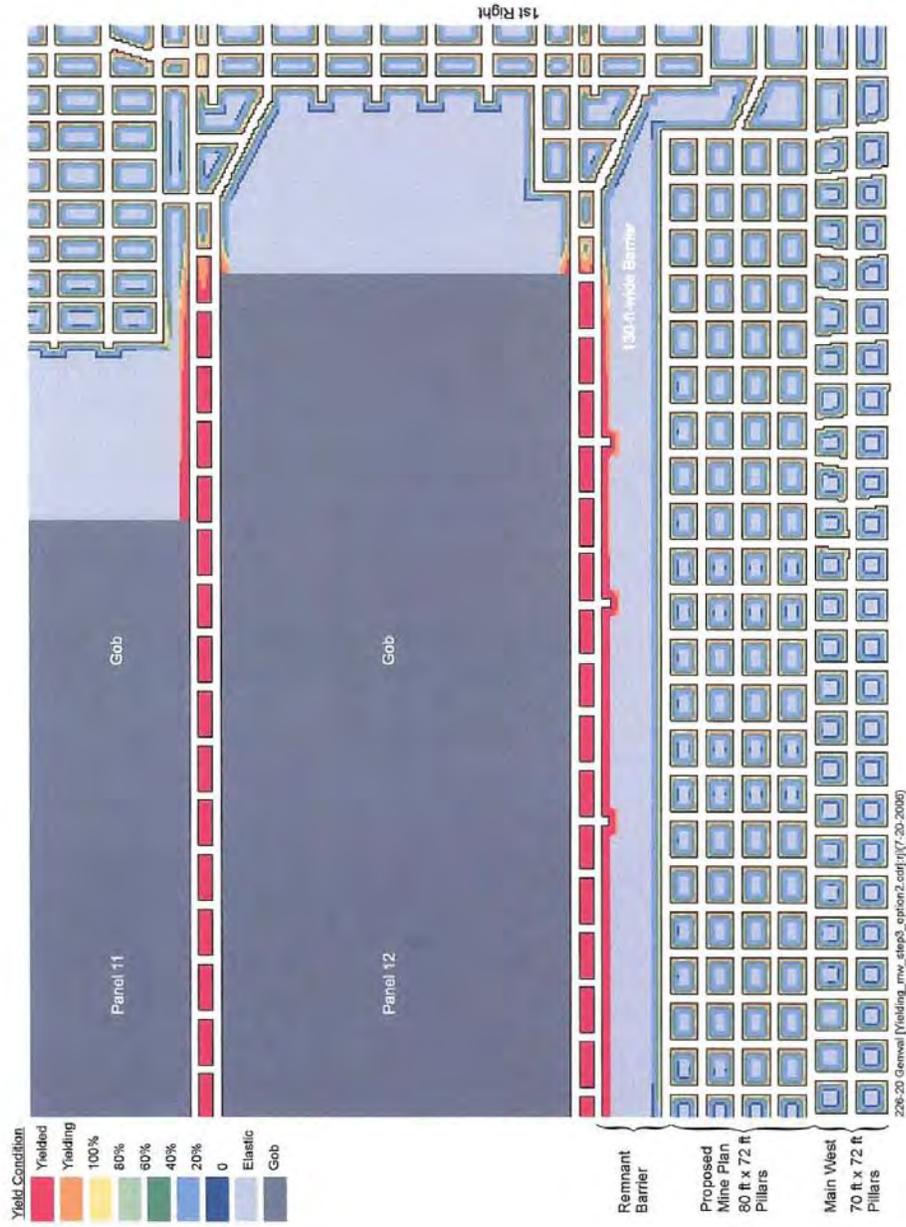
Figure 23. Modeled Coal Yielding—Main West Barrier with 60-ft by 80-ft Pillars

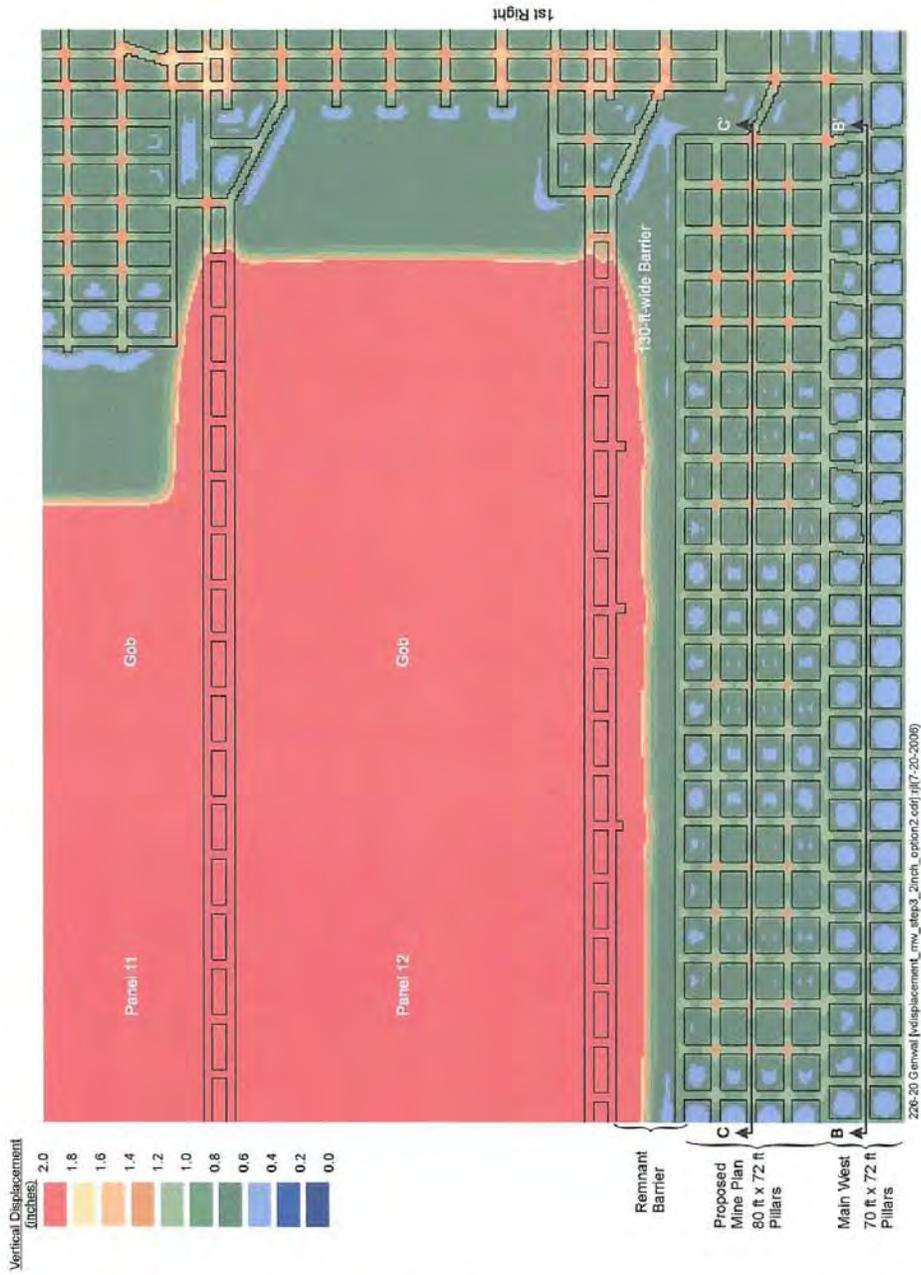
Figure 24. Modeled Roof-to-Floor Convergence—Main West Barrier with 60 ft by 80 ft Pillars
